Slowing and containing the flow at Southrepps Estate

A case study of on-farm improvements

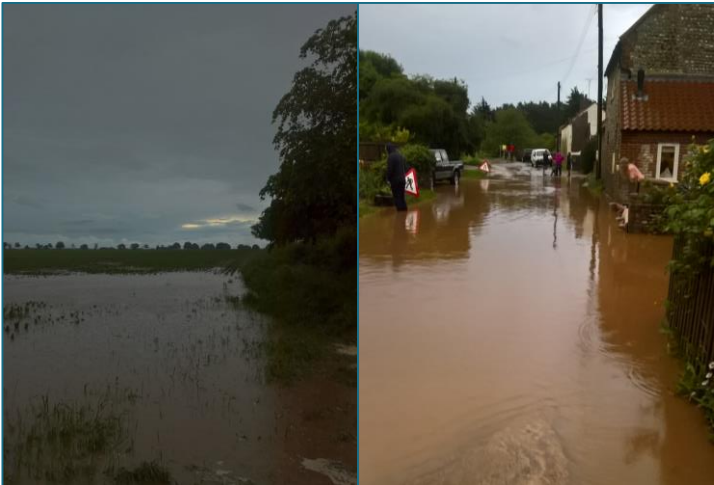
Figure 3. Run-off rapidly washing off field (left) and flooding in the Southrepps village (right).

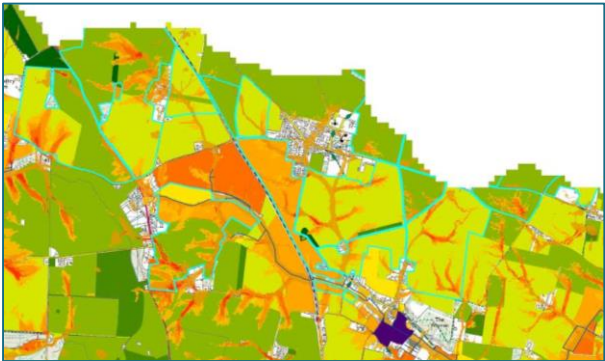
In August 2016, an initial farm visit was undertaken at the Estate by a Norfolk Rivers Trust farm advisor. This involved the use of water flow and field connectivity mapping (Figure 4), a walkover survey, and a discussion with the farm manager. The visit identified where potential issues remain, and which of these posed the greatest threat.

Figure 4. Water flow across fields (orange/red ‘flashes’) and how connected fields are to a watercourse (green = least connected, through to yellow and orange, and dark orange/red = most connected).

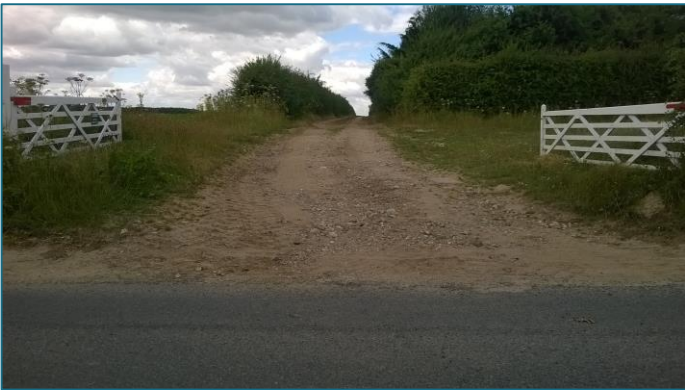
The farm track running between Manor Farm and Pitt Street was a major pathway for run-off and erosion. The track had a long slope, which enabled run-off to flow downhill across the yard and into a drain, which runs directly into Fox’s Beck and then through to Southrepps Common SSSI (Figure 5). The surface of the track was inadequate for large farm machinery, causing rutting and compaction.

Figure 5. Farm track leading down to Pitt Street (before works).

Work involved re-aligning and resurfacing the track, reducing the vertical slope, and adjusting the camber of the track to direct the run-off horizontally into small grips in a woodland - this will prevent the water from washing straight down the track (Figure 6 & 7). As a failsafe, and to capture run-off from the final stretch of track, two ditch-type silt traps were also placed at the bottom of the track on either side, with bunding behind them to hold back flow (Figure 8).

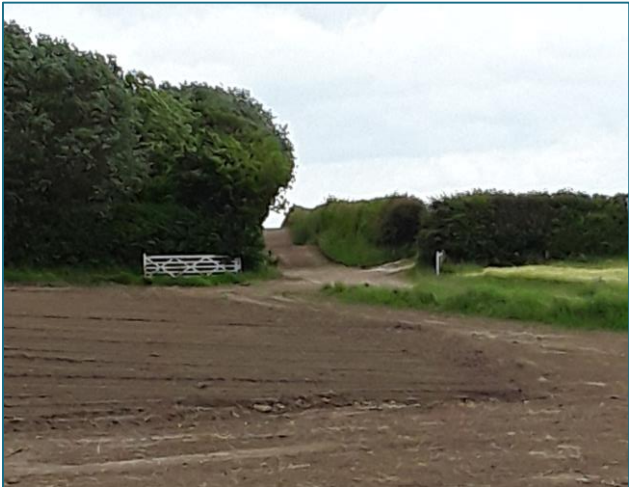
Figure 6. Farm track with re-worked tilt and camber (after works).

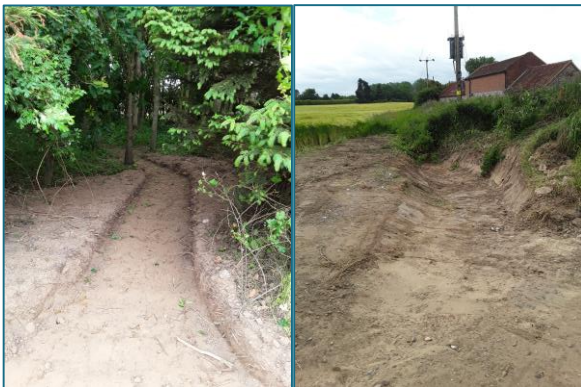
Figure 7. Grips leading to woodland from track (left) and diagonal ditch at bottom of track (right).

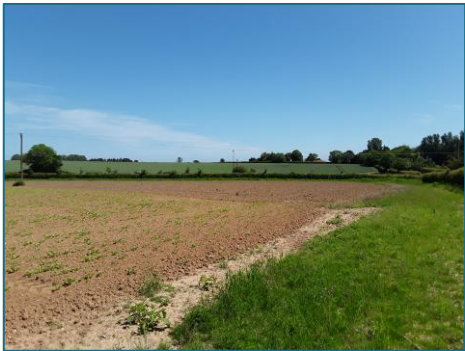
Figure 9. Newly sown corner buffer and field-edge buffer of 6m in depth.

26 hectares (ha) of new buffer strips were established along particularly vulnerable field boundaries and field corners. These will provide permanent vegetation cover to intercept run-off pathways and facilitate the settling out of sediments and pollutants. Pre-existing buffers were made wider where possible, ensuring that run-off could not wash straight over the strips during heavy downpours. In addition, native wildflower mixes were sown to provide nectar-rich food for pollinators and other invertebrates, as well as creating a vital source of seed for birds during the winter months (Figure 9).

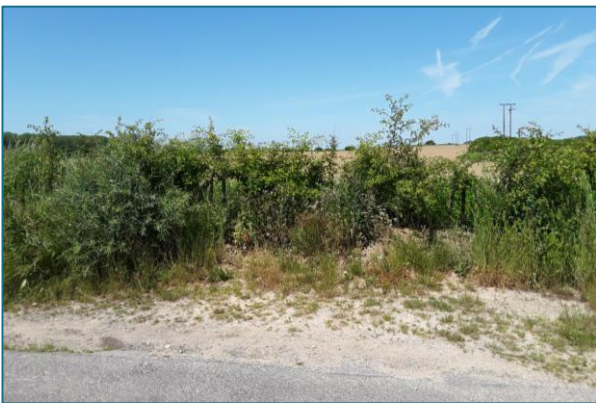
Figure 10. Gateway removed and blocked with a soil bund and new hedging.

Four high-risk gateways were removed and relocated to more appropriate locations e.g. away from low points. The old gateways were then bunded with soil and hedging to contain any run-off within the field (Figure 10).

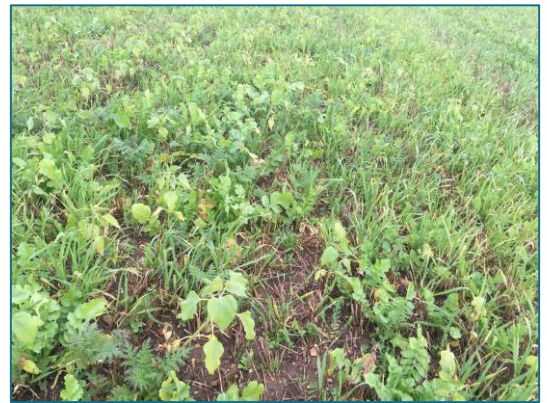
Figure 11. Cover crops as part of farm rotation.

Improving soil health on the Estate is essential for sustainable and profitable farming. 100 ha of cover crops have been introduced to the farm rotation (Figure 11). These crops are grown in fields during the winter months and provide many benefits to soil including:
