# Layer Brook

## Sediment Investigation

Essex and Suffolk Rivers Trust has been working with Essex & Suffolk Water and the Environment Agency to determine the best ways to investigate the sources of sediment and this report explains what has been and done and what has been found to date.

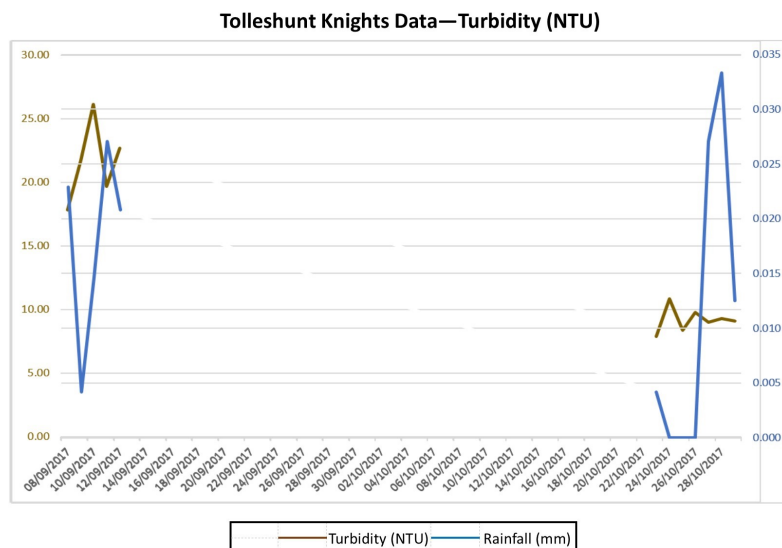
The data from Tolleshunt Knight is very limited at the equipment stop recording after the 18th October and due to problems with batteries there is no data from 14th September till the 22nd October.

It is very difficult to draw conclusions with such little data but the turbidity levels that were recorded at this point are low.

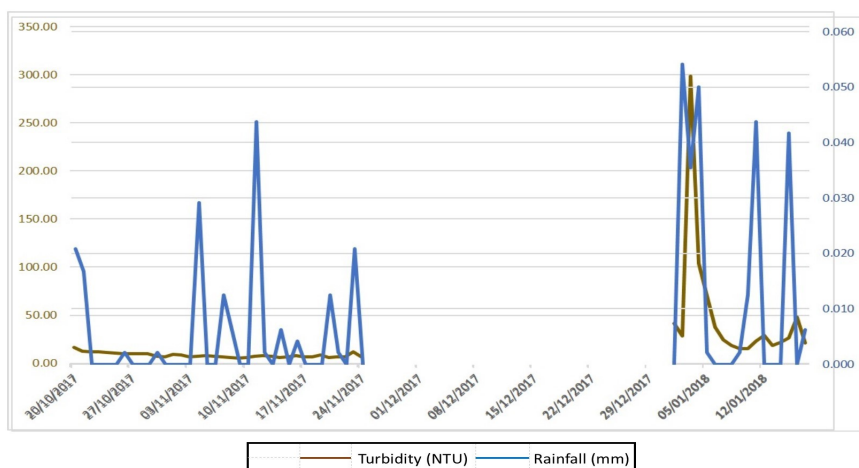
**Layer Marney Data—Turbidity (NTU) and Rainfall (mm) Data**

The data from Layer Marney has a gap between the 14th November 2017 and 3rd January 2018. This was due to problems with replacing batteries during this time. The data available shows one peak of turbidity in January that coincide with the rainfall event. This peak is the highest recorded amongst all the meters installed at around 310 NTU.

The turbidity data could be interpreted to indicate that the areas around Layer Marney and Rockingham Farm show the highest peaks of turbidity, however the meters in these areas gathered the most data and, perhaps more significantly, over the period of January 2018 when we had more rainfall than October—December 2018. Therefore the higher levels of turbidity in these two locations could be contributed to the time of year they were recorded. If the other meters were active during January, they may have shown similar peaks turbidity at all areas.

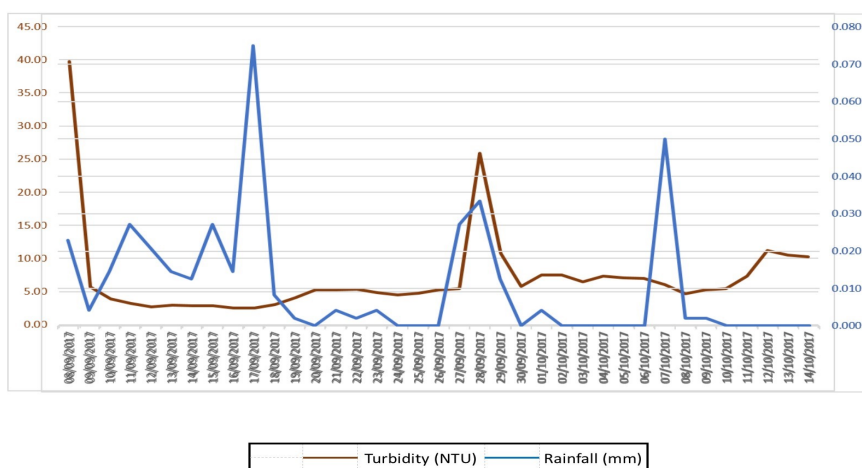
**Abberton Reservoir Data—Turbidity**

The data from Abberton Reservoir has no breaks but only covers the period 4th September till 14th October 2017. Again this was due to the equipment not recording after this date. The data shows only one peak around the 28th October (although as the data recording begins on 8th September but it is hard to determine the details as some of the data is missing) but there are 2 other peaks of rainfall that does not show a peak in turbidity. The reason for this is not know but could suggest that some activity or change in land use around this time in October resulted in levels of soil entering the brook to be greater then at other times during the recording period.

Although a peak is shown at the time the levels are very low at only around 26 NTU.

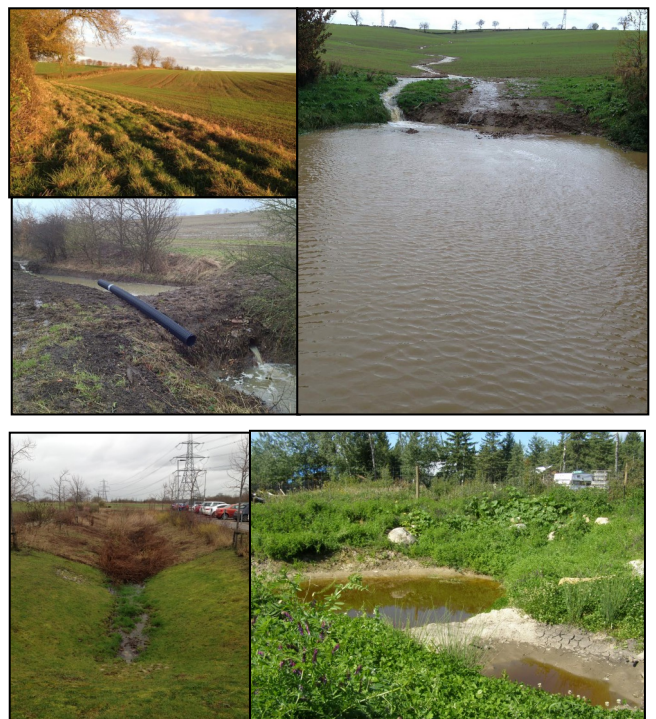
**Top Clockwise:** buffer strip; between field and river, interceptor pond; land runoff drains into the pond, remains long enough for sediment to drop out then flows into the water course, bund; under constructed within a ditch, this slows the flow and allowing sediment to drop out.

**Bottom left-right:** swale; vegetated ditch where runoff can collect and slowly filter through the ground into the ground water, Silt trap; a shallow pool connected to a ditch that stores land drainage. Both above features slow the water so that sediment is able to drop out and remain on the land.
