National analyses of nourishments;

*Coastal state indicators and driving forces for Domburg,
the Netherlands*

Date: 11/08/2021
Status: Final version

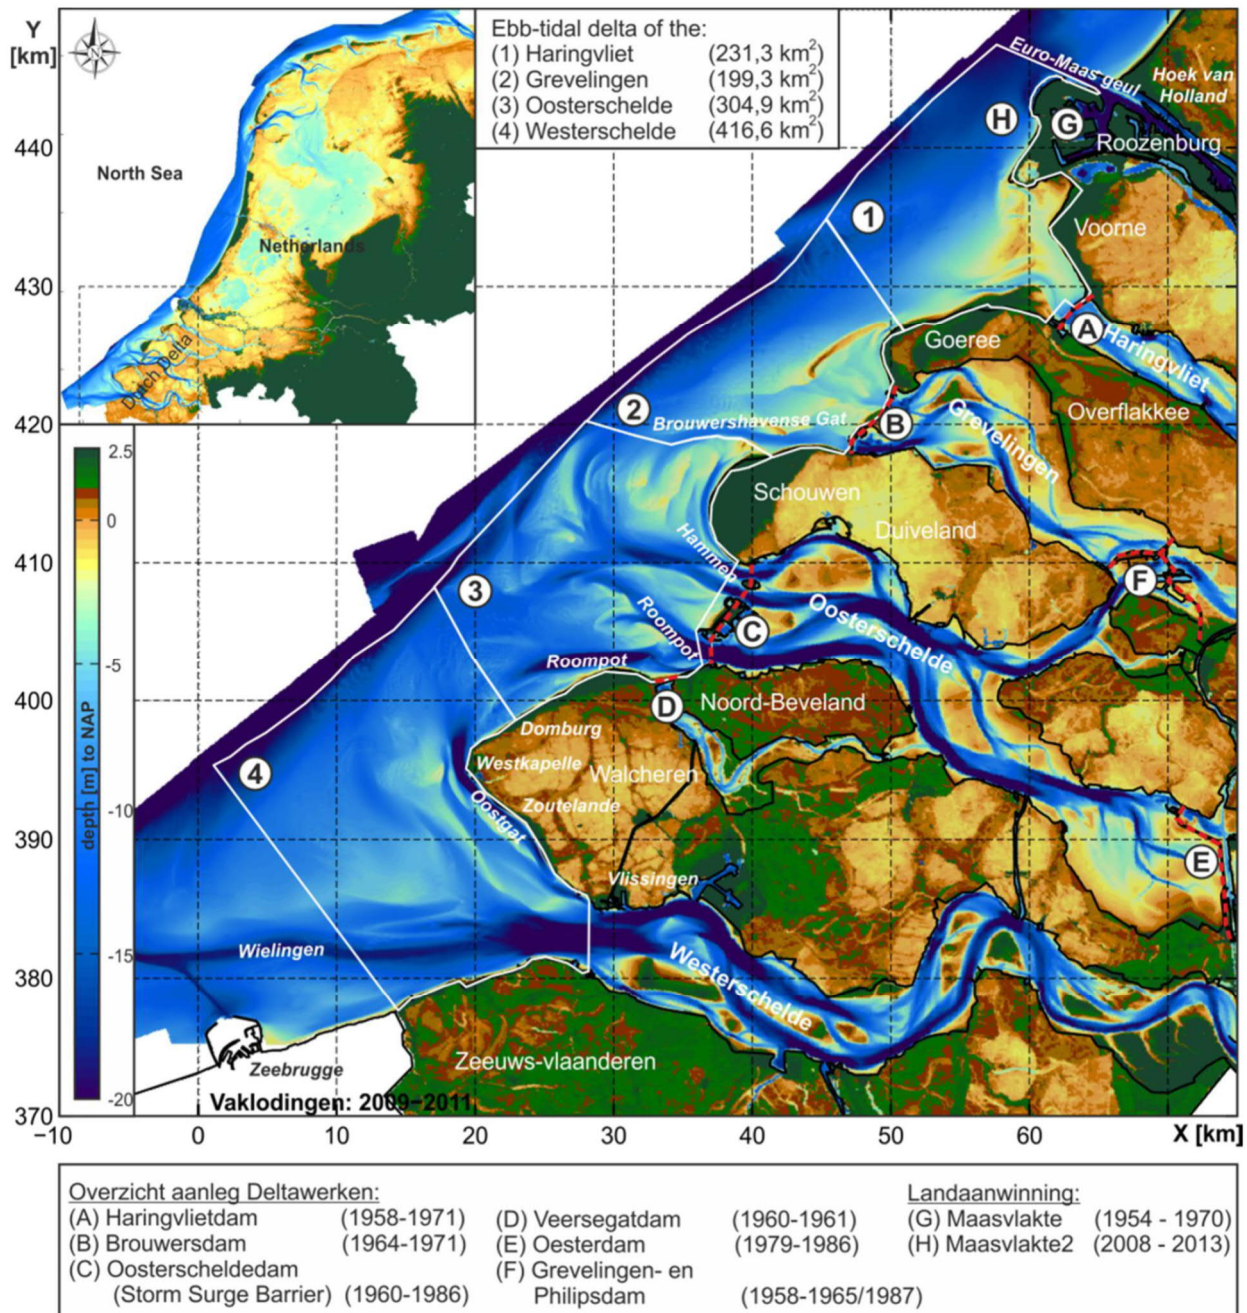
Figure 2: An overview of the coastal area near Domburg. The numbers and white lines indicate the ebb-tidal deltas. The dotted red lines and the letters indicate the major closer dams of the Delta Works. Reprint from (Elias , Spek, & Lazar , 2016)

The coastal laboratory of Domburg is located in the southwestern part of the Netherlands situated near the city Domburg (Figure 2). It is enclosed by the Eastern Scheldt estuary to the North and by the Western Scheldt to the South. The area is characterised by morphological features typical for such an environment, like ebb tidal deltas and tidal channels. The behaviour of these features strongly influences the management and maintenance of the coast. The area are strongly influenced by the waves, (tidal) currents, human interference and interactions between these processes.

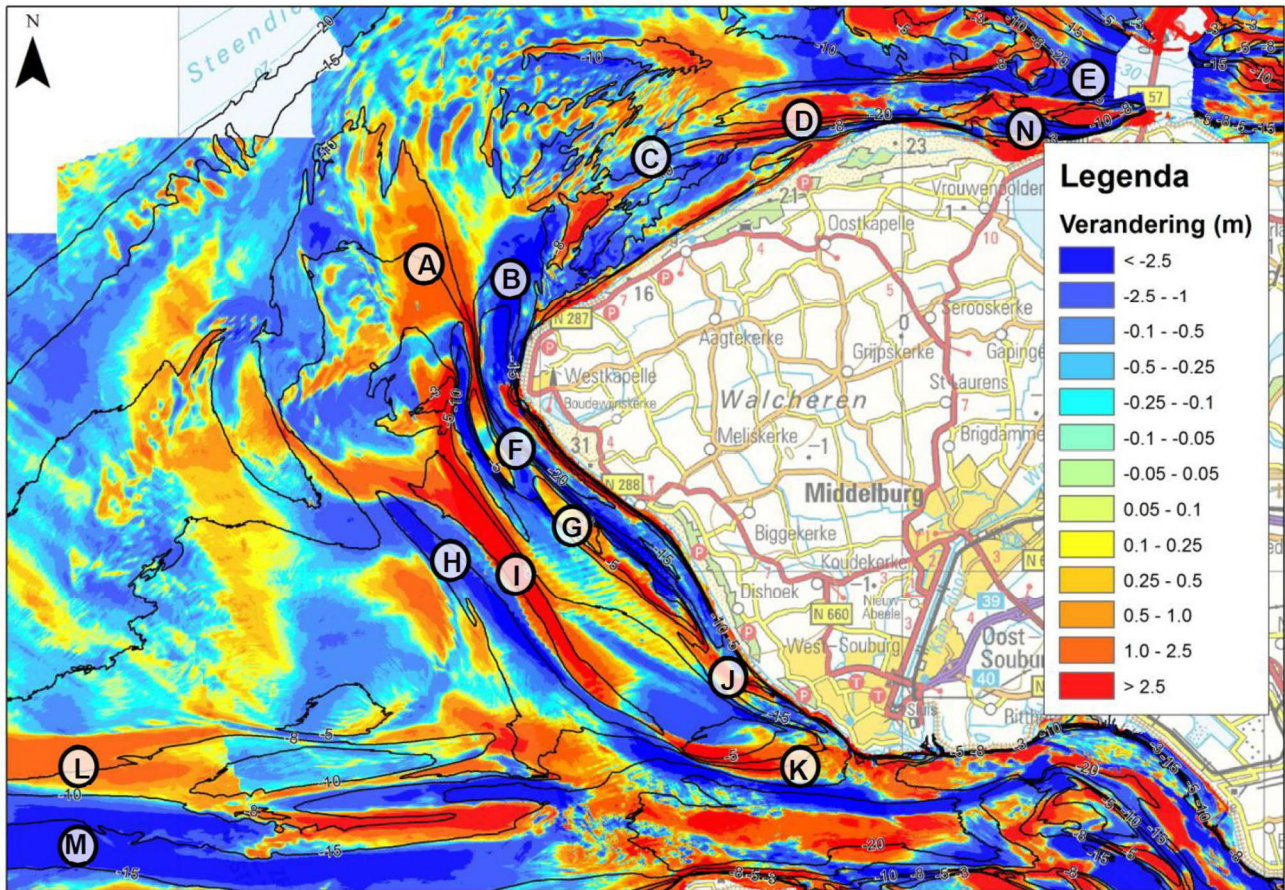
Figure 3: Map of the difference in bed level 1964 – 2010/2011 combined with the contours of 2010/2011. Several important morphological changes are indicated by the letter A till N. East of "L" an abrupt jump can be observed. This jump results from a difference in grid resolution between datasets and has no physical meaning. Reprint from (Vermaas & Bruens, 2012).

To indicate the dynamics in the system the morphological changes are shown in Figure 3. The letters indicate several large morphological changes:

- A. Sedimentation North of the Rassen.
- B. The Oostgat is expending northward.
- C. The Roompot is expending westward.
- D. Sedimentation of the Roompot.
- E. Erosion in front of the Eastern Scheldt storm surge barrier.
- F. Deepening of the Oostgat.
- G. Narrowing of the Bankje van Zouteland
- H. Merging of de Geul van de Walvischstaart and Deurloo-West
- I. A sandbar arises between Rassen and Nolleplaat.
- J. Sedimentation of the sandbar at Oostgat/Sardijngeul
- K. Sedimentation eastward of the Nolleplaat
- L. Dumping ground for dredged sediment
- M. Deepening of the Wielingen due to dredging works.
- N. Sedimentation of the sandbar at the Veerse Gatdam and deepening of the Schaar van Onrust.

The figure suggests that the erosion of the beaches is limited and in several locations the dunes are growing. It should be taken into account that results from all the nourishment executed in this area are being displayed in the figure. Without these nourishments the coast would have been eroded significantly.

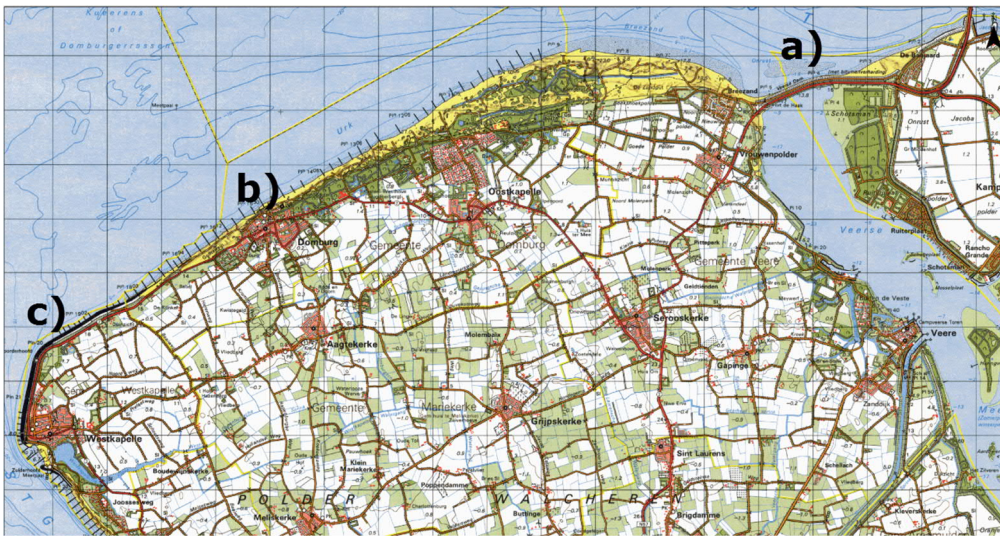
Figure 4: Overview map with coastal infrastructure: a) Veerse Gatdam with Eastern Scheldt storm surge barrier in the background, b) pole rows on the beach (black lines perpendicular to the coast), c) Westkapelse Seadijk.

At and in the vicinity of the nourishment location several coastal defence constructions are present. East of the location a former sea arm is closed off by a dam and the Eastern Scheldt storm surge barrier is located to the North. To the west, at the town Westkapelle, a sea dike is constructed. At the nourishment location itself wooden poles in rows perpendicular to the shore are present on the beach. An overview of the locations is given in Figure 4, images can be found in Figure 5.

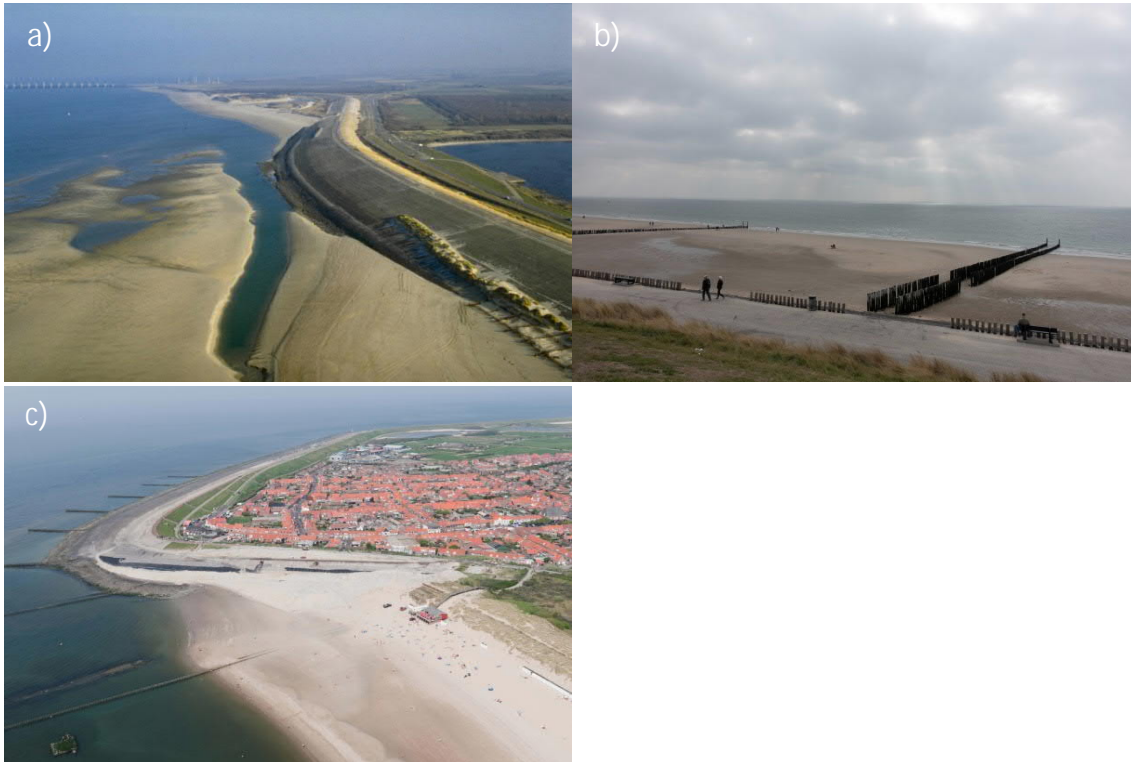
Figure 5: Coastal infrastructure around the nourishment location: a) Veerse Gatdam with Eastern Scheldt storm surge barrier in the background, b) pole rows on the beach, c) Westkapelse Seadijk. Source: <http://beeldbank.rws.nl/>.

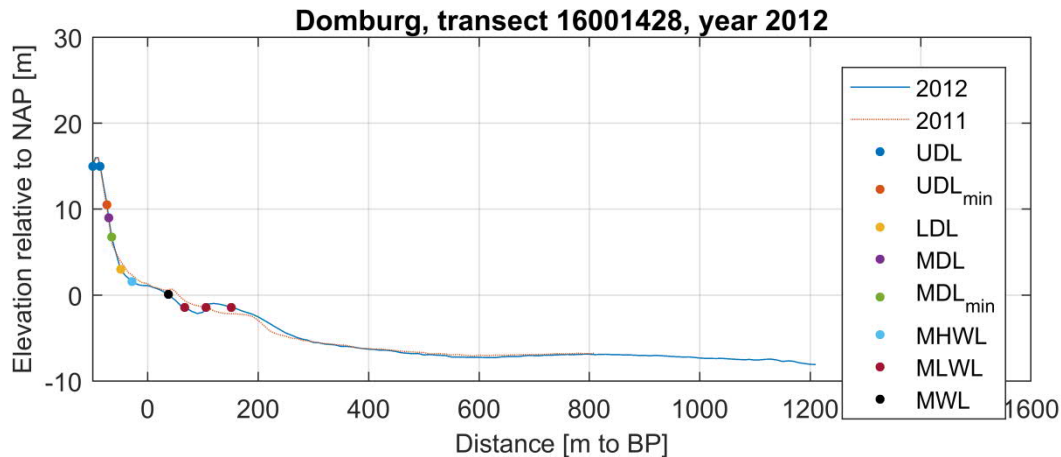
Figure 6: An example of coastal profile and the levels described as in 4.2.1. UDLmin means the Upper Dune Level minimum and the MDLmin the Mid Dune Level minimum.

A typical beach profile at Domburg is visualised in Figure 6, including the levels of the coastal state indicators (CSI's) for this lab (see paragraph 4.2.1). The values of the CSI's are given in Table 2. The profiles shows the first dune, a relatively small beach and a gently sloping shoreface without breaker bars.

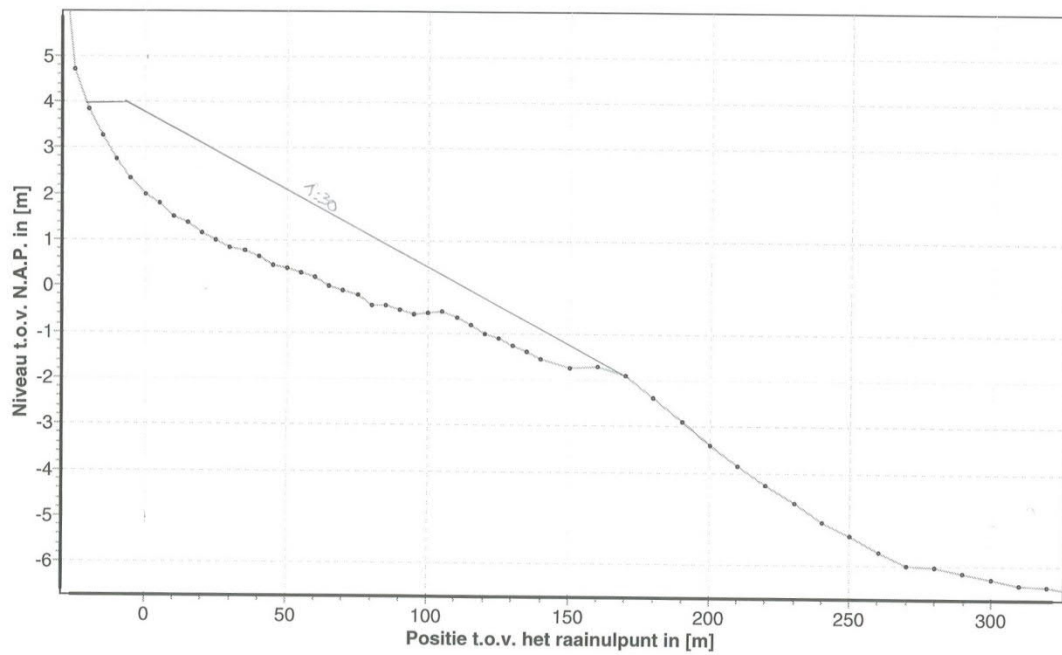
Figure 7: The design of the nourishment at Domburg for transects 15.30. The design was based on the bathymetry of 2006.

The nourishment at Domburg consisted of a beach nourishment where sand was placed directly on the beach. This is typical for nourishments at Domburg. The nourishment is placed attached to the dunes and is designed at a height of NAP +4m. Like frequently done, a slope of 1/30 is applied resulting in landward position of the nourishment at a vertical position of NAP -1.9 m, see Figure 7. Other details of the nourishment are given in Table 3.

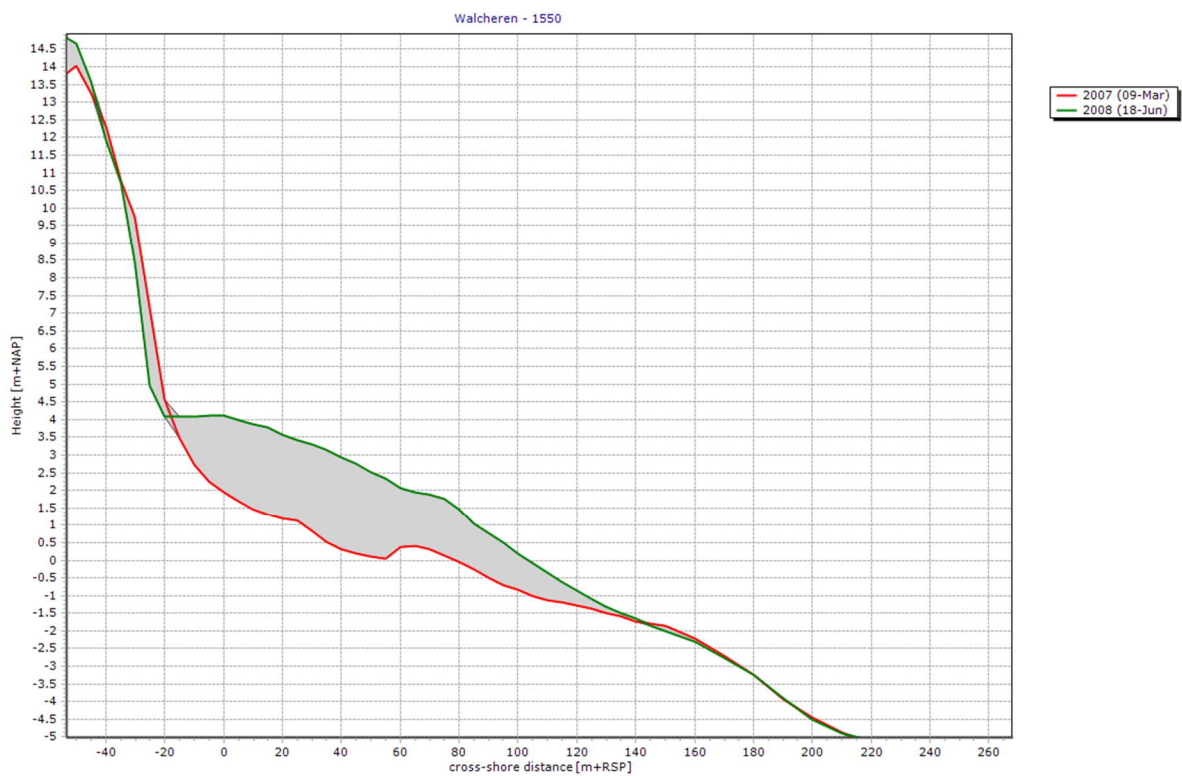
Figure 8: Placement of nourishment in transect 1550

The actual placement of the nourishment is very close to its design, see Figure 8 and Figure 9. During the measurement of 2008 only the central part of the nourishment was placed, approximately between transect 1509 and 1571. The other parts are visible in the measurement of 2009, as can be seen in Figure 9 and Figure 10.

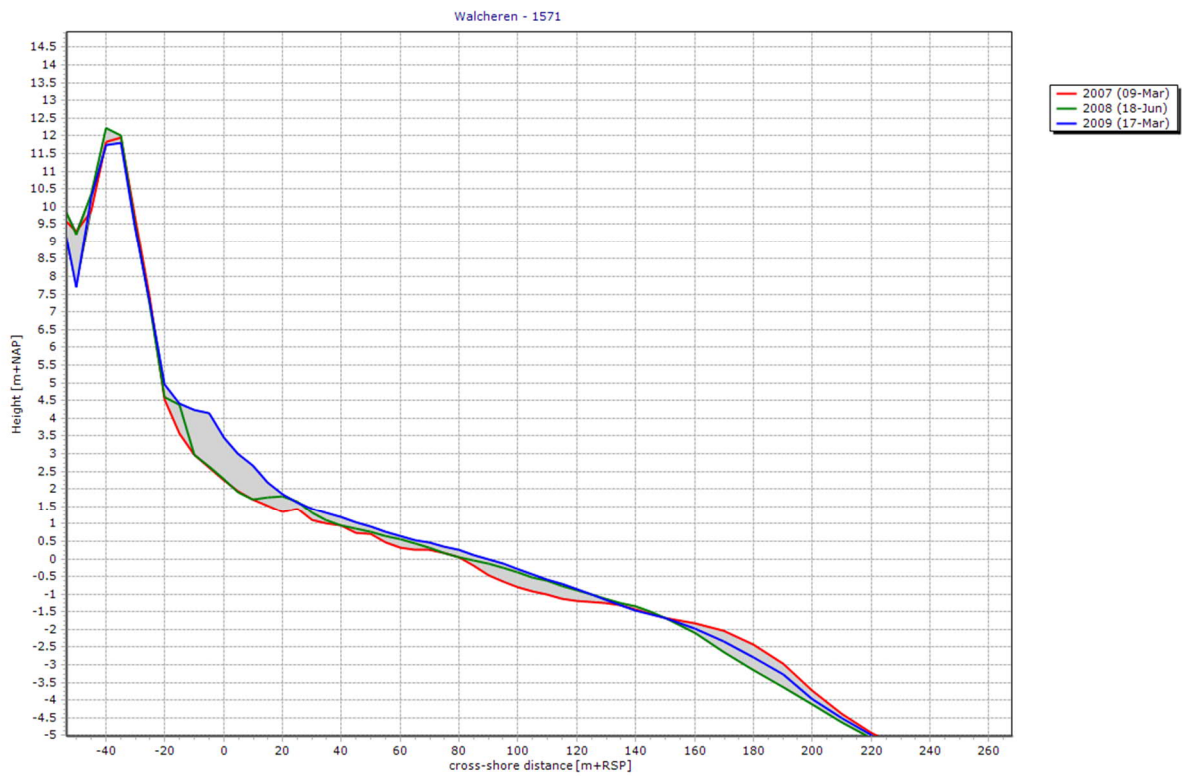
Figure 9: Placement of nourishment in transect 1571

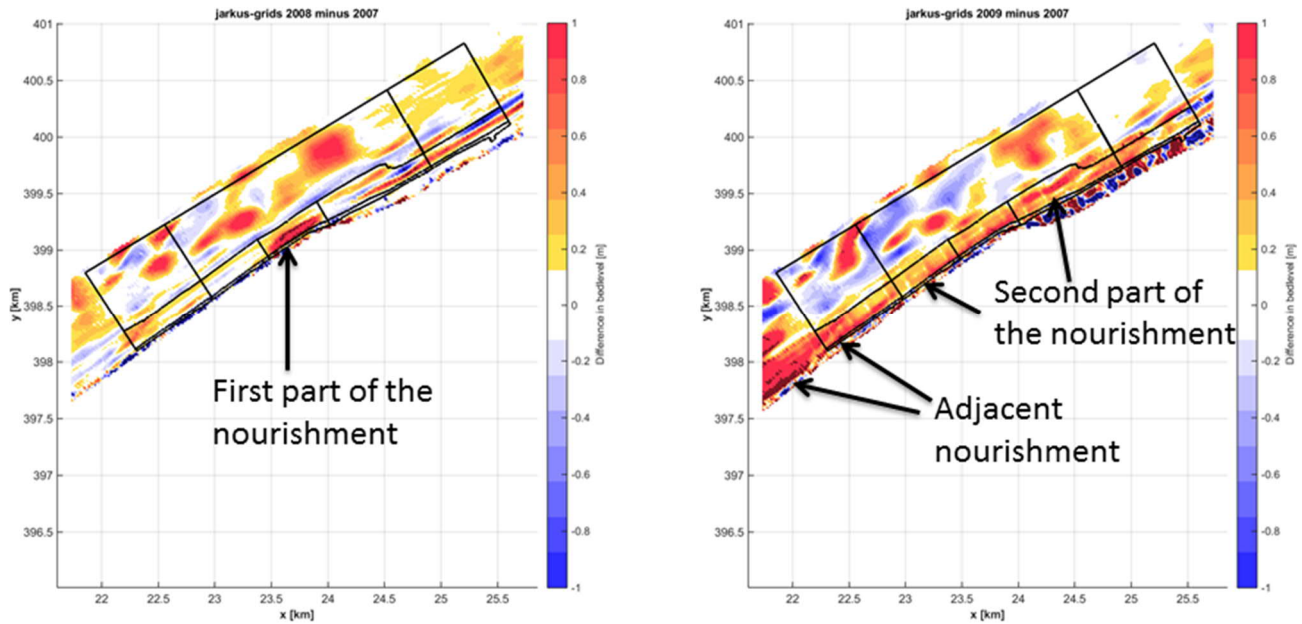
Figure 10: Placement of nourishment visible on difference maps 2008-2007 (left) and 2009-2007 (right)

In the central part the sediment volume increased between 2007 and 2008 with ca. 80.000 m³, in the entire nourished area with ca. 100.000 m³. In 2009 the entire nourished area gained ca. 180.000 m³ of sediment. This is much lower than the designed volume of ca. 370.000 m³, probably due to the long period between placement and, mainly, following measurement (2009) for the side parts, during which part of the nourished sediment already eroded.

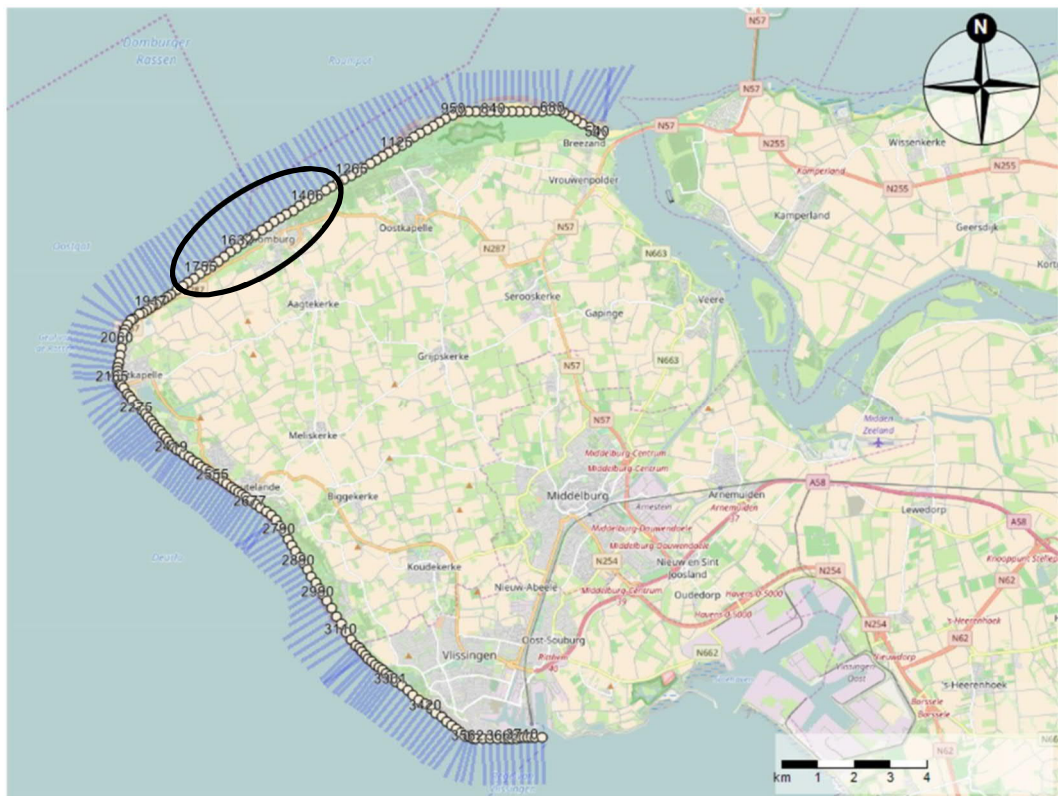
Figure 11: A top view of Walcheren. The blue lines indicate transect 540 till 1883. The black circle marks the transects which are considered in this report. Reprint from (Masterberg, Nederhoff, Valk, & Maarse, 2017)

Since 1965 the Dutch coast is yearly measured along cross-shore transects: the JARKUS transects, see Figure 11. These transects are located over the entire Dutch coast and are 130 to 210 m apart. For each transect part of the dunes, the beach and the shoreface is measured. The dry areas are measured using laser altimetry and the wet area by singlebeam echosounders. The data is combined to determine the vertical level along each transect. Because several sources are used, the cross-shore resolution changes from a 5 m resolution when altimetry data is used to a vertical level every 10 m for the echosounder data. Each year the position of the transects and the location of a vertical level along a transect are identical but extension of the measurement offshore differs.

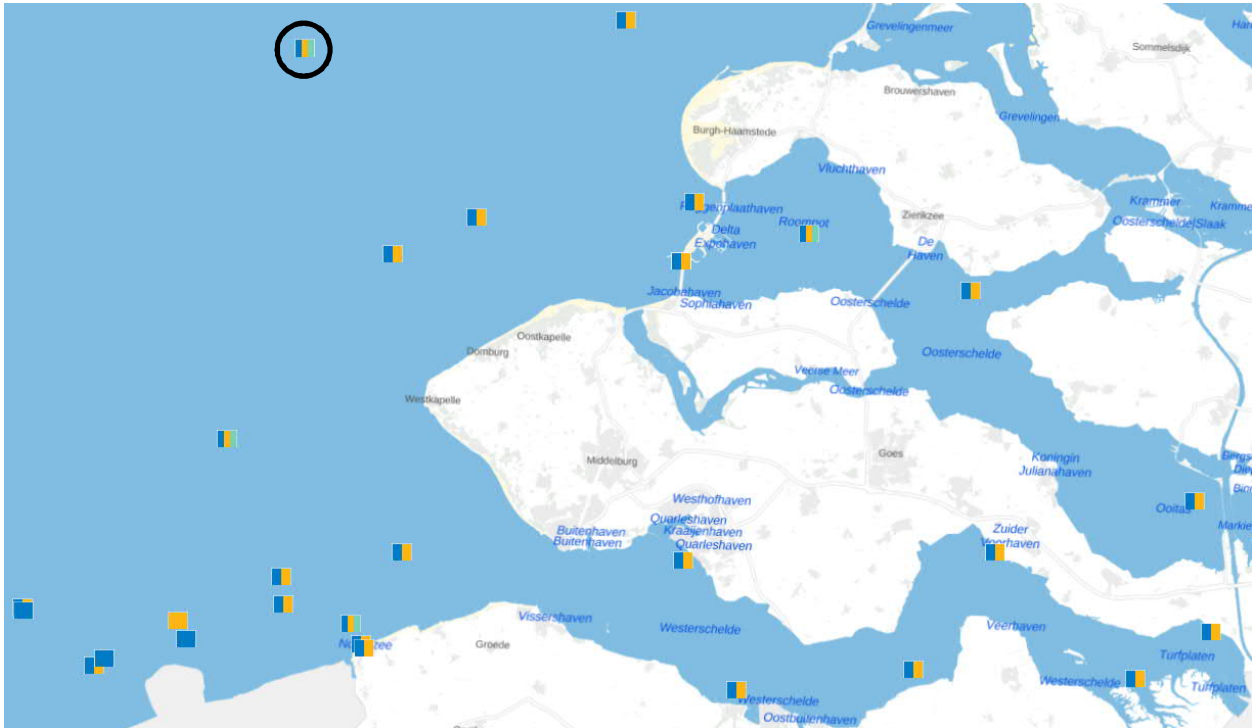
Figure 12: The measuring location for the wave height located in the area of Domburg. The vertical stripes of the symbols indicate which bulk wave condition is available at a station. The black circle marks the Europlatform; the station which is analysed in this report.

In front of the Dutch coast a considerable number of measuring locations are available, see Figure 12. Their data is freely provided by Rijkswaterstaat (waterinfo.rws.nl). The physical quantities measured at each station can be different at each location. Also, the duration of the measurements varies from location to location. For Domburg, several locations are combined to obtain sufficient data. The combination procedure is explained in Chapter 5.

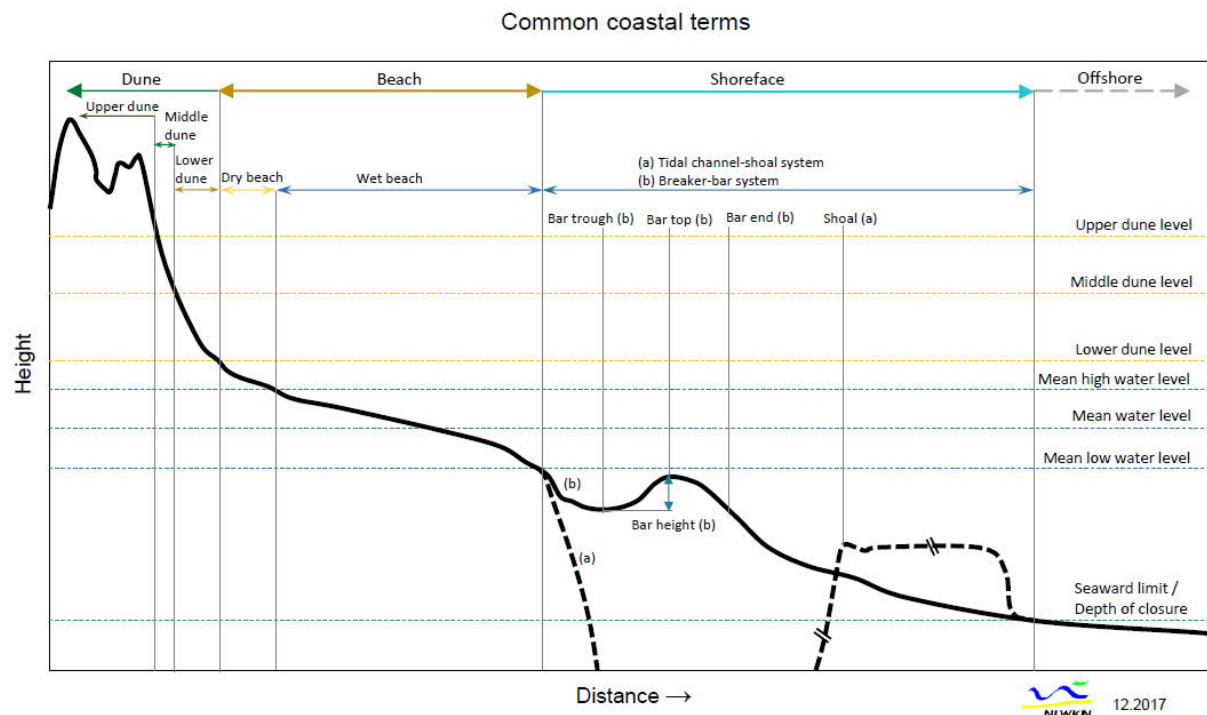
Figure 13: General definition/terminology coastal profile used. On the vertical axis various levels in the profile are shown. The horizontal axis shows different zones in the profile. Source: Simon Hillmann (NLWKN)

The coastal zone terminology in figure 1 will be applied throughout the analysis. The CSI's corresponding to the coastal terminology are shown in Figure 13 and described in Table 4. The morphological development

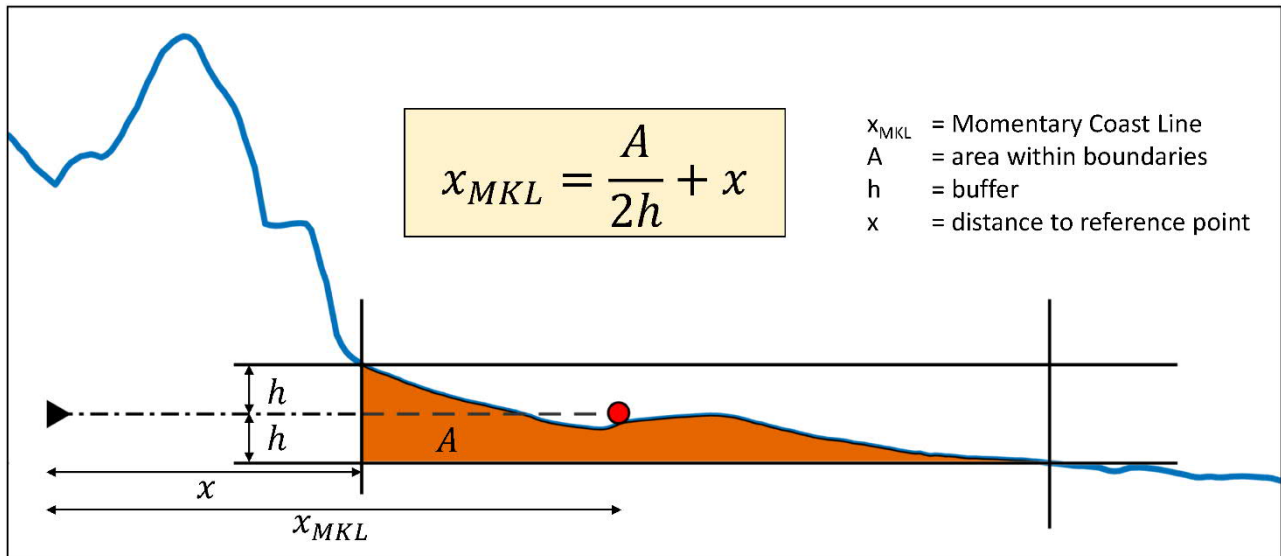
Figure 14: Example of the MKL-Model

The calculated distances to the physical marks are plotted in time-distance diagrams (change of one physical mark for one transect over time) and transect-distance diagrams (distance along the transects for one specific time, plotting multiple times with different colours). These graphs are used to analyse the development of the coastal area in time by visualizing trends of sedimentation or erosion, or periodic changes of both.

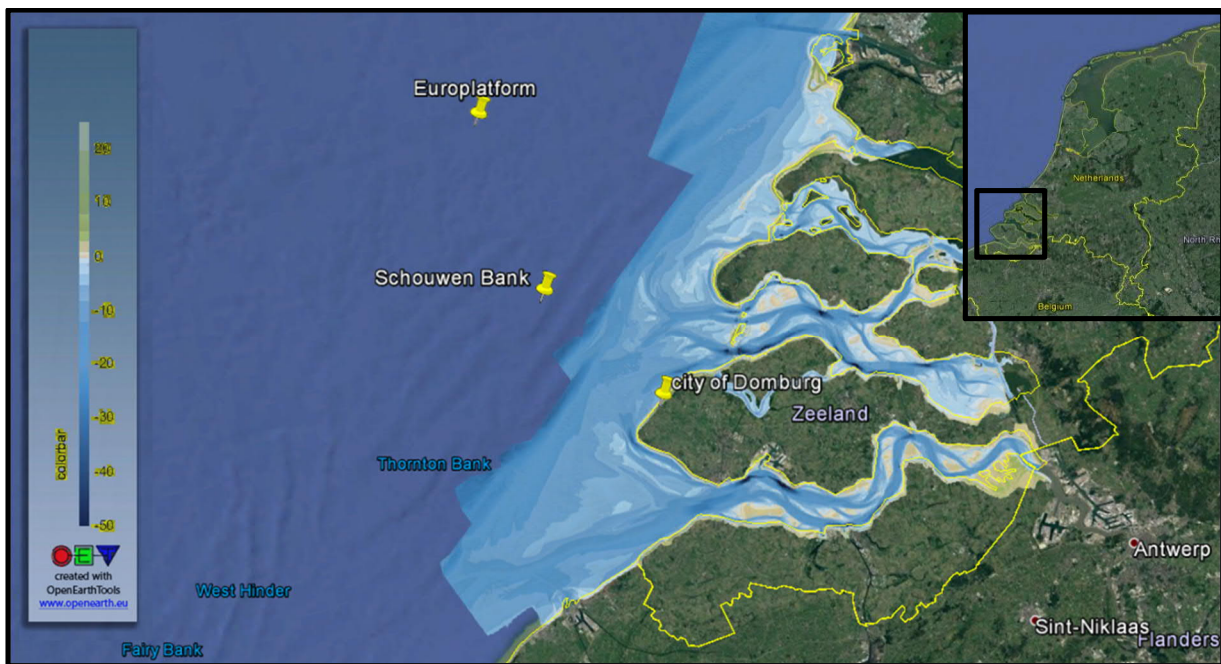
Figure 15: A google earth screenshot indicating the location of the Europlatform and the Schouwen Bank. The figure also contains the bathymetry based on the vaklodgingen.

For Domburg two logical measuring stations can be chosen: measuring location Europlatform and measuring location Schouwen Bank, see Figure 15. The measuring station Schouwen Bank is the station closest to the coastal laboratory. Therefore, the waves measured at this station should be most representative for the conditions at Domburg. On the other hand, only since 2004 measurements have been taken at the Schouwen Bank and the time series contains several intervals with no data, see Figure 16.

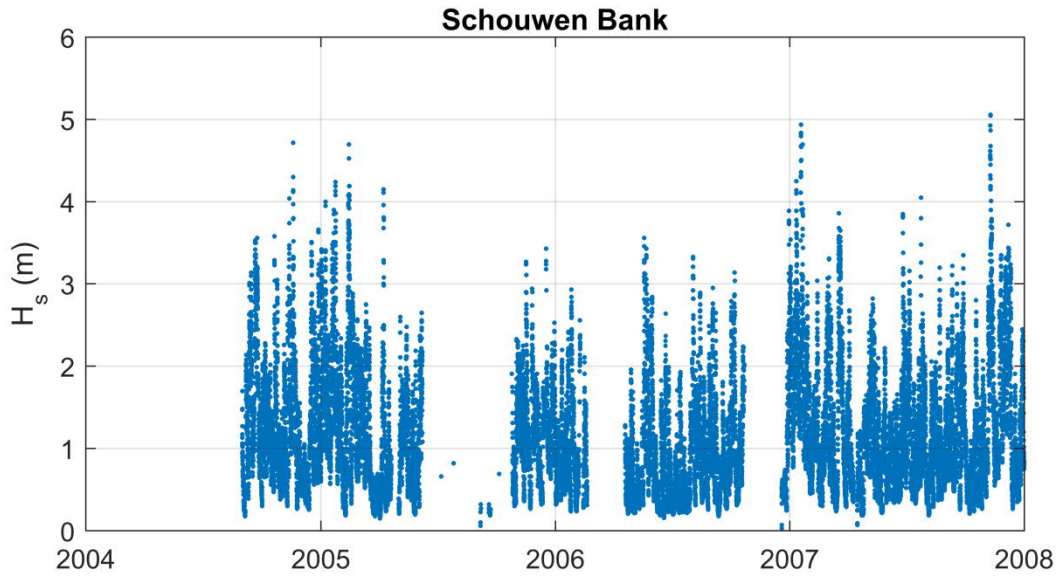
Figure 16: H_s measured at the Schouwen Bank before from 2004 till 2008.

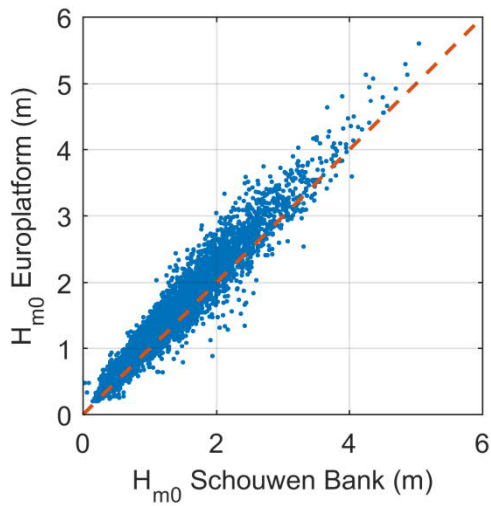
Figure 17: A scatterplot of the H_s measured at the Schouwen Bank and at the Europlatform from 2004 till 2008.

At the Europlatform the wave height is measured since 1989. These measurements can be used in the analysis if they show the same pattern as the measurements at Schouwen Bank. Only the pattern requires to be the same because it is going to be used in a qualitative analysis. Figure 17, Figure 18 and Figure 19 show scatterplots of the measurements from 2004 till 2008 for which at both location measurements were available. The scatterplots reveal a good comparison between the hydraulic conditions. Therefore, the hydraulic conditions measured at the Europlatform are used as a measure for the hydraulic condition at Domburg.

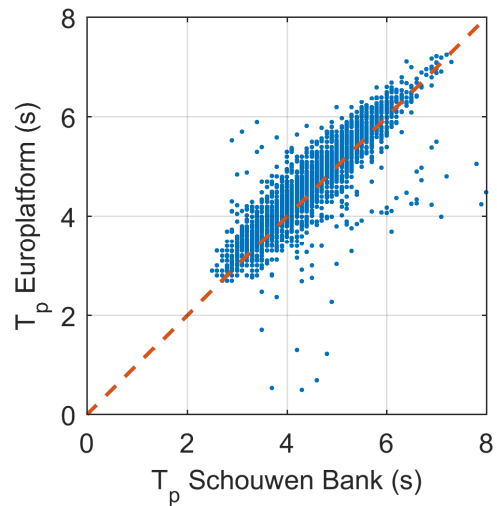
Figure 18: A scatterplot of the T_p measured at the Schouwen Bank and at the Europlatform from 2004 till 2008.

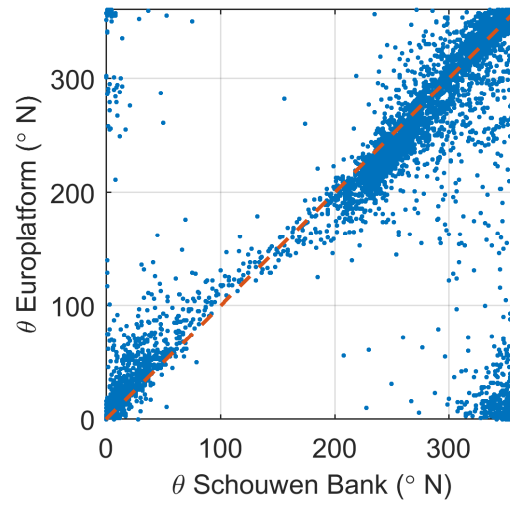
Figure 19: A scatterplot of the θ measured at the Schouwen Bank and at the Europlatform from 2004 till 2008.

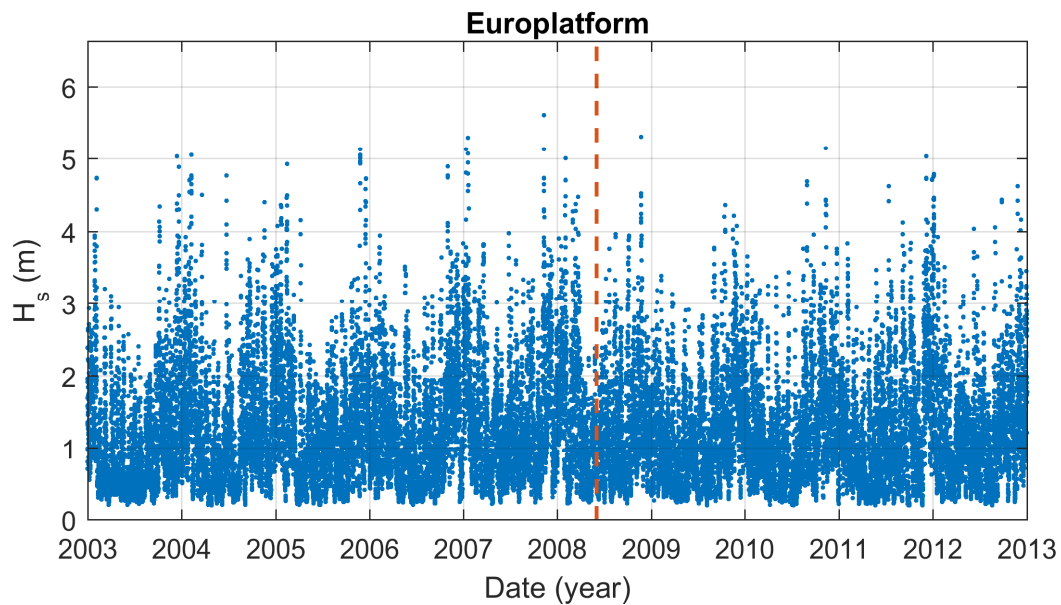
Figure 20: The measured value of H_s at the Europlatform. The red dotted line indicates the nourishment.

The measured time series at the Europlatform are given in Figure 20, Figure 21, Figure 22. The time signal for H_s shows several local maxima due to storms. The maximum H_s during a storm is in the order of 5–6 m and each year contains multiple storms. The peak period is in the order of 7 s during these events. The 7 s period is typical for wind generated waves. The direction shows a dominant direction from the 200° till 50°.

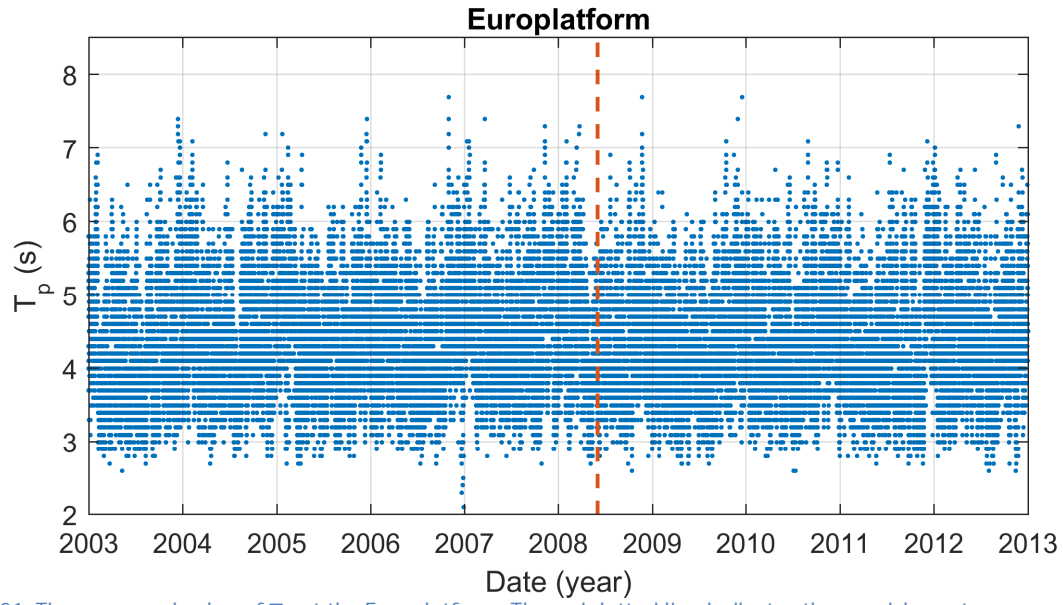
Figure 21: The measured value of T_p at the Europlatform. The red dotted line indicates the nourishment.

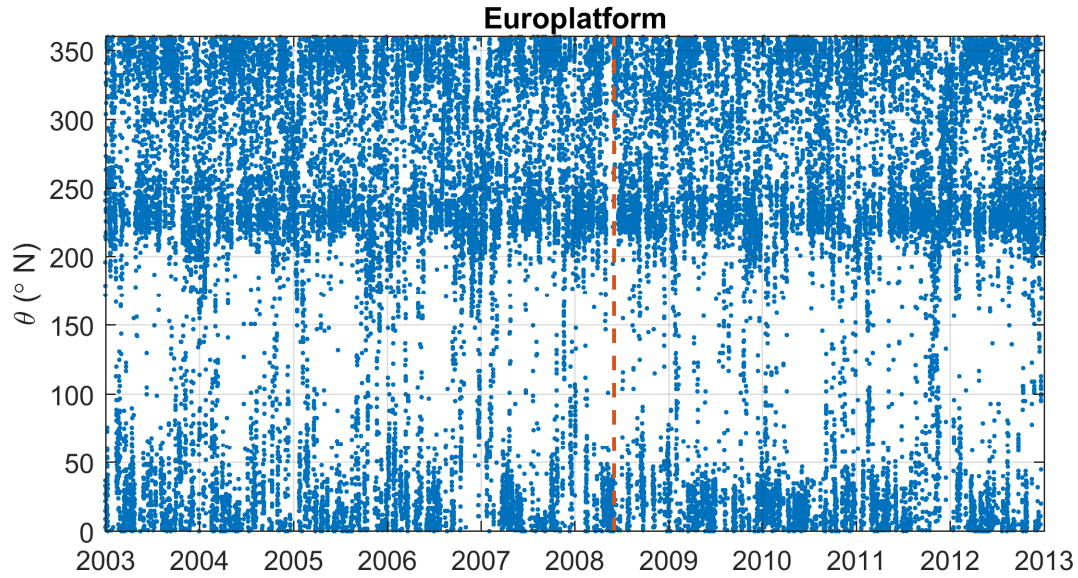
Figure 22: The measured value of θ at the Europlatform. The red dotted line indicates the nourishment.

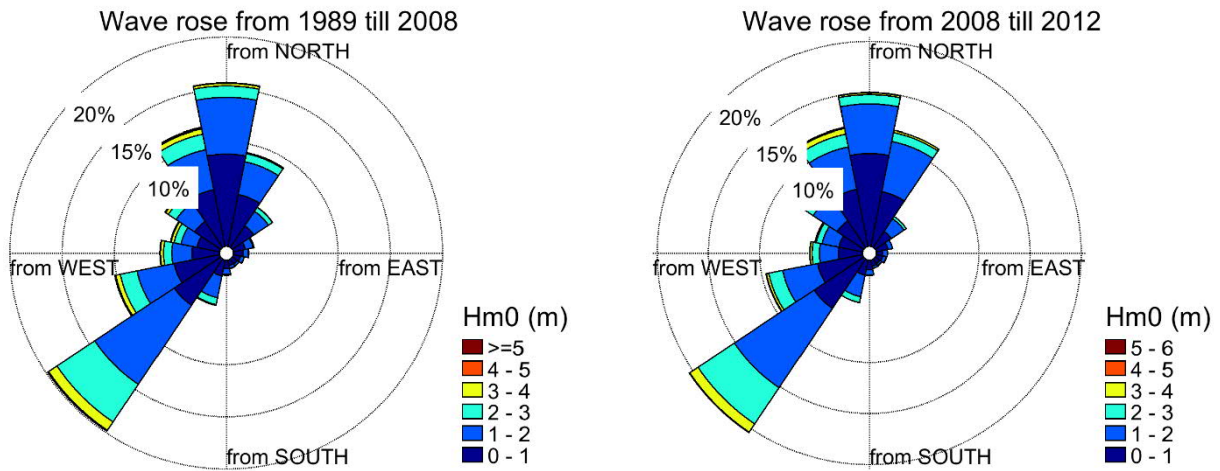
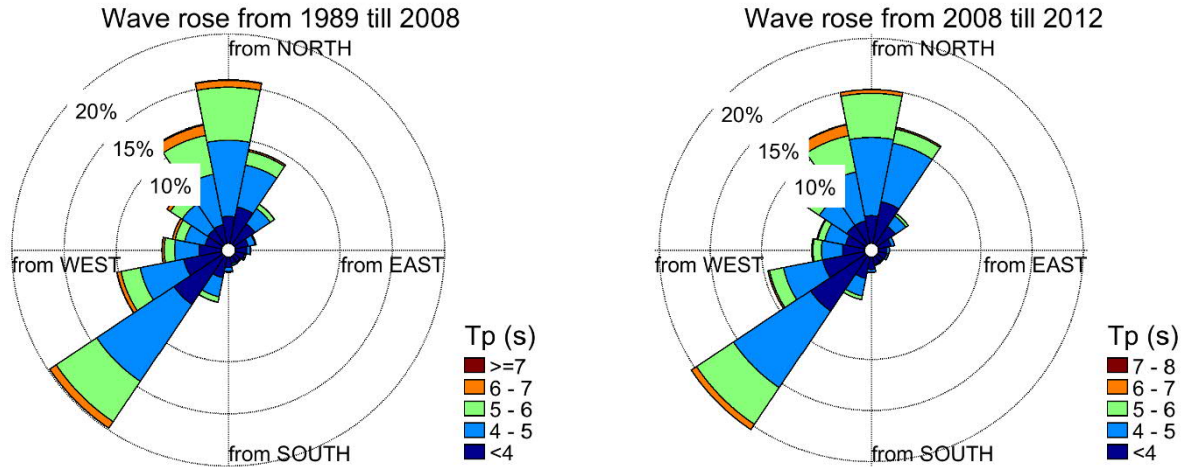
Figure 23: Wave roses based on the measurements at the Europlatform. The year 2003 till 2008 is before the nourishment and 2008 till 2012 is after the nourishment.

To further analyse the direction, wave roses are plotted, see Figure 23. All the four roses show two dominant peaks, from the North West and South West direction. It is a so-called bidirectional system. The wave rose for T_p has a similar shape as for H_s indicating the correlation between T_p and H_s . It means the waves are mainly wind generated. When the wave rose is investigated in more detail, it shows that the highest waves are coming from the North-West, the typical northwest storm. Most importantly, the wave roses show a similar pattern before and after the nourishment. In other words, similar hydrodynamic conditions took place before and after the nourishment.

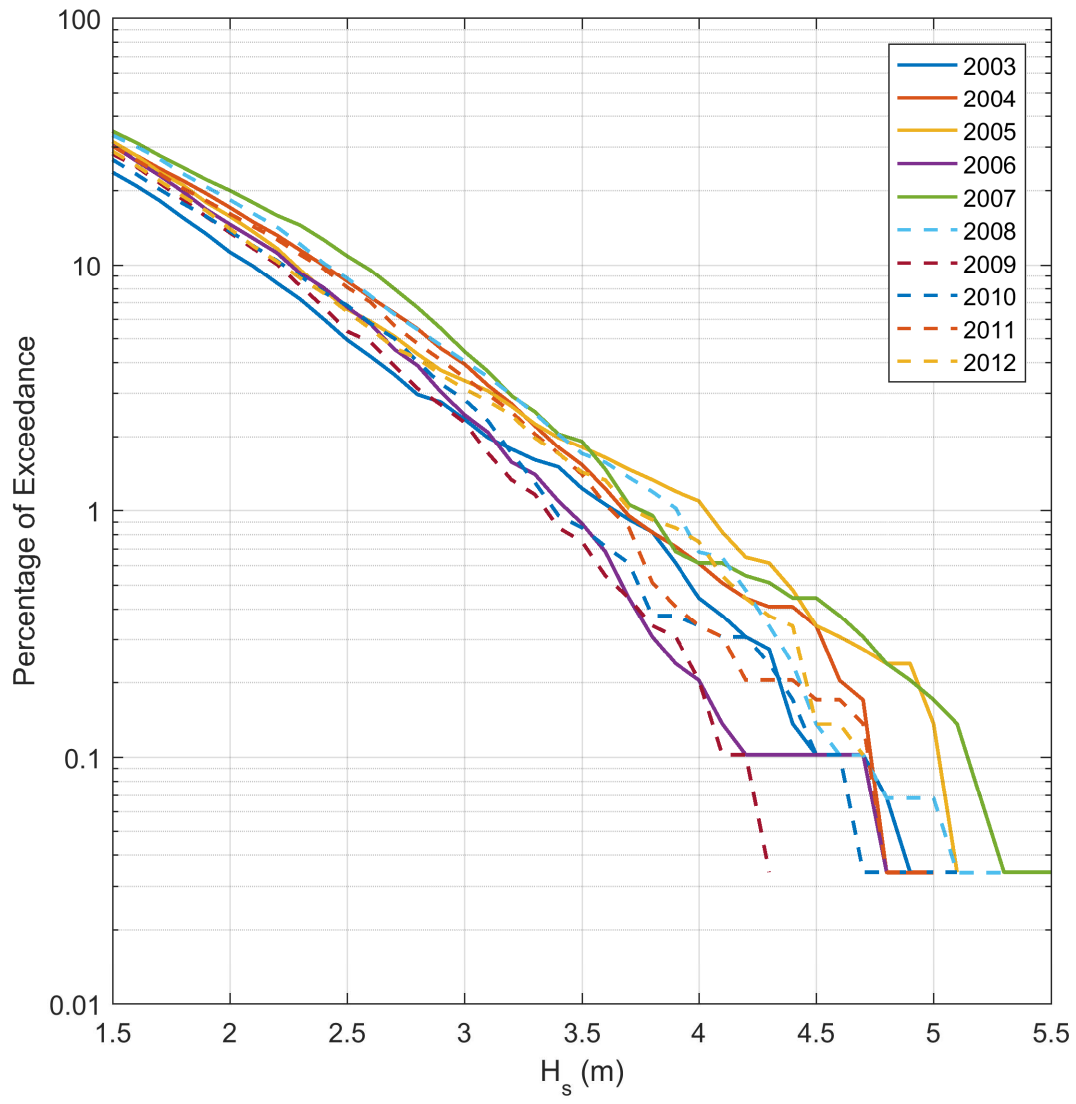
Figure 24: Percentage of exceedance of the measurements H_s at the Europlatform for each year.

In Figure 24 and Figure 25 the percentages of exceedance of H_s and T_p are visualised to compare the severeness of the hydraulic conditions. The solid lines are the years before the nourishment and the dotted lines after the nourishment. Overall, the percentage of exceedance for the solid lines is higher for the same value of H_s or T_p . It means that the hydraulic conditions before the nourishment were more harsh than after the conditions. Note, the percentage of exceedance is based on the number of measurements and not on the duration of a specific value.

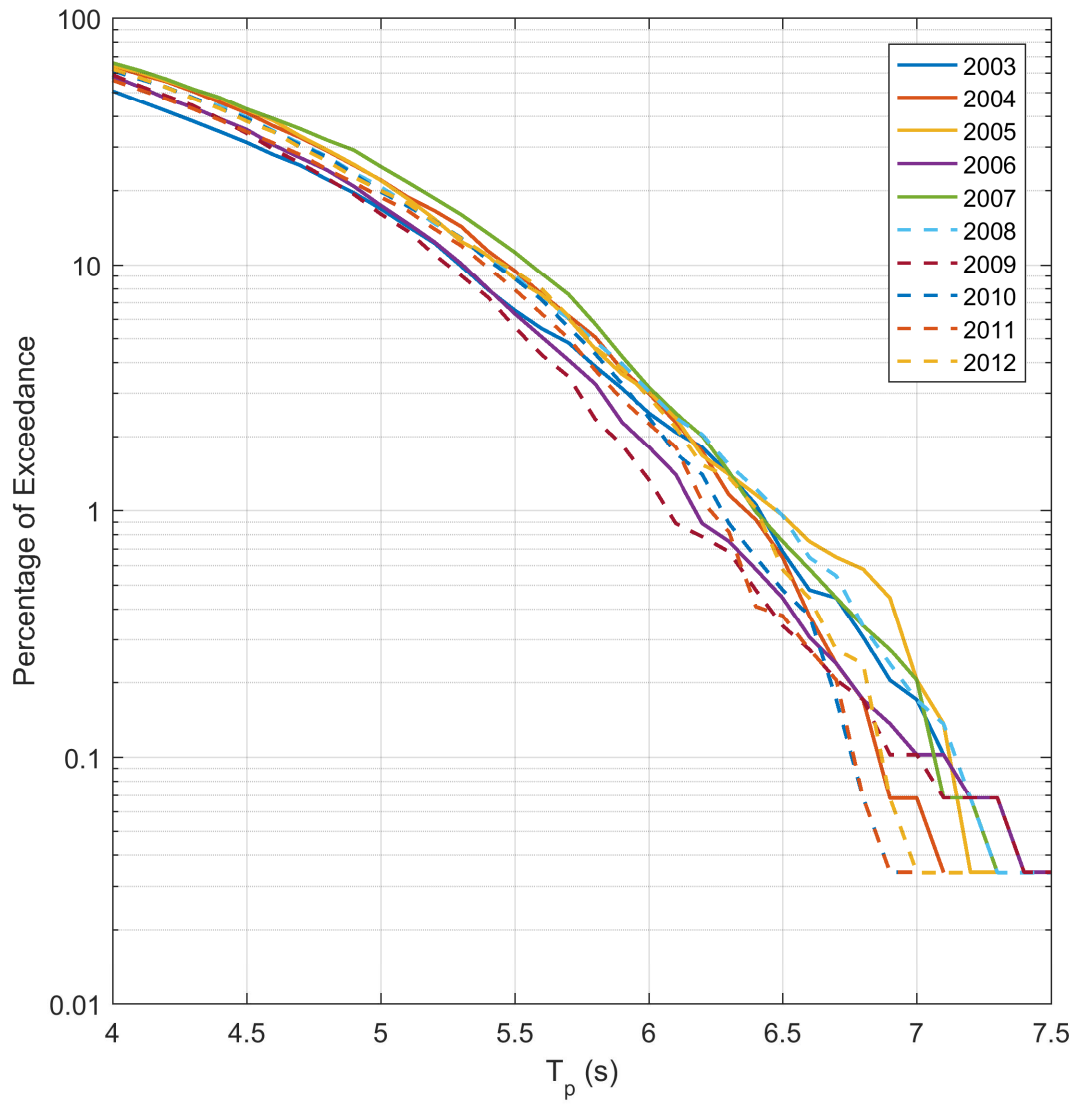
Figure 25: Percentage of exceedance of the measurements for T_p at the Europlatform for each year.
