National analyses of nourishments;

*Coastal state indicators and driving forces for Domburg,
the Netherlands*

Date: 11/08/2021
Status: Final version

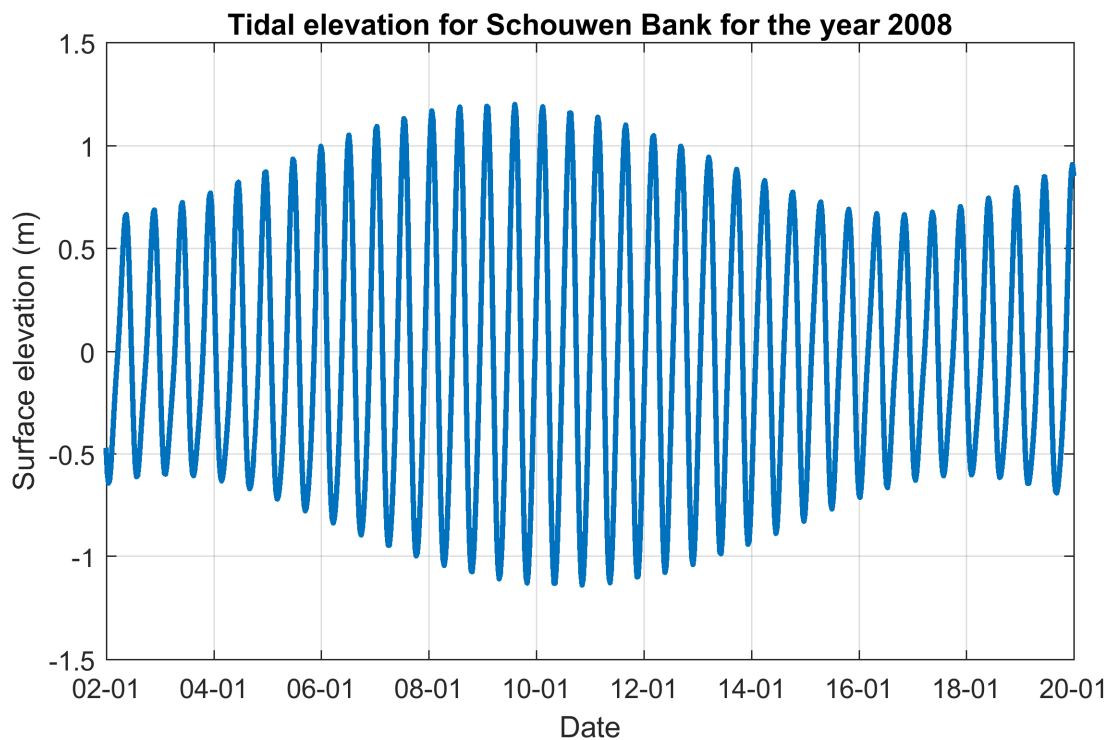
Figure 26: Part of the tidal signal from the IHO station Schouwen Bank.

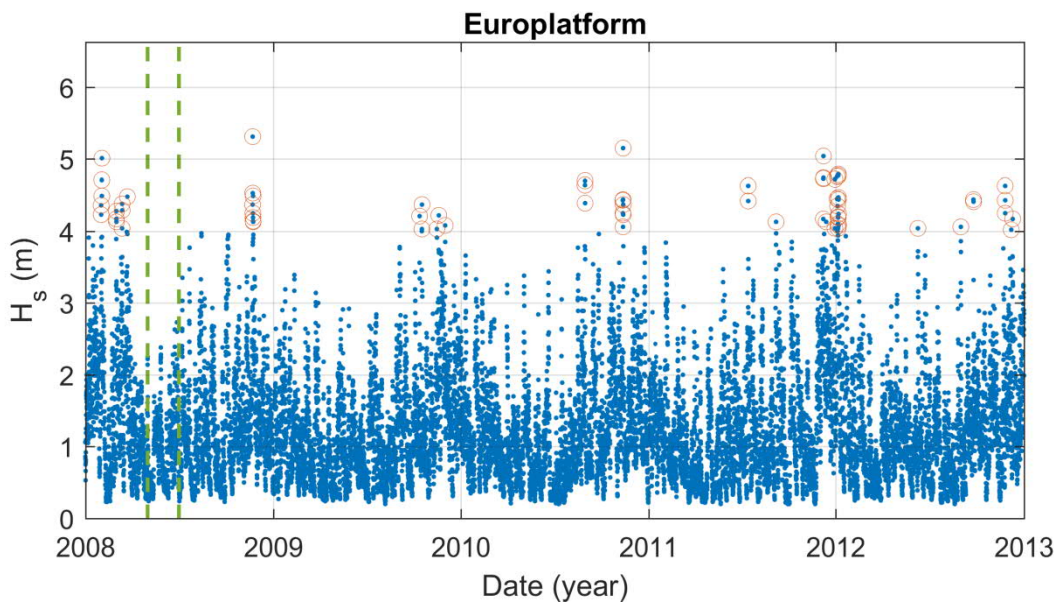
Figure 27: A time series of the wave height. The red circles indicate the events with $H_s > 4\text{m}$ and the green lines the start and end time the nourishment.

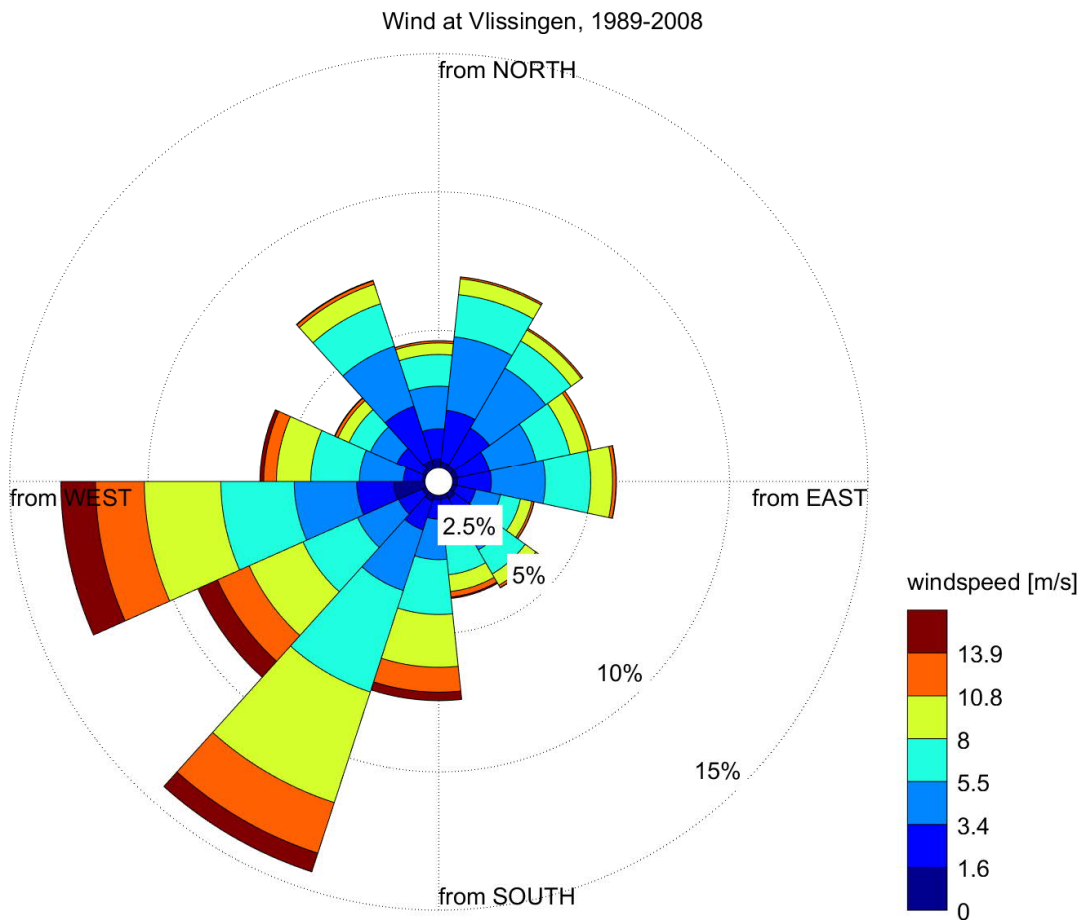
Figure 28: Wind conditions for the long term, pre nourishment period 1989-2008

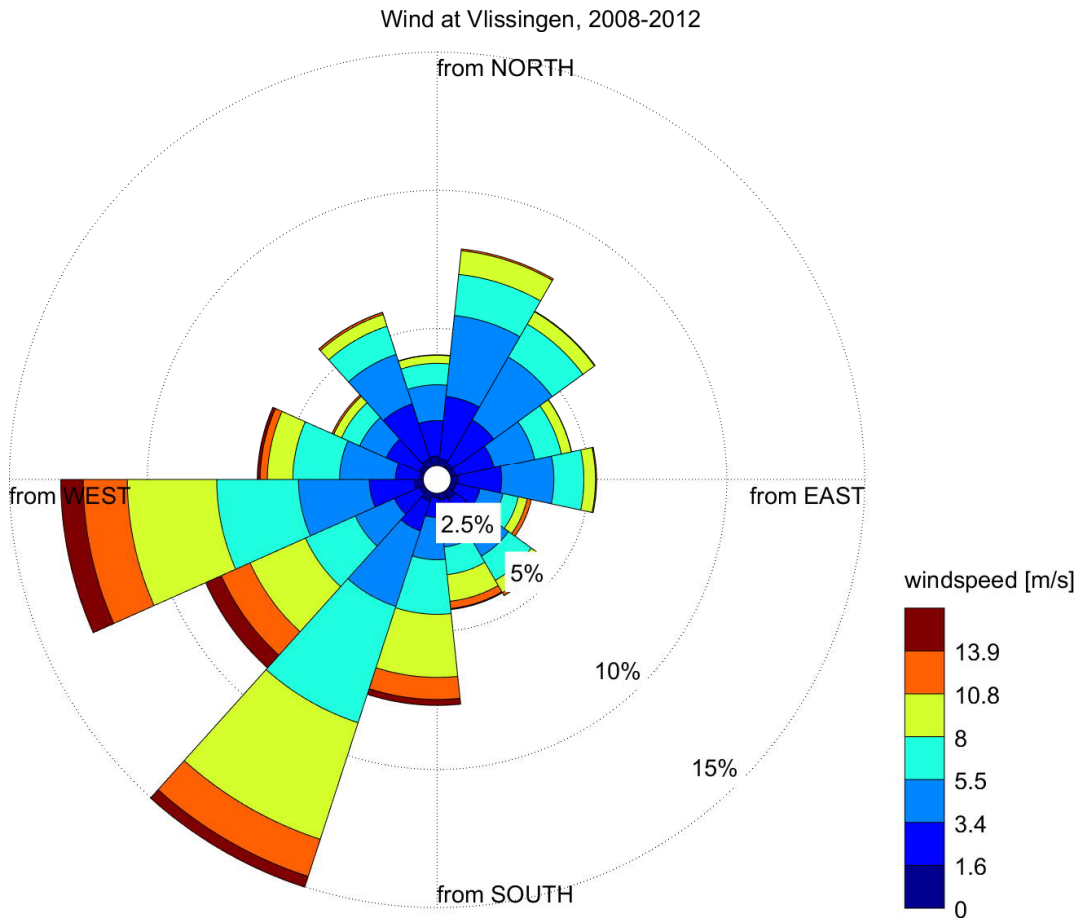
Figure 29: Wind conditions in the nourishment period

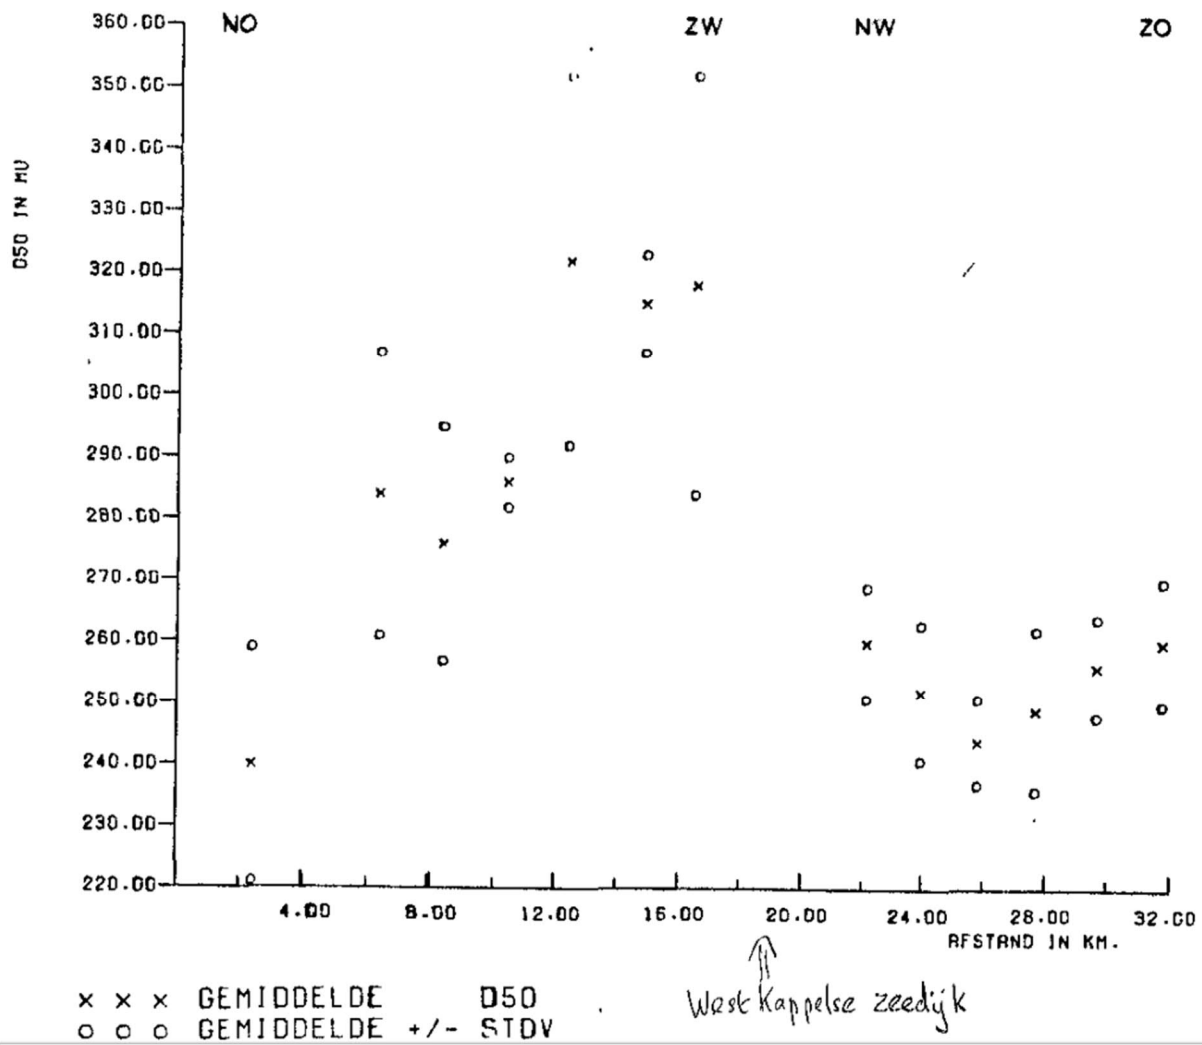
Figure 30: Average median grain size for the dunes of Walcheren, the studied nourishment is around 15.00 with a D50 around 300 micron. Source: Kohsiek (1984)

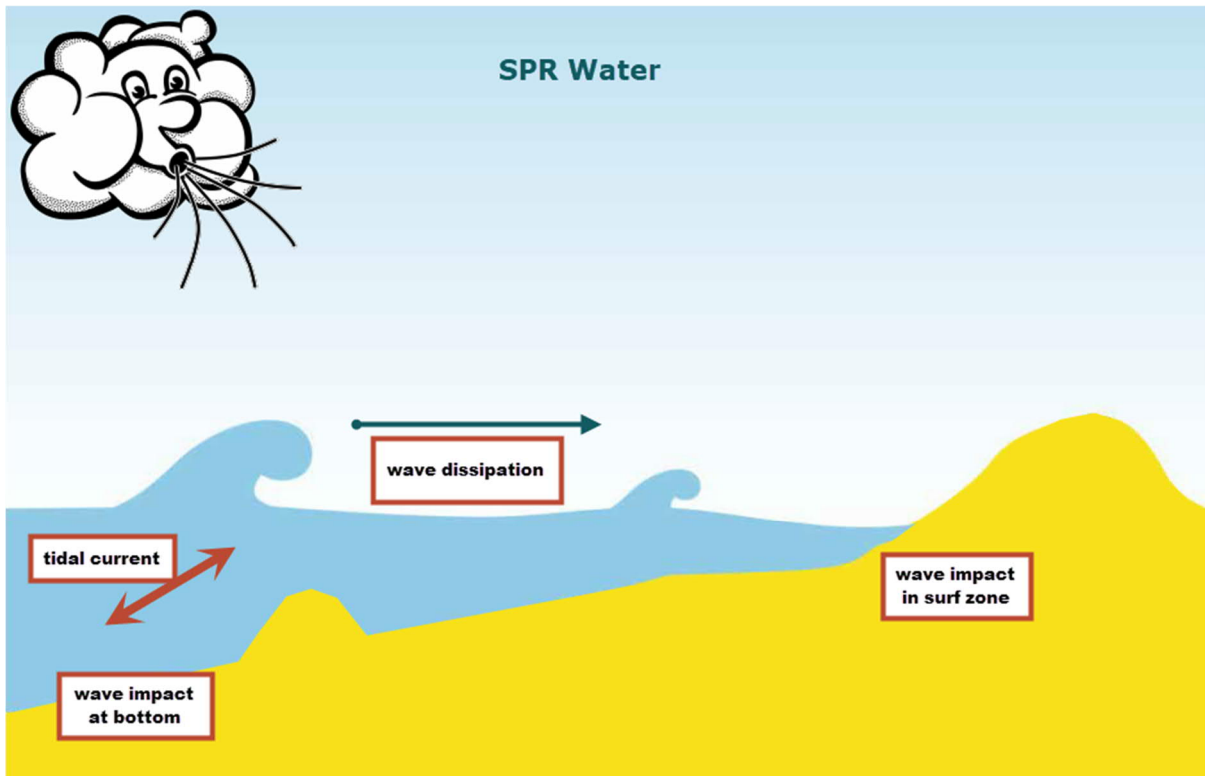
Figure 31: Schematic cross-section showing the main processes driving water

There are two main processes that cause the water motion: waves and tide, the first caused by wind, the second by gravitation of the moon and sun (the 'source'), see Figure 31 and Figure 32.

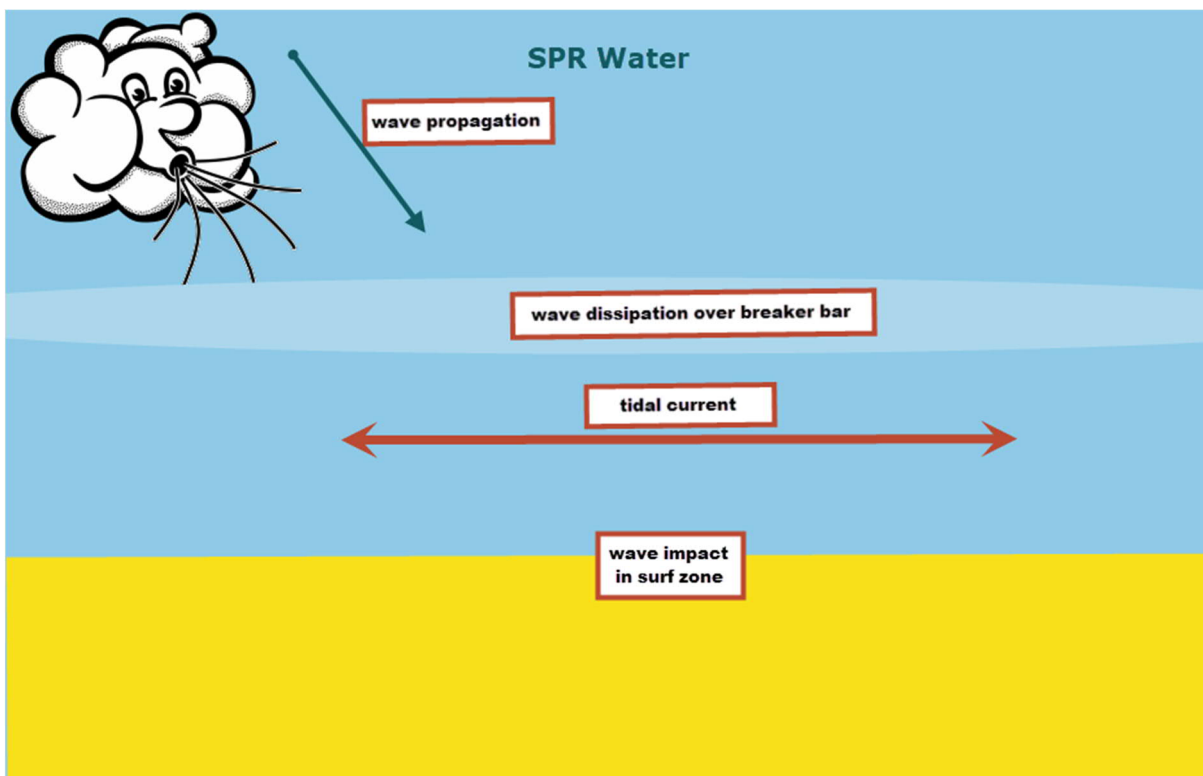
Figure 32: Schematic plan view showing the main processes driving water

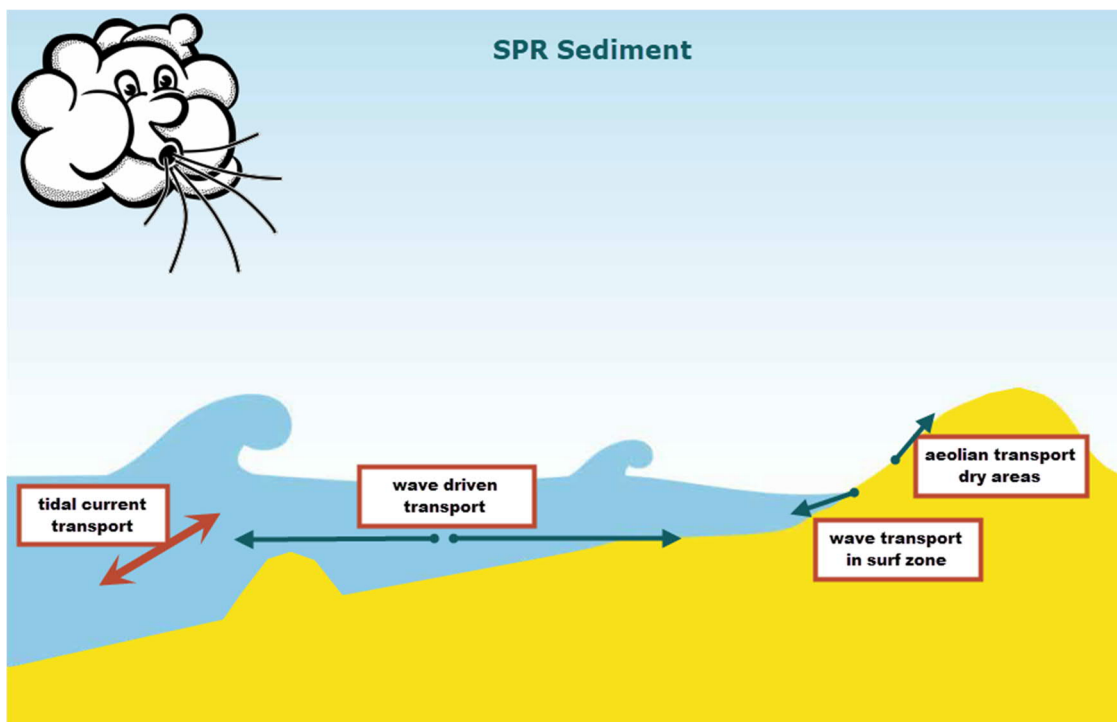
Figure 33: Schematic cross-section showing the main processes driving sediment transport

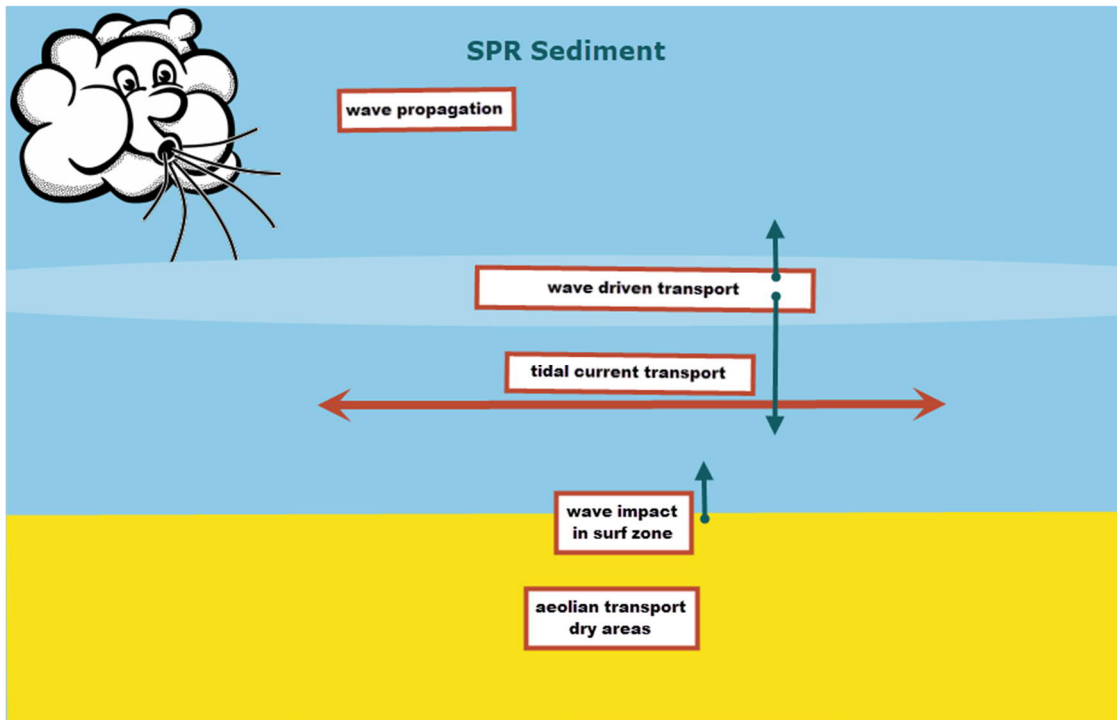
Figure 34: Schematic plan view showing the main processes driving sediment transport

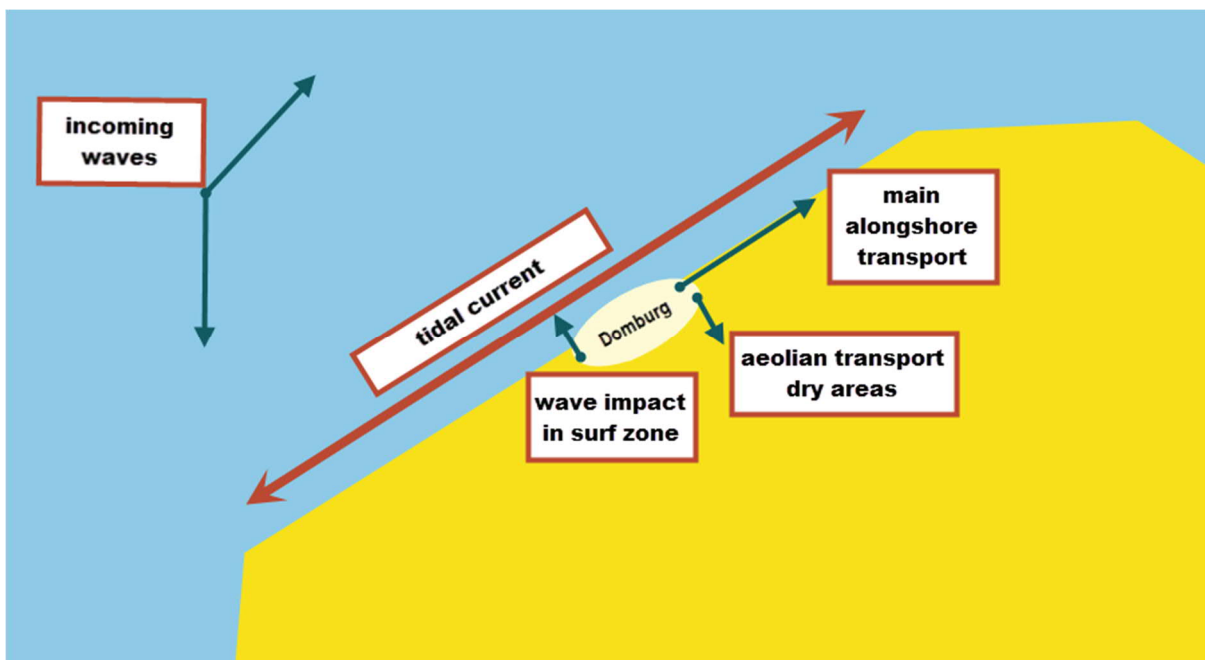
Figure 35: Schematic plan view showing the main processes driving sediment transport for the Domburg lab

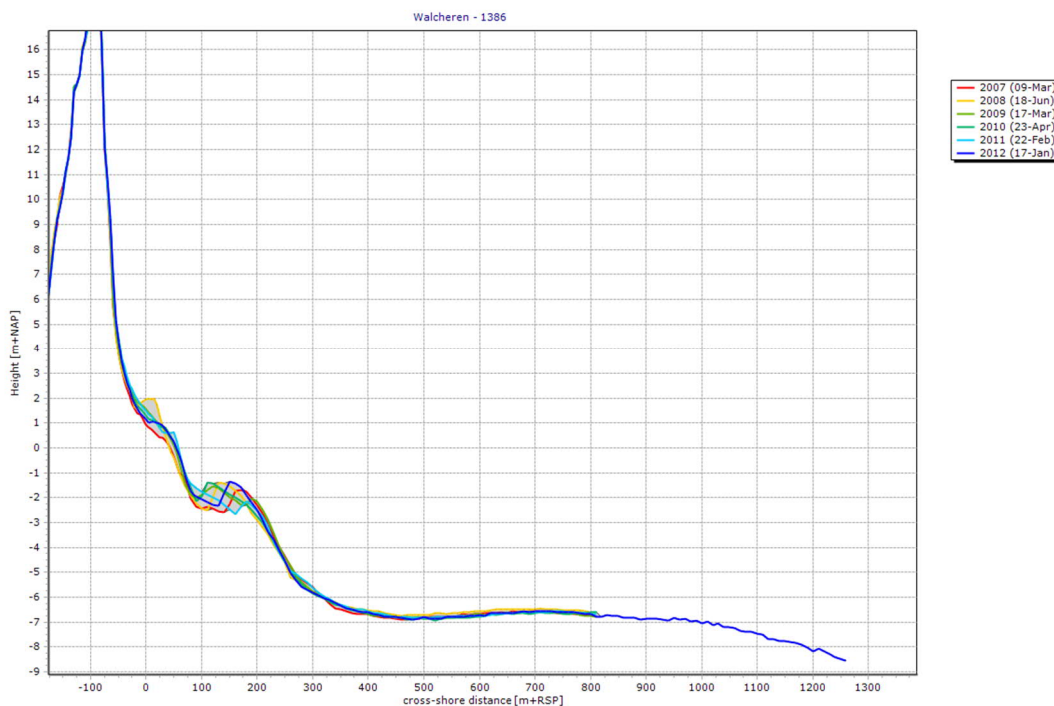
Figure 36: Development of shoreface in transect 1386 between 2007 and 2012

The shoreface at the nourishment location deepens up to about NAP -8 m and remains at this depth for ca. 600 m, where the Roompot channel begins. The shoreface is relatively stable on the short term, see Figure 36 and Figure 37. Small undulations that are visible are caused by morphological bed forms similar to sand waves, which are visible in multibeam bathymetry, see Figure 38. No significant change in the shoreface is visible in the years after the beach nourishment.

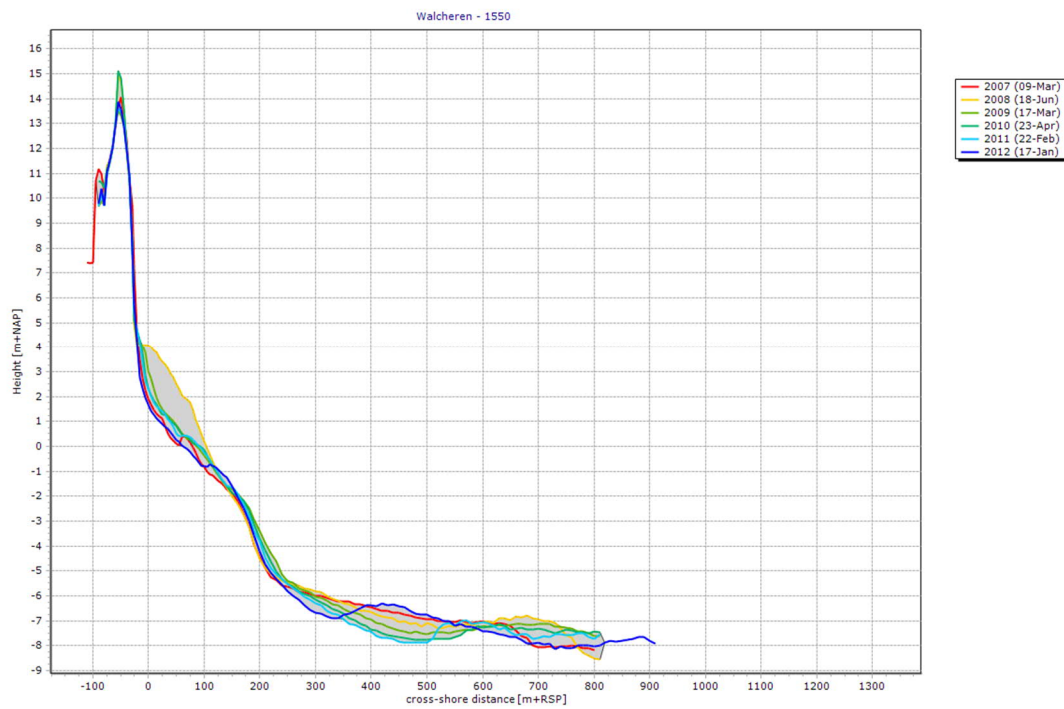
Figure 37: Development of shoreface in transect 1550 between 2007 and 2012

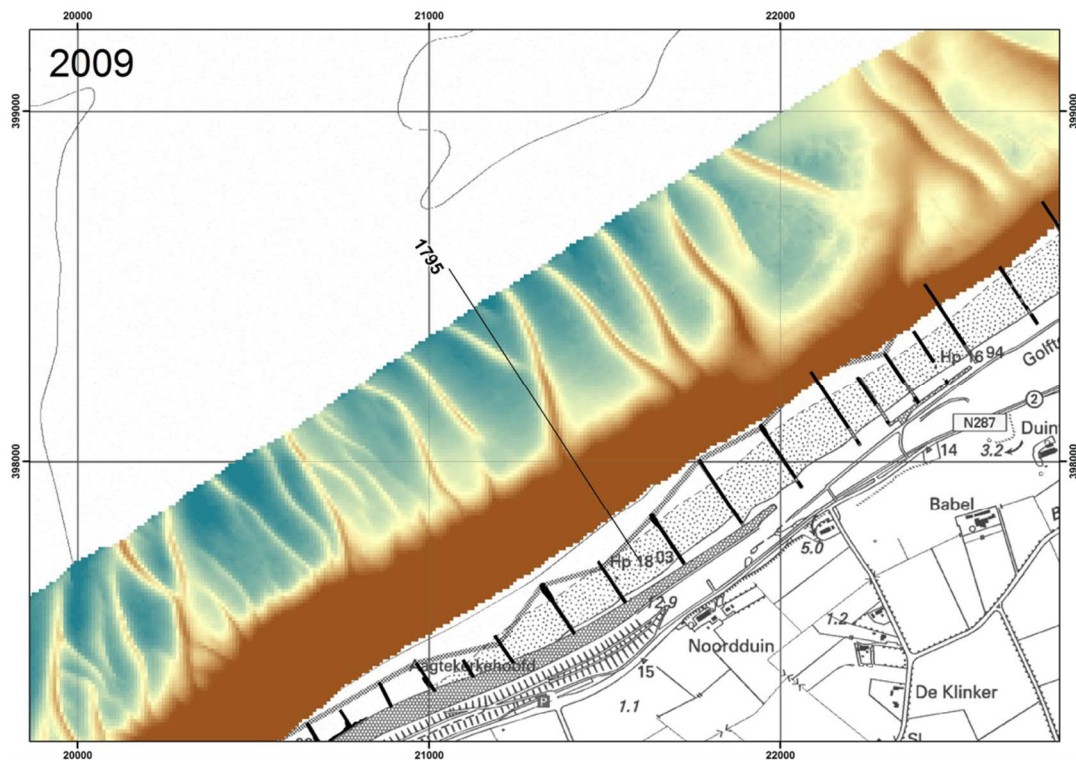
Figure 38: Multibeam bathymetry of shoreface close to Domburg (source: Mastbergen et al., 2017)

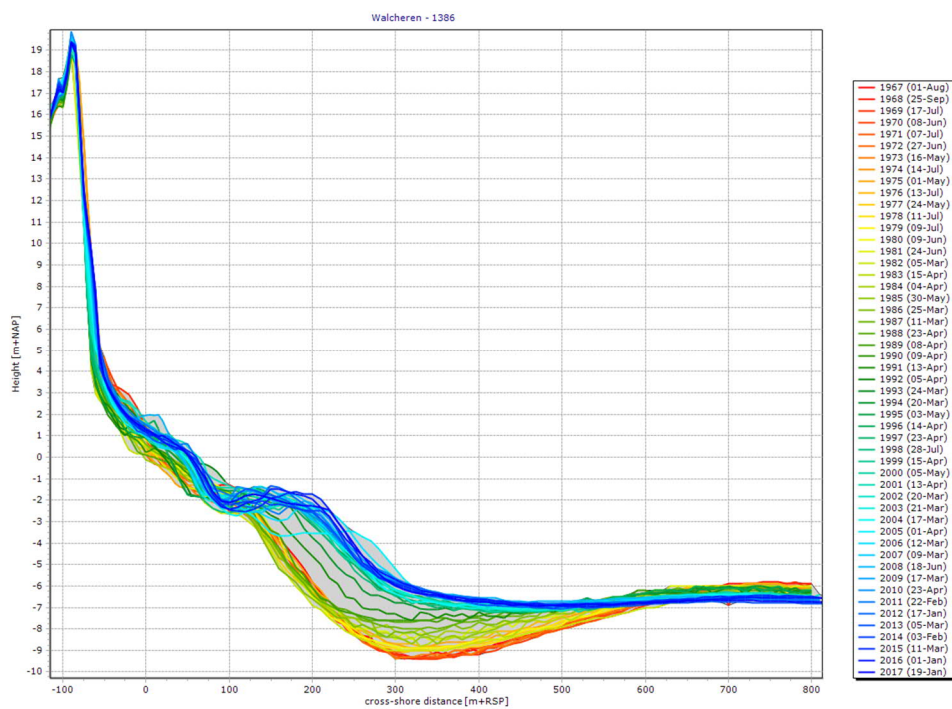
Figure 39: Development of shoreface in transect 1386 between 1967 and 2017

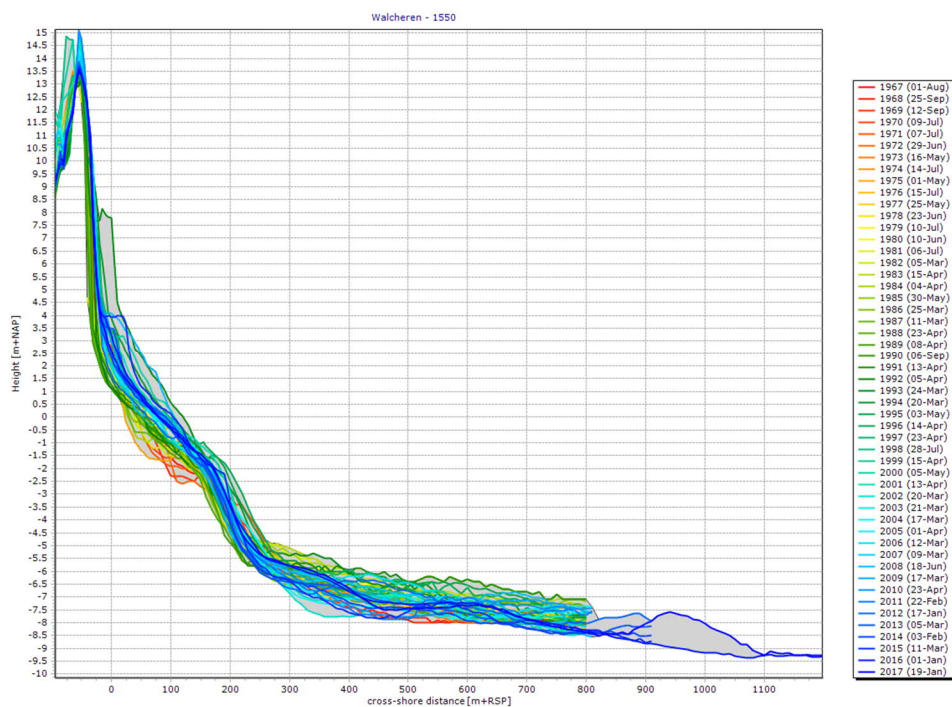
Figure 40: Development of shoreface in transect 1550 between 1967 and 2017

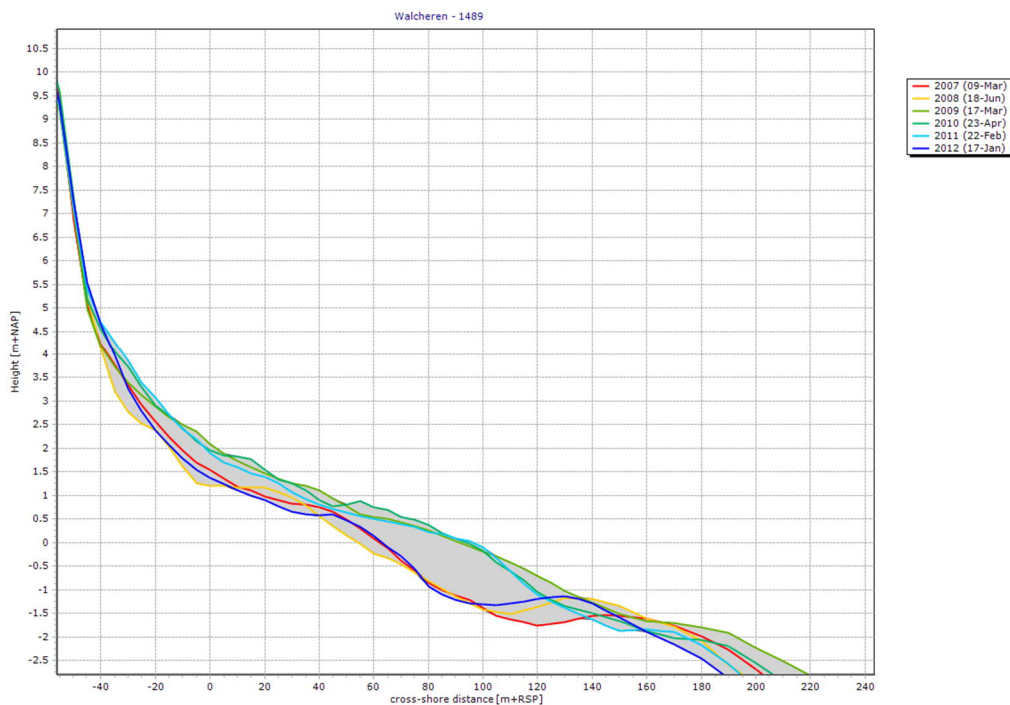
Figure 41: Development of beach and dune in transect 1489 between 2007 and 2012

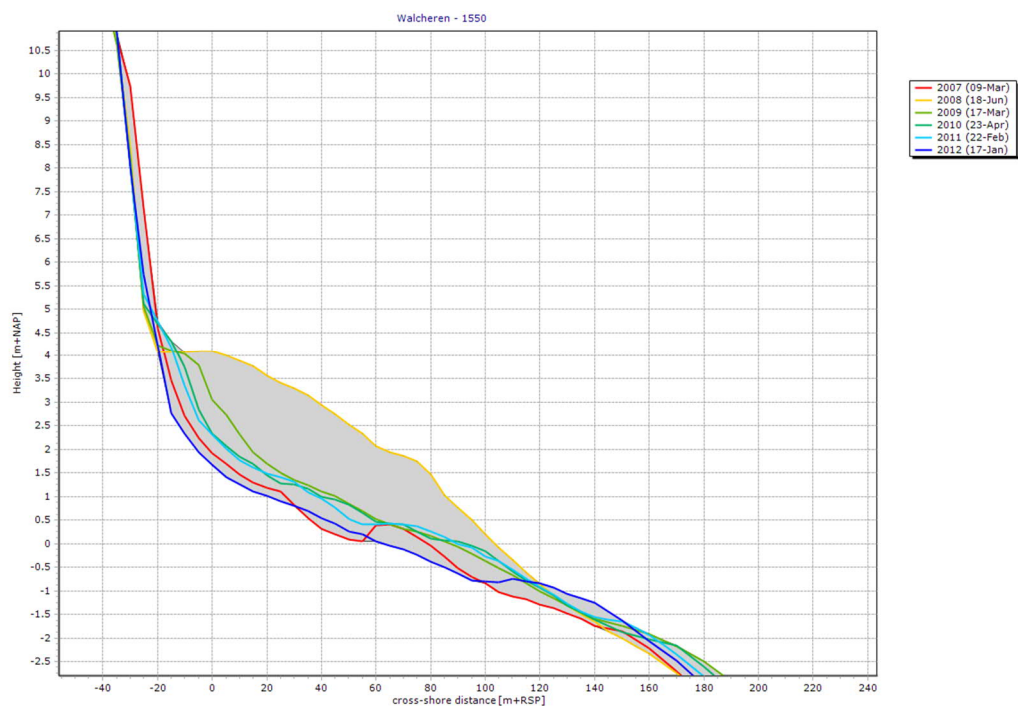
Figure 42: Development of beach and dune in transect 1550 between 2007 and 2012.

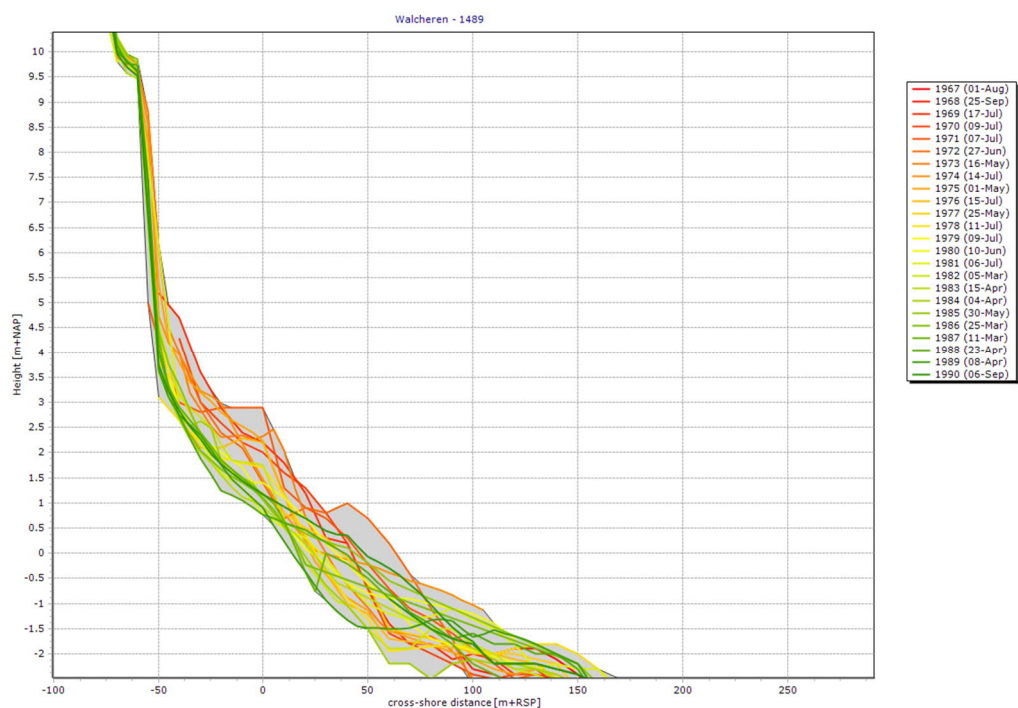
Figure 43: Development of beach and dune in transect 1489 between 1967 and 1990.

On the long term a division in two periods can be made: before and after approximately 1990. In the period up to 1990 erosion occurred at the beach. Especially the upper part of the beach, above ca. NAP +0.5 m, shows constant erosion, see Figure 43, and Figure 44. After 1990 there is still erosion, however regular nourishments cause large jumps in the profile, with a small 'plateau' around NAP +4 m, see Figure 45 and Figure 46.

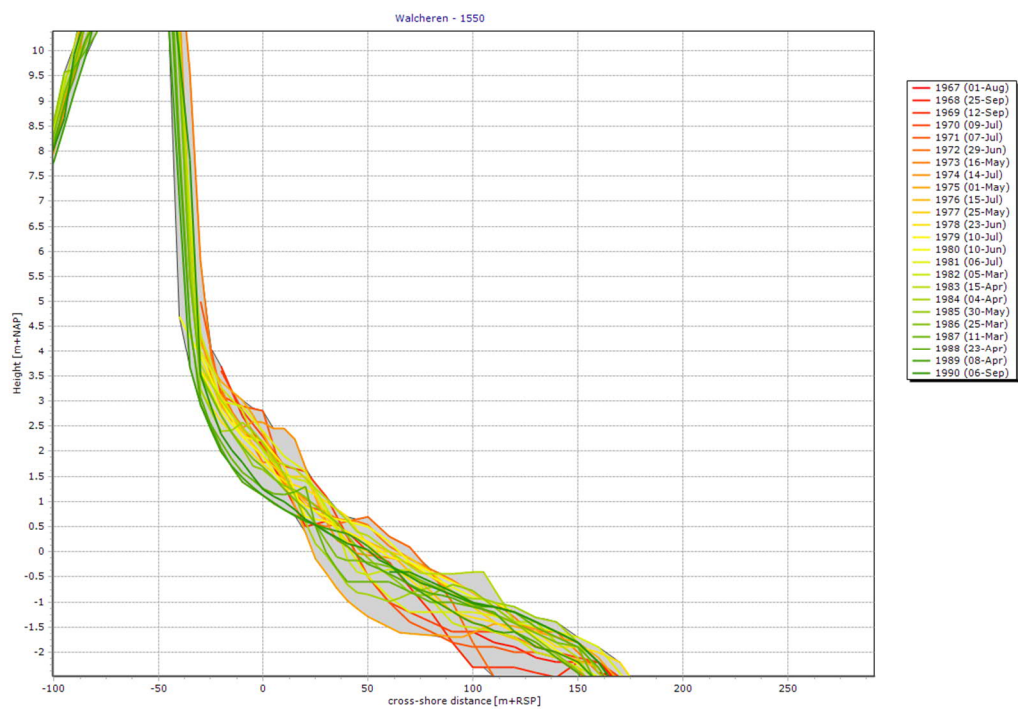
Figure 44: Development of beach and dune in transect 1550 between 1967 and 1990.

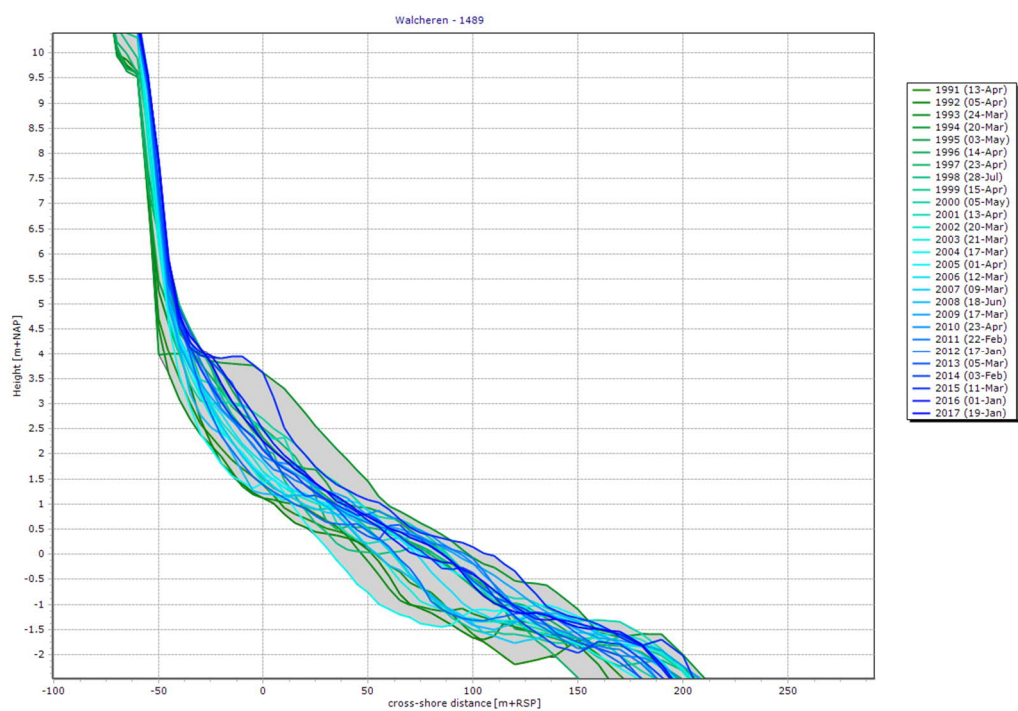
Figure 45: Development of beach and dune in transect 1489 between 1990 and 2017

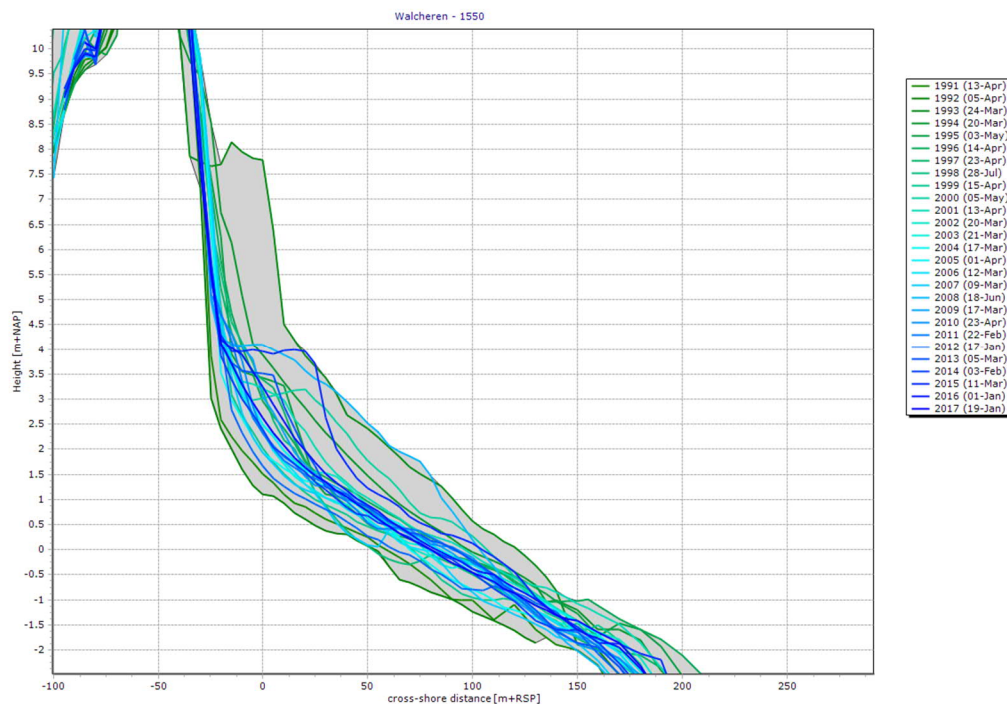
Figure 46: Development of beach and dune in transect 1550 between 1990 and 2017

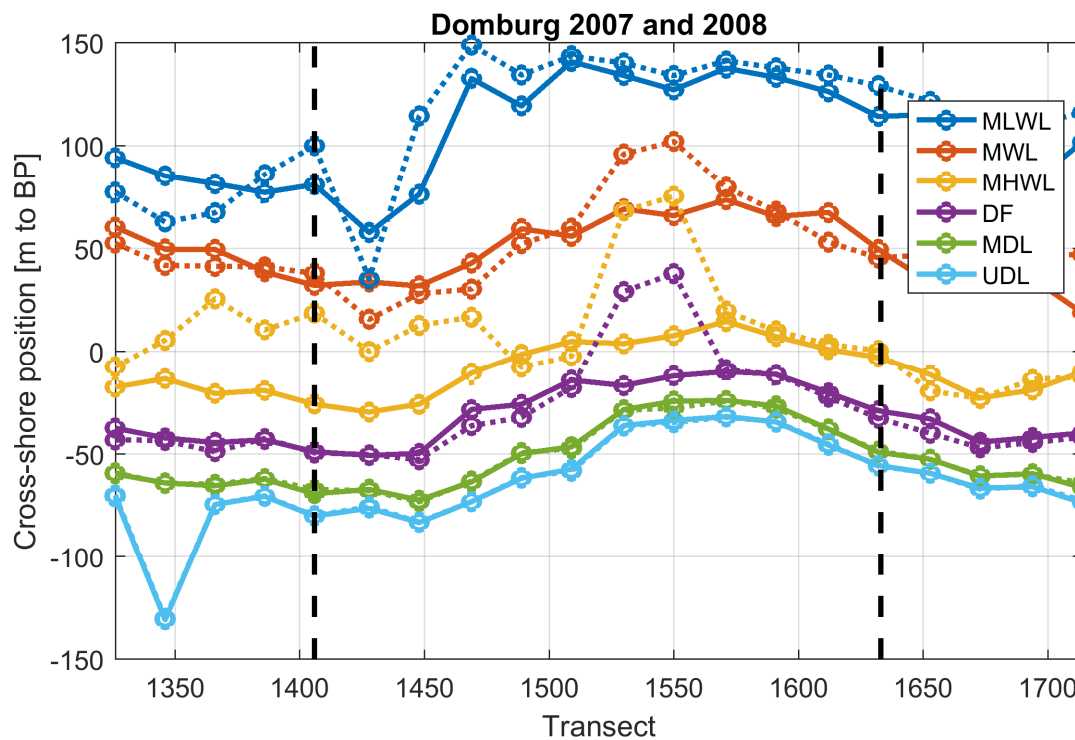
Figure 47: The physical marks of the transects at Domburg for the year 2007 (solid line) and the year 2008 (coloured dashed line). The colours indicate the defined level, see 4.2.1. The black dashed line indicates the prescribed boundary of the nourishment.

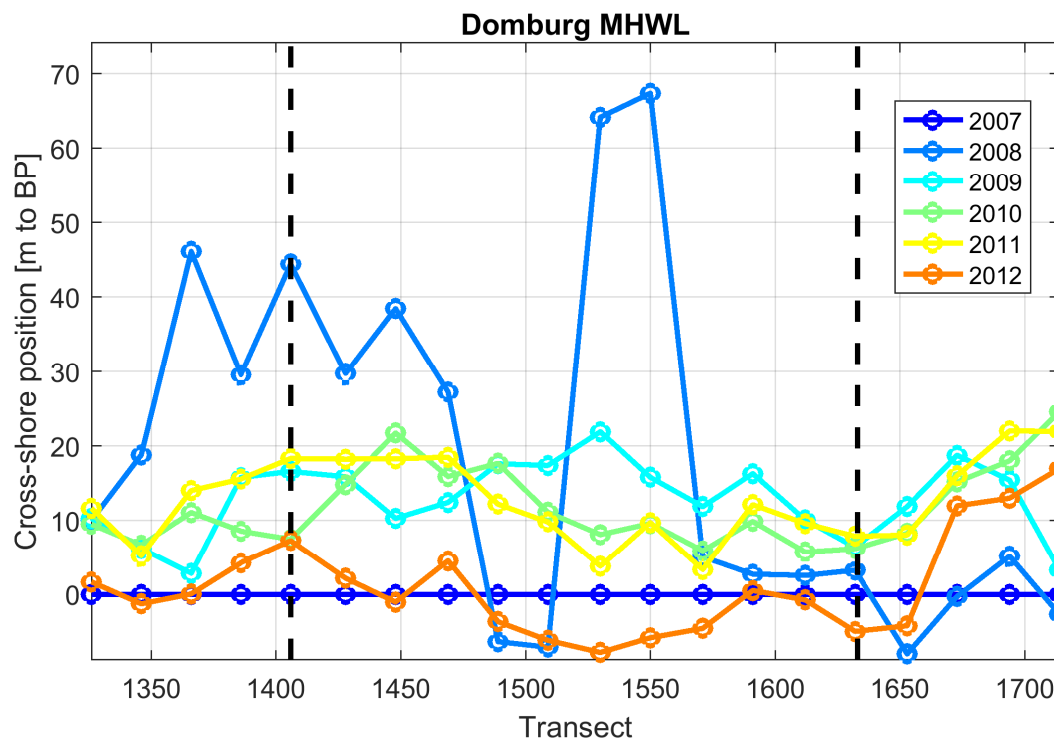
Figure 48: The difference in cross-shore position of MHWL with respect to 2007. When the value is positive the position lays more offshore than in 2007.

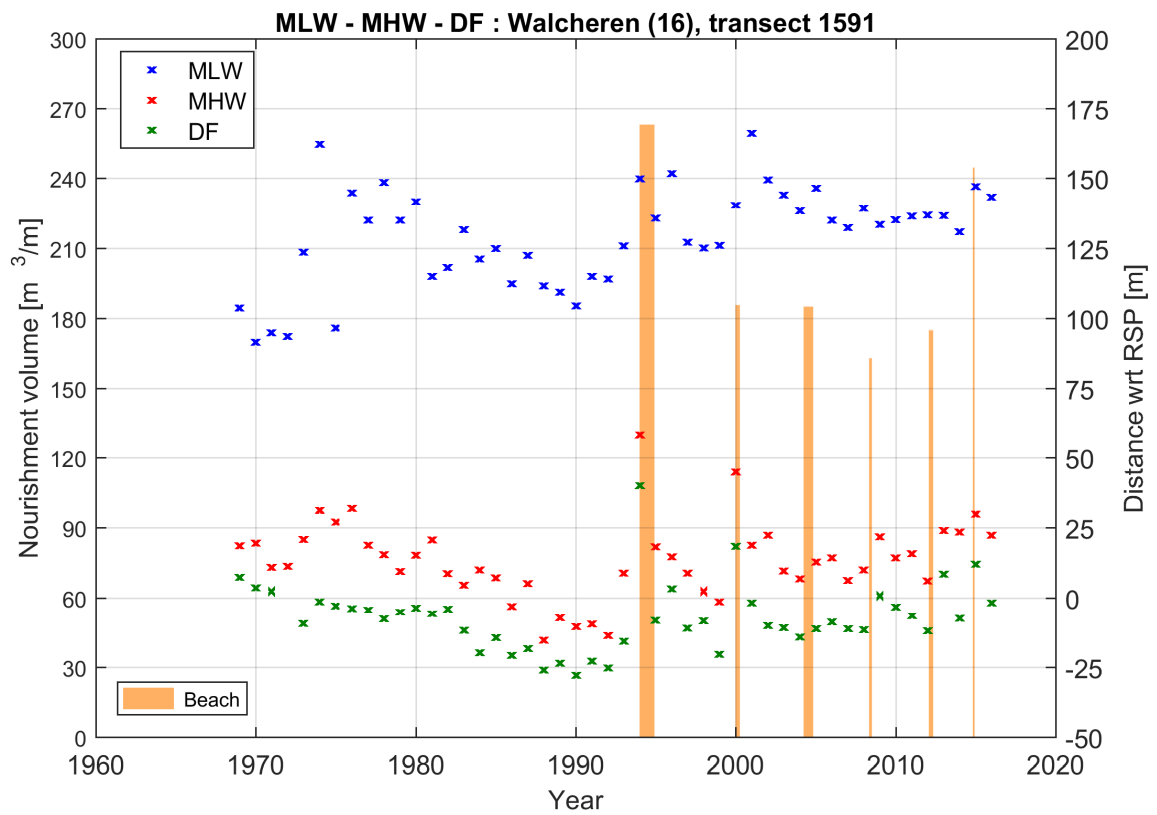
Figure 49: Long term location of the MLW (Mean Low Water), MHW (Mean High Water) and the Dune Foot (DF) as a function of time for transect 1591. The orange bars indicate the volume for a nourishment.

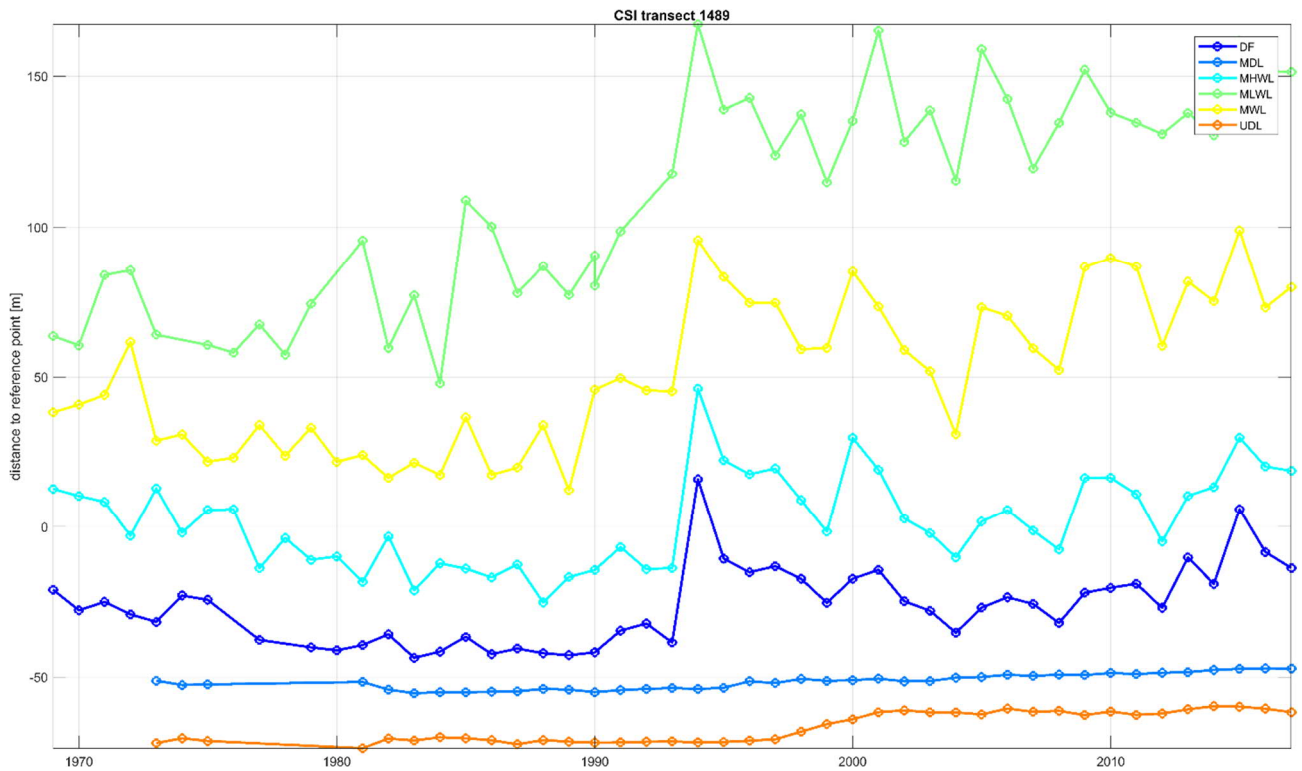
Figure 50: Timeseries of physical marks for transect 1489

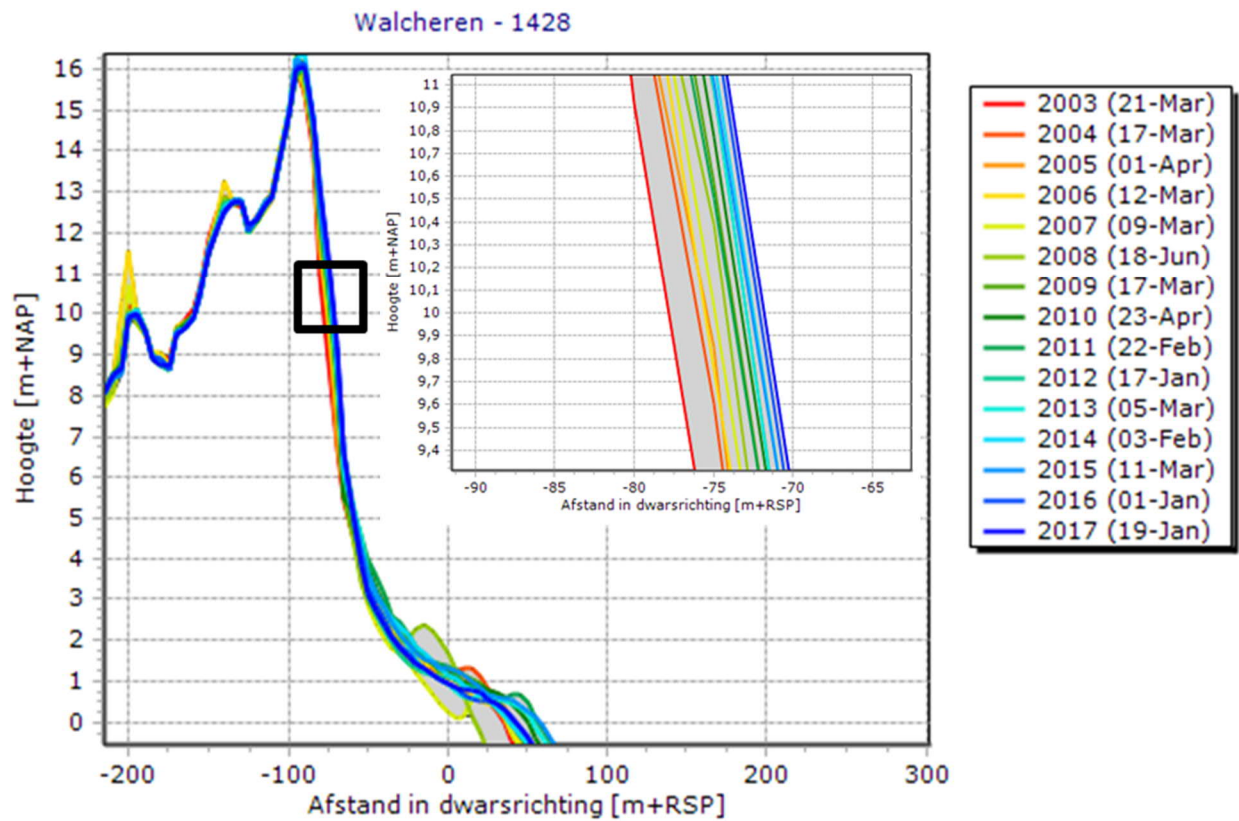
Figure 52: The dune profile for transect 1428 for the years 2003 till 2017. The colours represent various years. The figure also contains a zoom in of the profile. The black square indicates the location off the zoom in.
