National analyses of nourishments;

*Coastal state indicators and driving forces for Domburg,
the Netherlands*

Date: 11/08/2021
Status: Final version

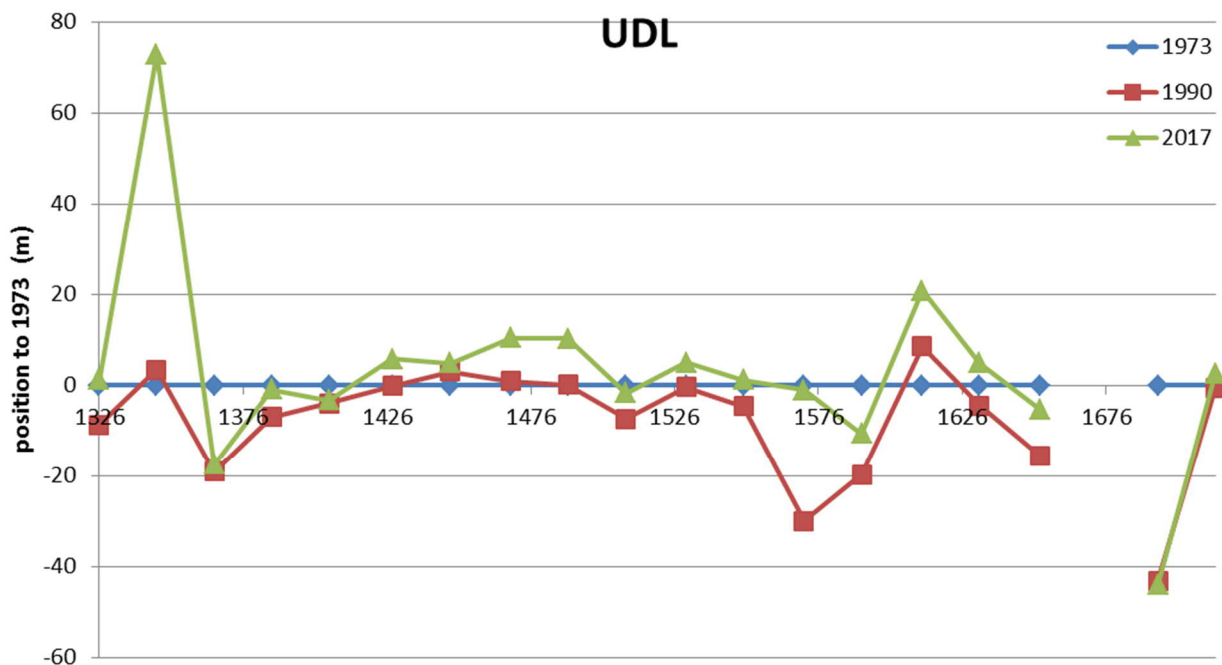
Figure 53: Position of the upper dune level for studied transects in 1973, 1990 and 2017

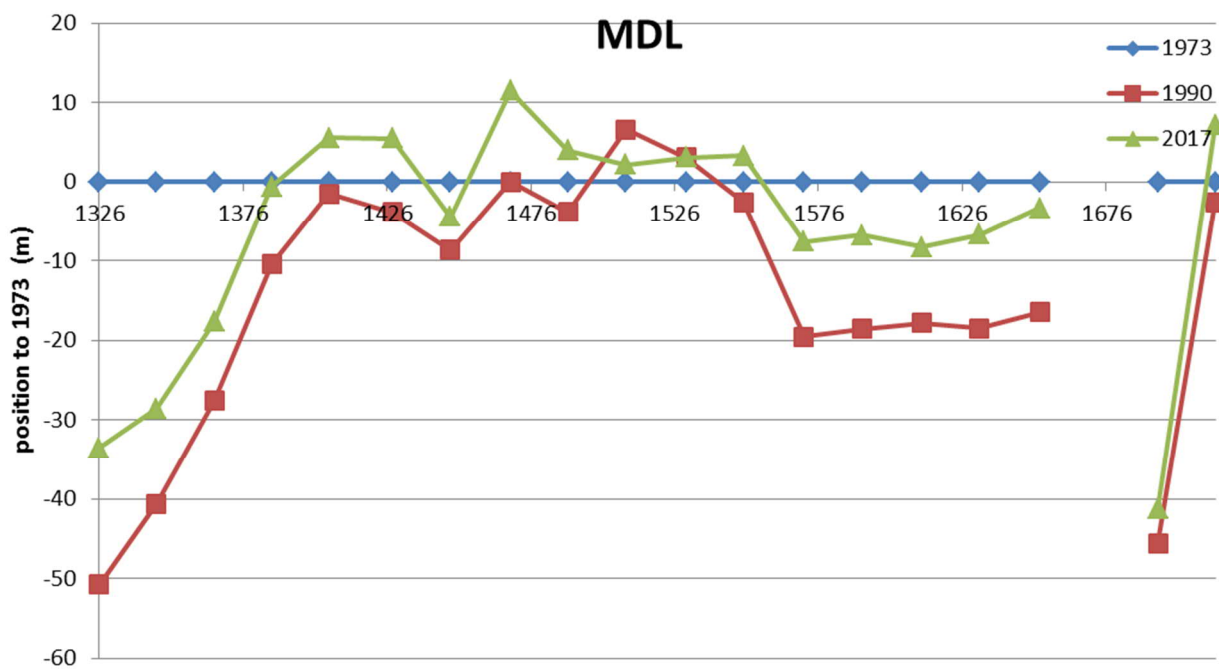
Figure 54: Position of the middle dune level for studied transects in 1973, 1990 and 2017

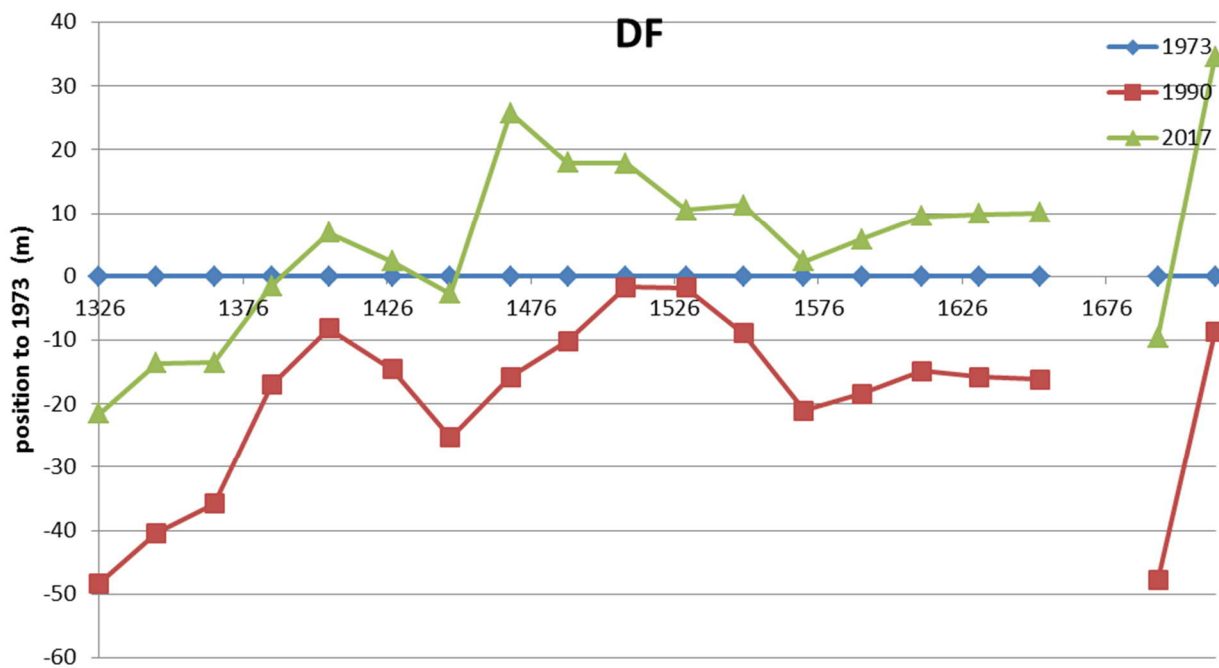
Figure 55: Position of the dune foot for studied transects in 1973, 1990 and 2017

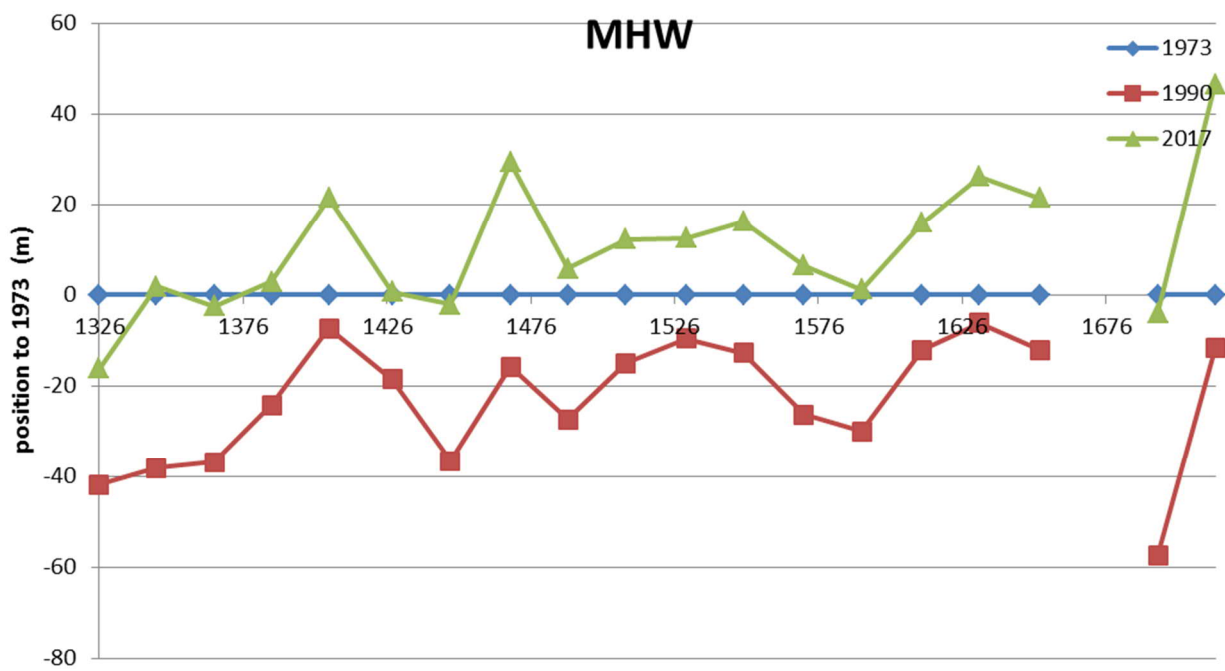
Figure 56: Position of the mean high water level for studied transects in 1973, 1990 and 2017

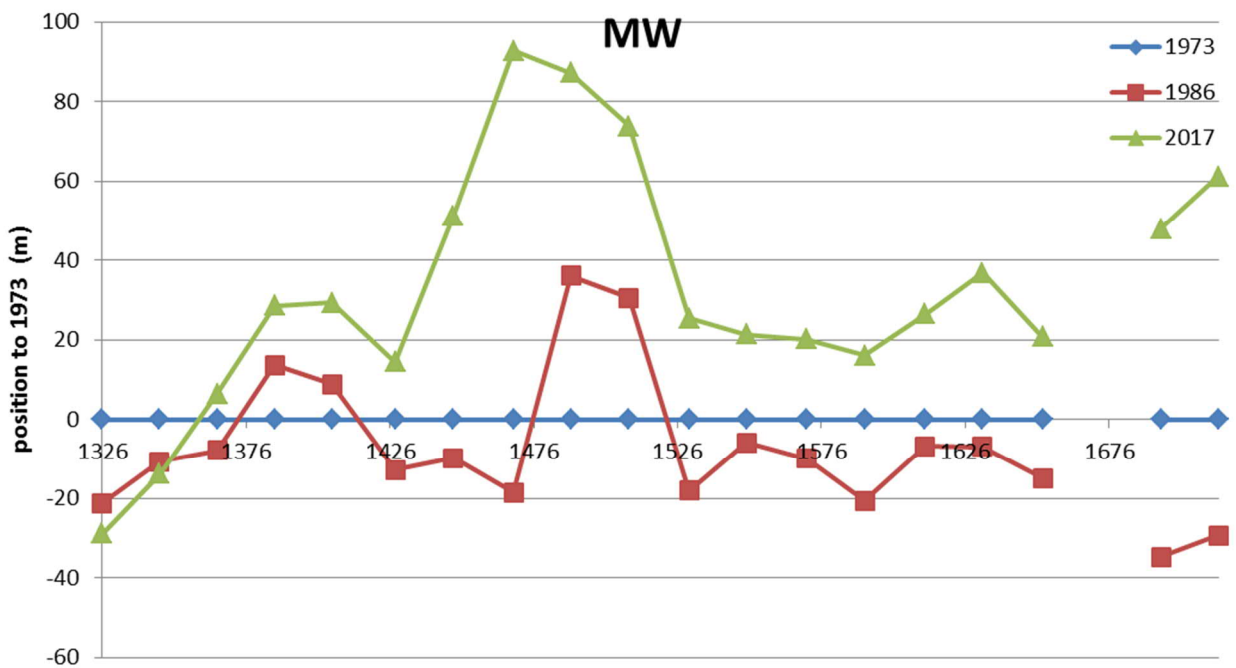
Figure 57: Position of the mean water level for studied transects in 1973, 1986 and 2017

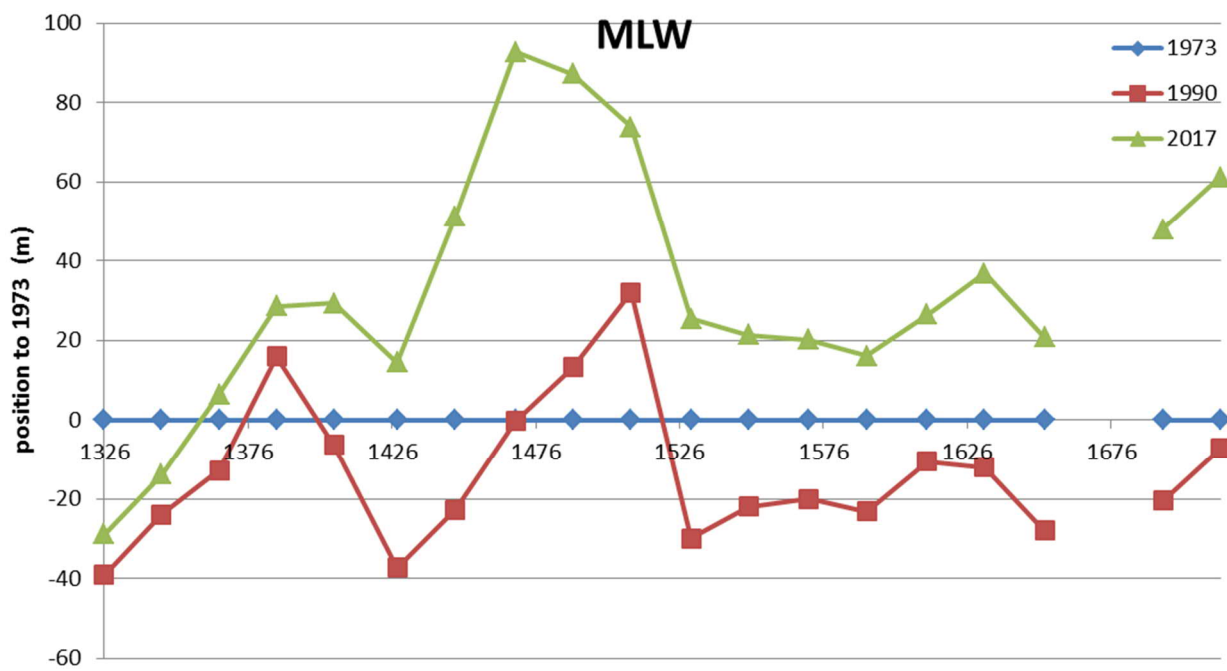
Figure 58: Position of the mean low water level for studied transects in 1973, 1990 and 2017

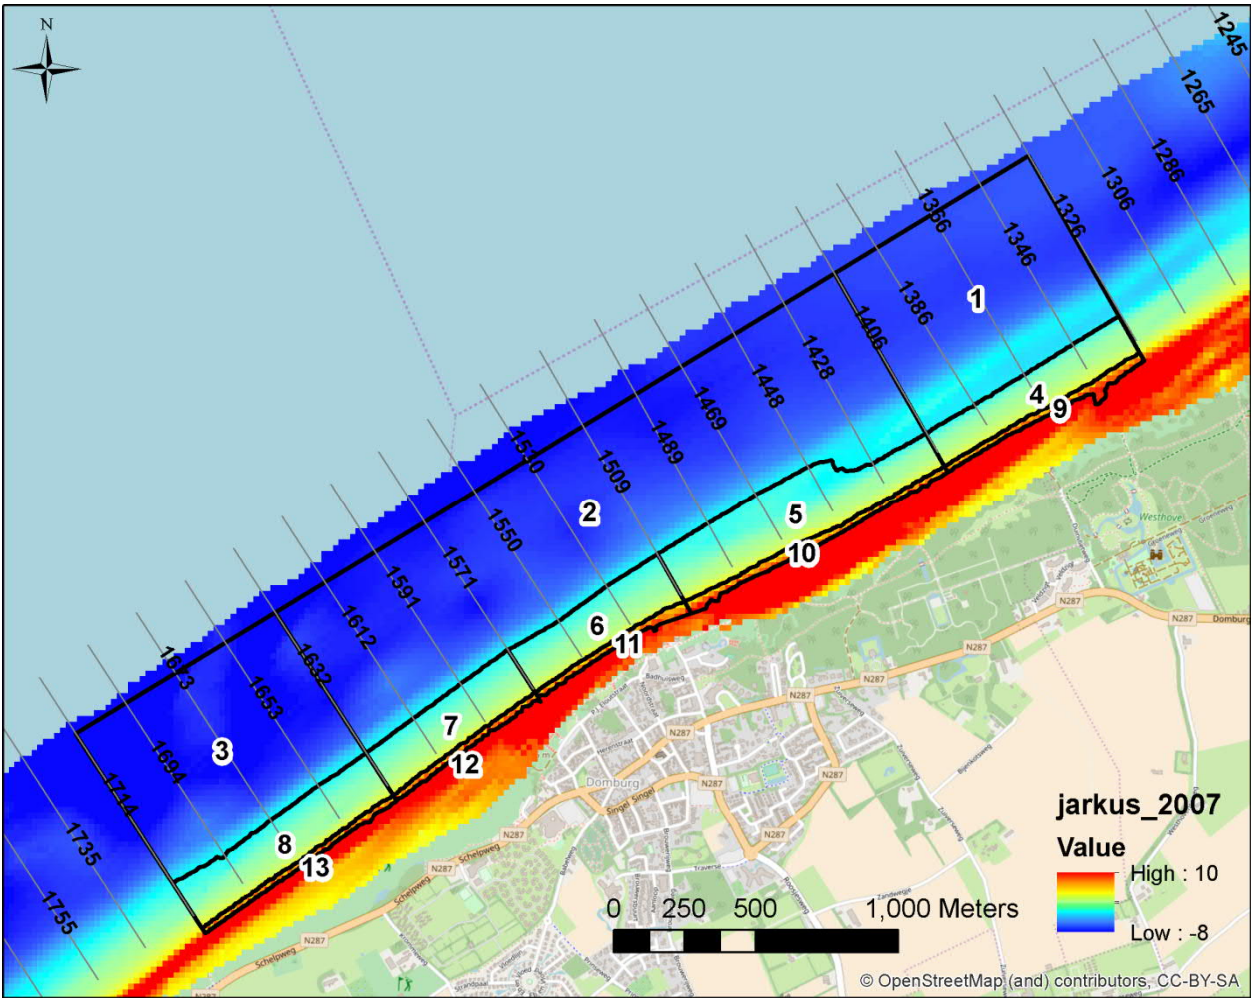
Figure 59 Areas used for calculation of volumes

The erosion of the nourished area (5-7) between 2008 and 2012 is 25.000 m³/year. This is relatively low, caused by the incomplete volume in the measurement of 2008. When in 2008 the design volume of 370.000 m³ would have been reached, the erosion rate is 93.000 m³/year, similar to the erosion rate after the 2000 nourishment (100.000 m³/year erosion in area 4-8 between 2000 and 2004). For the total area (1-8) the erosion was 49.000 m³/year, when correcting for the outlier of area 2 in 2008 and the incomplete nourished volume this is 79.000 m³/year.

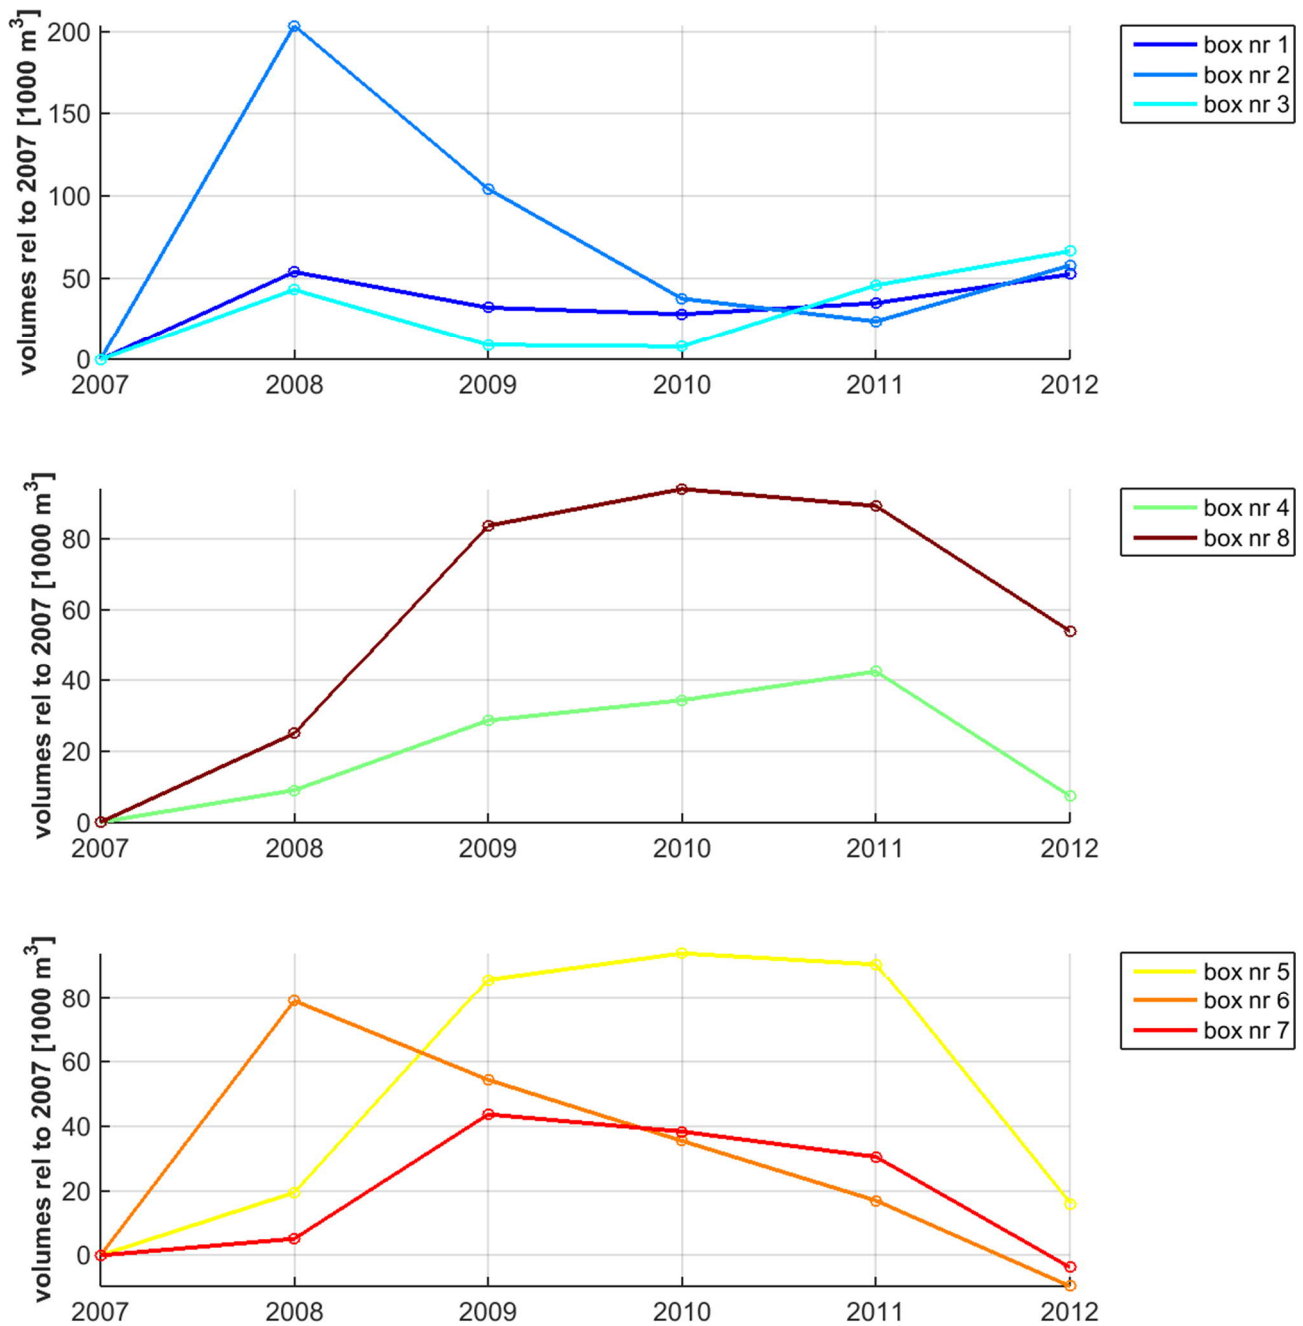
Figure 60 Volume development from one year before the nourishment until the last year before the next nourishment

The average vertical changes (Figure 63) show similar change in time as the volumes (Figure 60). The most significant difference is the much lower vertical change in the shoreface areas (1-3), caused by the much larger surface area.

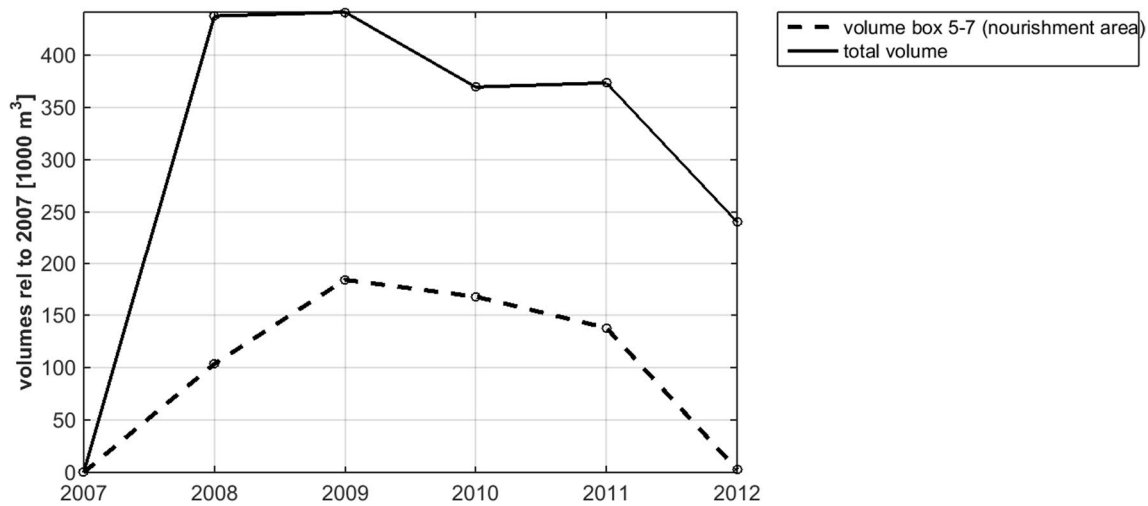
Figure 61 Volume development nourishment polygons (5-7) and polygons 1-8 (total volume)

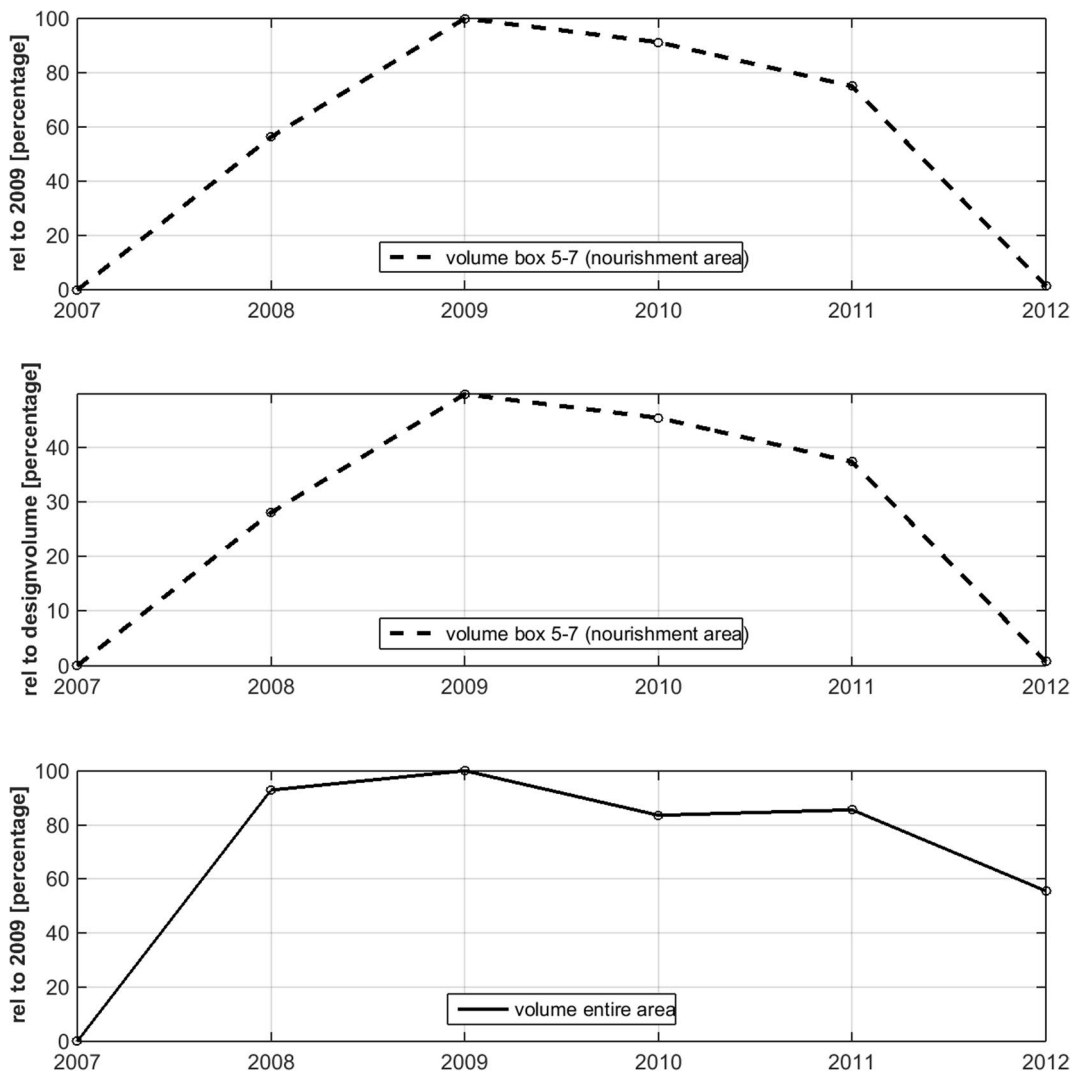
Figure 62 Volume development in percentages for nourishment area relative to maximum volume in 2009 (top), relative to design volume of 370.000 m³ (middle) and for entire area (area 1-8) relative to maximum volume (bottom)

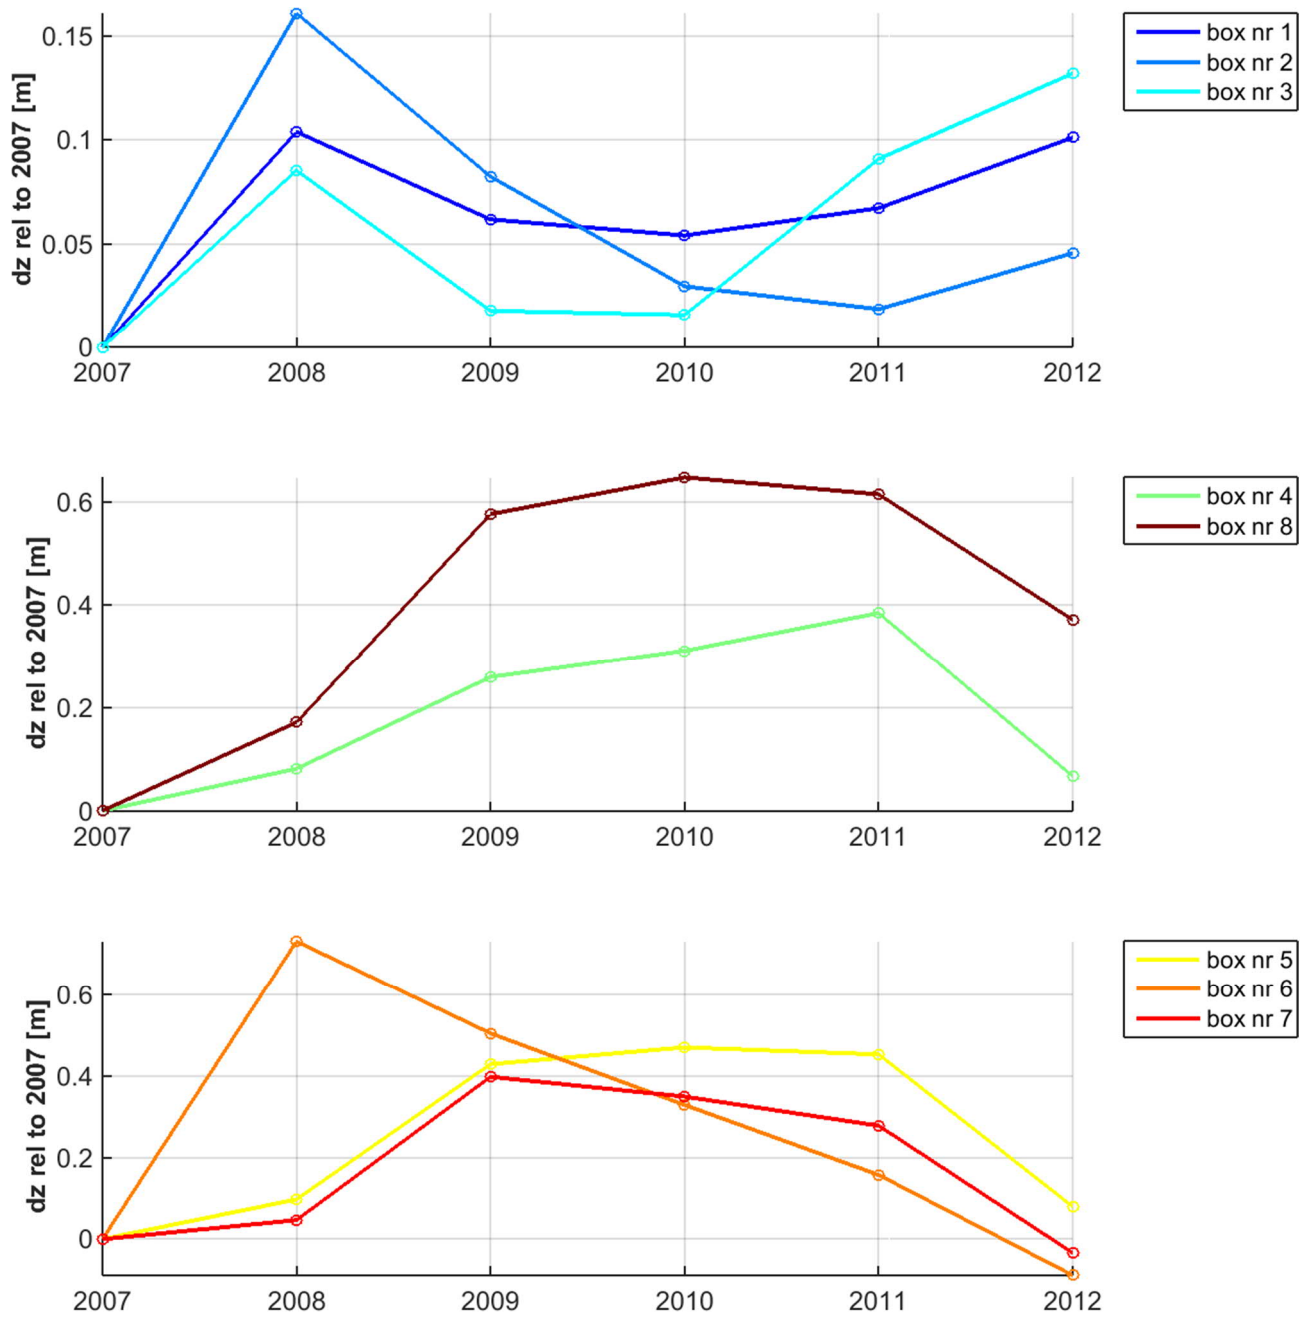
Figure 63 Change in average bed level for each polygon

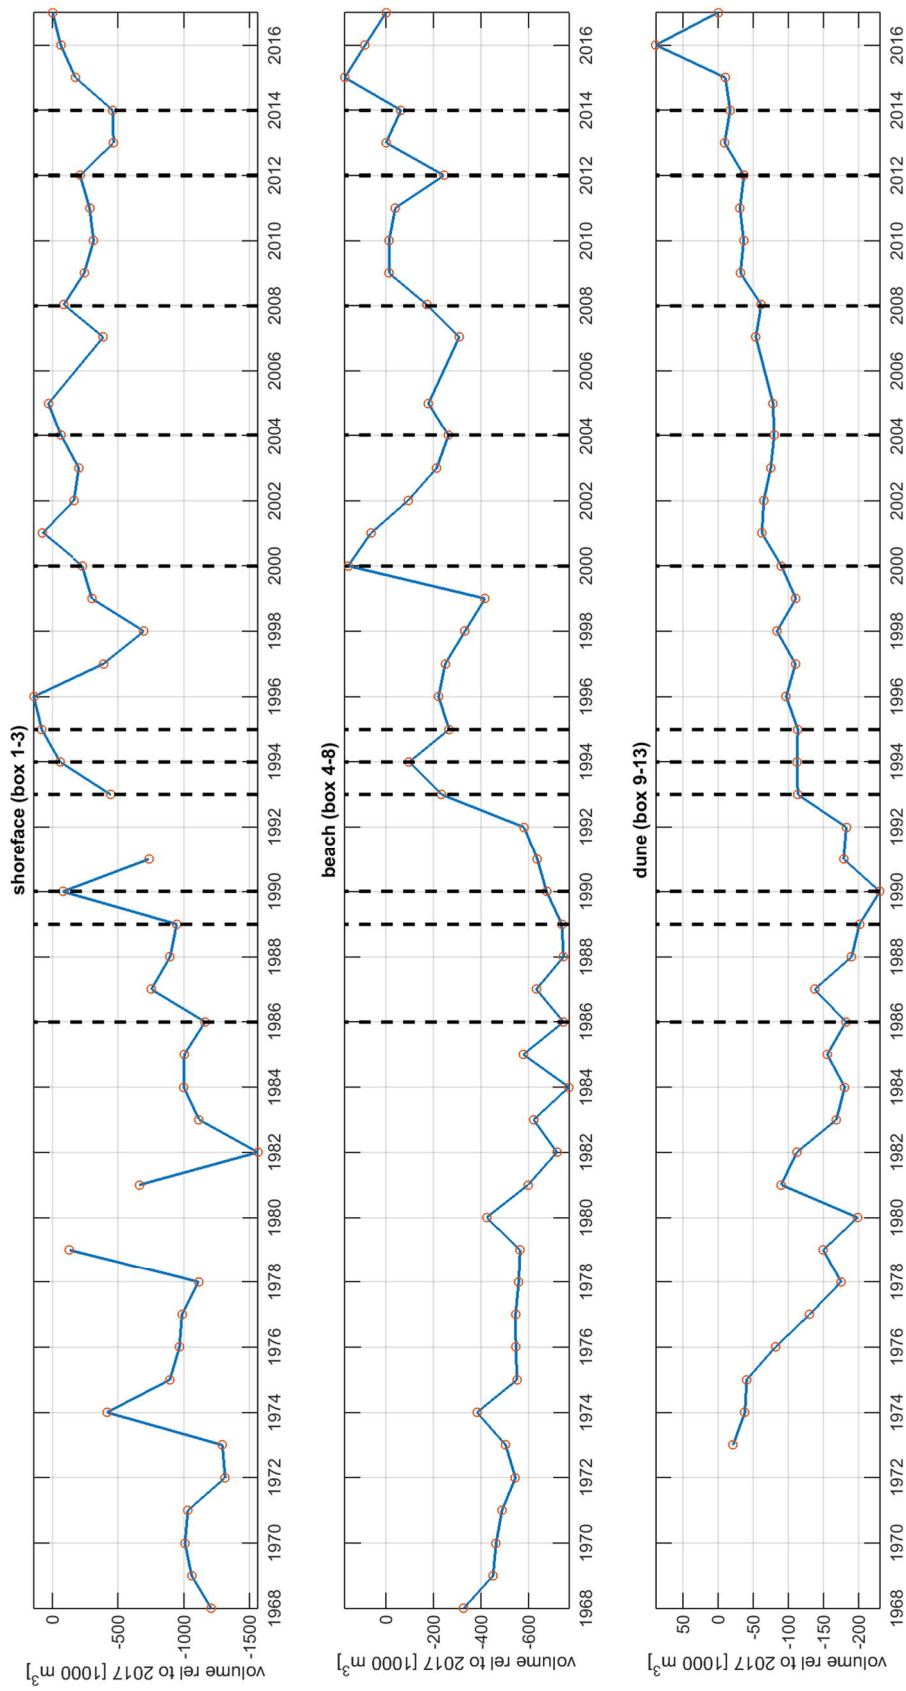
Figure 64 Long term volume development shoreface, beach and dune, dashed lines indicate nourishments

volume was decreased with more than 200.000 m³ – -12.300 m³/year. The increase up to 2017 is very linear – +8.500 m³/year.

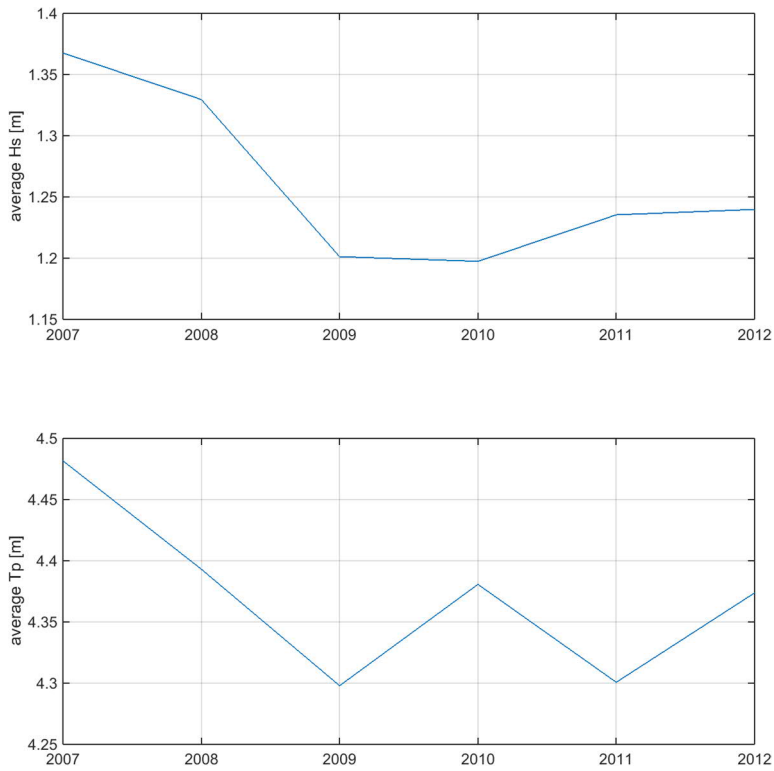
Figure 65 Yearly averaged significant wave height (top) and period (bottom)
