**FILTER SYSTEMS FOR A
SUSTAINABLE AGRICULTURE**

FIELD CASE DESCRIPTION

**Moving Bed Biofilm Reactor (MBBR)
for drain water from horticulture**

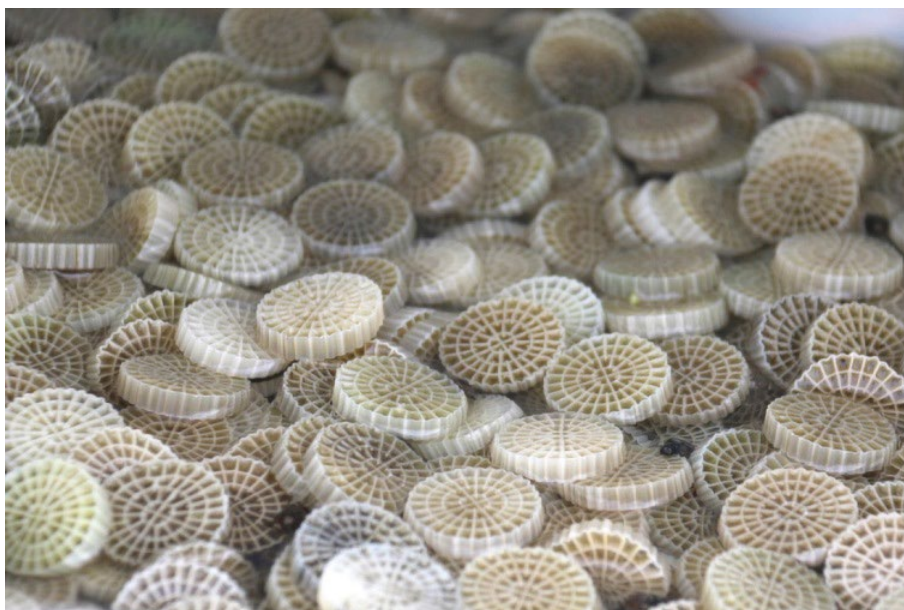
Photo 1 Plastic carriers in a MBBR, on which a biofilm will develop

The MBBR consists of a tank (1 m^3) filled with water and special plastic carriers that provide a surface where a sludge (biofilm) can grow on. This biofilm carries out the denitrification. The irregular and large specific surface area of the carriers forms an ideal habitat. In the installation at PCS, AnoxKaldnes K5 carriers are used with a specific surface of $800 \text{ m}^2/\text{m}^3$. The tank is filled for 40% with these carriers (Photo 1). It takes a few weeks for the biofilm to develop on the carriers, but this can be accelerated by transferring a certain number of carriers from a MBBR installation already in operation. An air pump creates some movement in the carriers and to prevent clogging of the biofilm in the carriers.

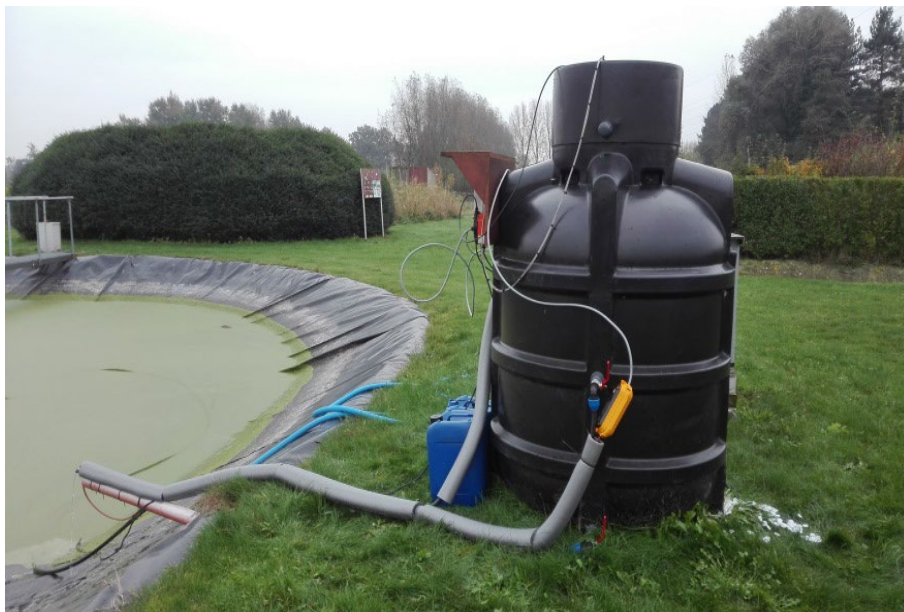
Photo 1 Moving Bed Biofilm Reactor at PCS in 2018

The MBBR filter was installed in the summer of 2018 at PCS and was constructed by KULeuven (Photo 1). Water from the storage pond was pumped through the MBBR. In the storage pond, water from the covered fields of azalea was collected which mostly contains high nitrate concentrations.

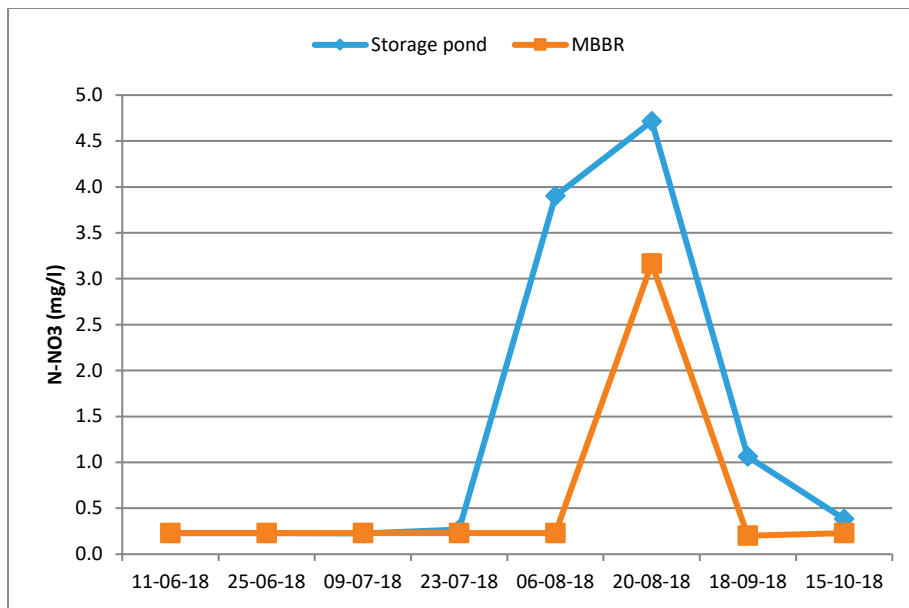
Figure 1 Results for N filter (MBBR) at PCS during Summer 2018

The results are shown in Figure 1. The filter was only during a short period in operation. There were problems with the dosage of the C-source and there were also several problems with a blockage of the filters due to duckweed, algae and sludge in the storage pond. The influent pump sucked this up into the MBBR with an effect on the level measurement. Therefore, the efficacy could not be evaluated very well.

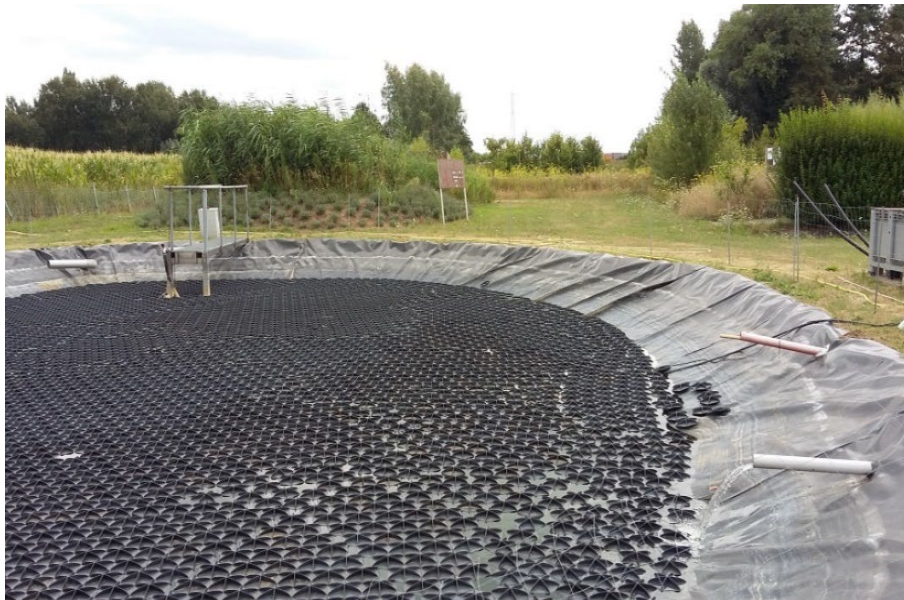
Photo 2 Hexacover on the water surface in the storage pond

During winter, the storage pond was drained and cleaned and the leaks in the storage pond were repaired. Afterwards, the water surface of the storage pond was covered with Hexacover to prevent the growth of algae and duckweed (Photo 2). So, problems with blocked filters were solved.

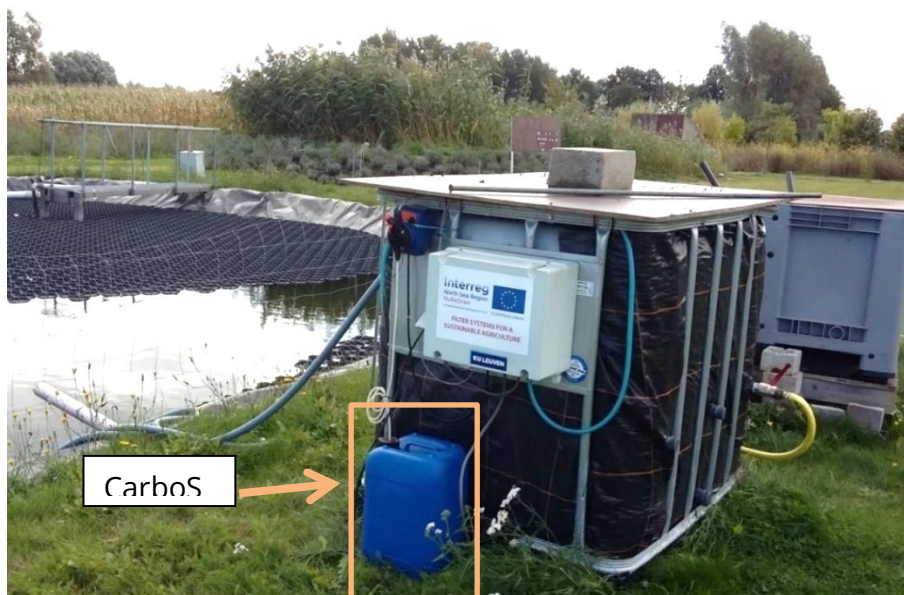
Photo 3 Moving Bed Biofilm Reactor at PCS in 2019 with CarboST as C-source

At the start of the season, the installation was replaced by an adapted installation (Photo 3). KULeuven designed this 'new' MBBR as a low cost self-assembly package in an IBC tank. Water level was controlled with 2 sensors (minimum and maximum level). An air pump with a membrane disc diffuser is working each 3 hours for a minute to create some movement in the carriers and to prevent clogging of the biofilm in the carriers. The effluent flow is reduced to 2 l/minute (120 l/h) by a tap. The residence time of the water in the filter was 8 hours.

CarboST was used as C-source, injected by a dosage pump (5 l/h) working together with the influent pump. The dosing rate was set at 8% (= 0,4 l/h). When the MBBR is filled, 100 l is pumped from the buffer basin during 3 minutes. This means that the MBBR treats 2880 l/d (or 2 l/min) or is operational during 86,4 min/d. The dosing pump likewise is operational for 86,4 minutes and consequently injects ca. 0,58 l/d.

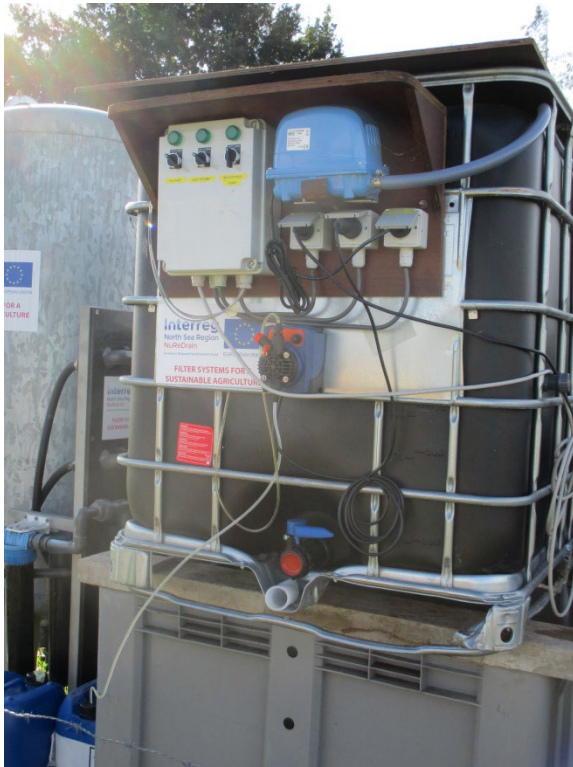
Photo 4 MBBR at Floristry Meuninck

At Floristry Meuninck, already for several years, all drain water is collected in a storage tank during winter, and in spring/summer, water was pumped through P filters. In 2019, also a MBBR filter was placed at Floristry Meuninck (Photo 4).

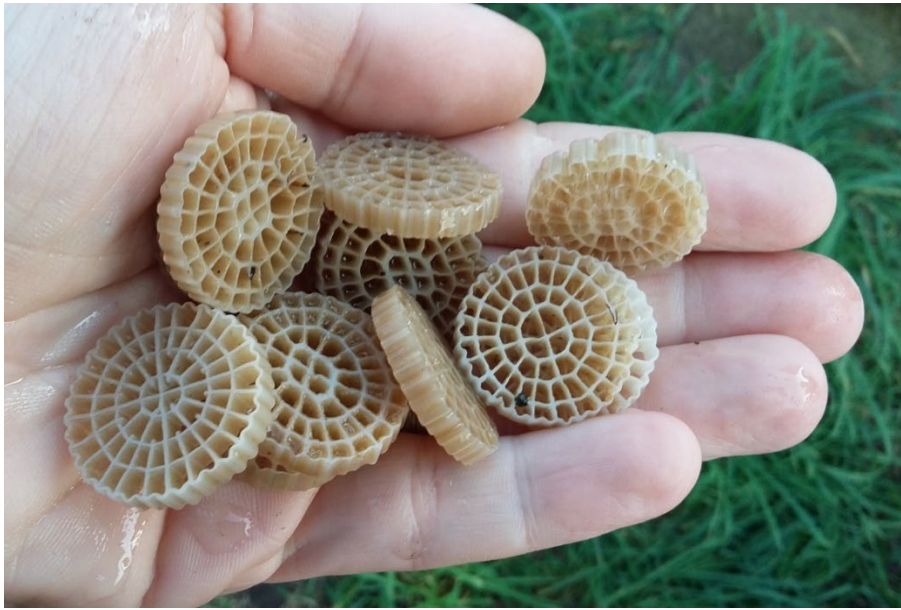
Photo 6 K5 carriers from the MBBR at Floristry Meuninck on 22/10/19

The MBBR was initiated at the beginning of August 2019, about 10 L carriers were taken from the MBBR installation of the PCS to inoculate the new installation. On these carriers, there was already a good development of the biofilm. On 22/10/19, there was a good working biofilm on the K5 carriers in the MBBR (Photo 6). The installation removed nitrates from the drain water very efficiently. The N-NO₃ concentration in the buffer tank was 28,7 mg/l N-NO₃ and after the MBBR, the concentration decreased till 5,4 mg/l N-NO₃ (Figure 4). In the tank beyond the MBBR, even all nitrates were removed. Photo 7 shows clearly that there is biofilm leaching from the MBBR. So, any additional denitrification can occur in the gray bin after the MBBR which can explain the complete removal of nitrates after the P filters. Also in 2020, the results for the MBBR were very good as can be seen in Figure 5. On 21/09/20, nitrates were not denitrified as expected, because the bin of the carbon source was empty.

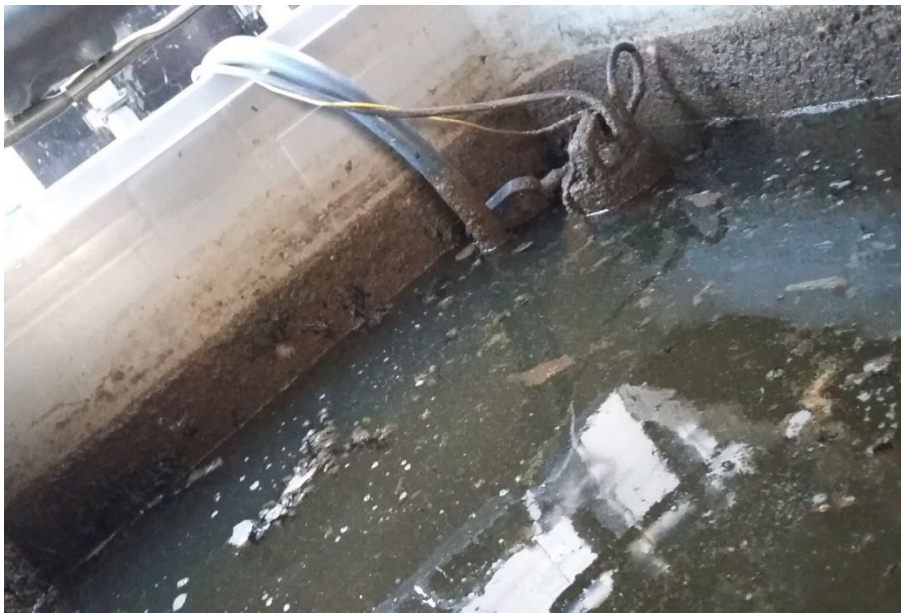
Photo 7 Bin which contains water that is passed through the MBBR at Floristry Meuninck on 22/10/19

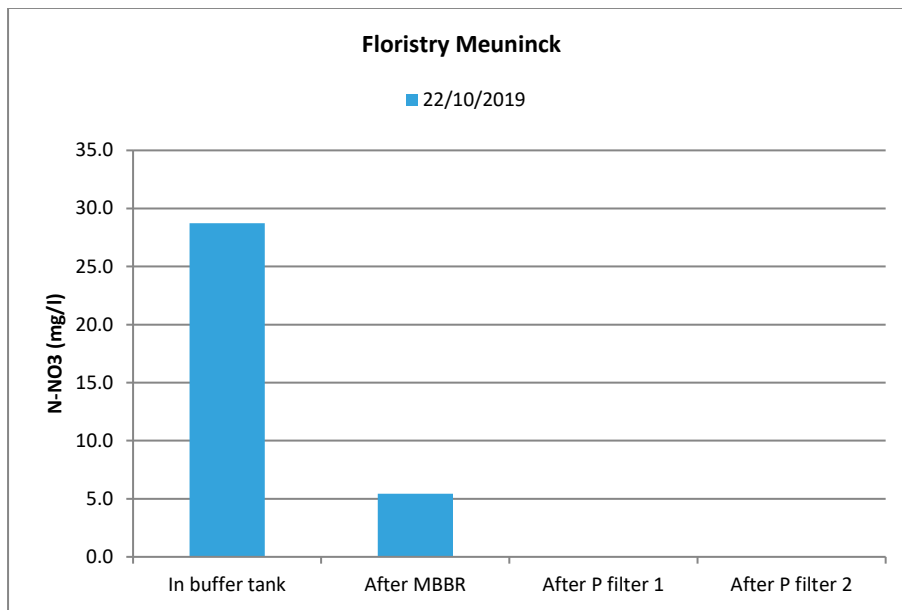
Figure 4 Results of nitrate removal for MBBR at Floristry Meuninck on 22/10/19

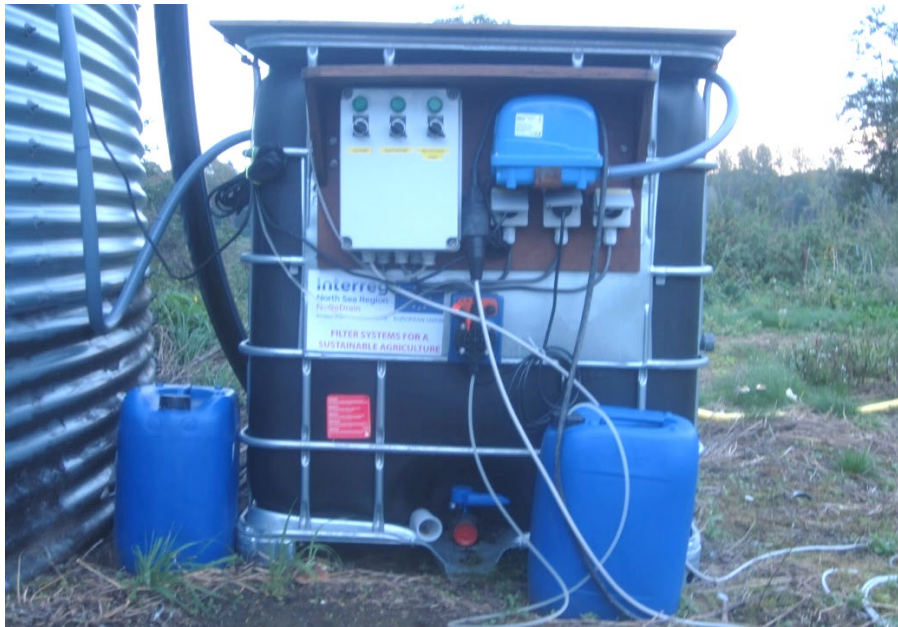
Photo 8 MBBR at Floristry Azaro

At Floristry Azaro, the MBBR was initiated at the end of September 2019 (Photo 8). About 10 L carriers were taken from the MBBR installation at the PCS to inoculate the new installation. After some weeks, a biofilm was developed very well on all carriers (Photo 9). Nitrates in the drain water were removed very well by the MBBR. Figure 6 shows some results. N content in the storage tank was 23,2 mg/l N-NO₃ and after MBBR, N content was lower than 0,1 mg/l N-NO₃. On 12/11/19, the N content in the storage tank was 12,0

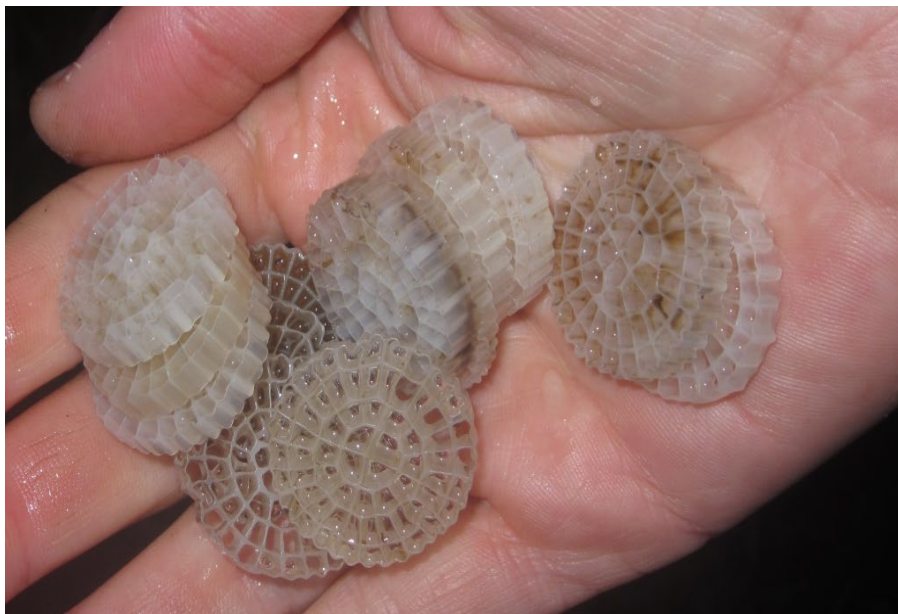
Photo 9 K5 carriers from the MBBR at Floristry Azaro on 24/10/19

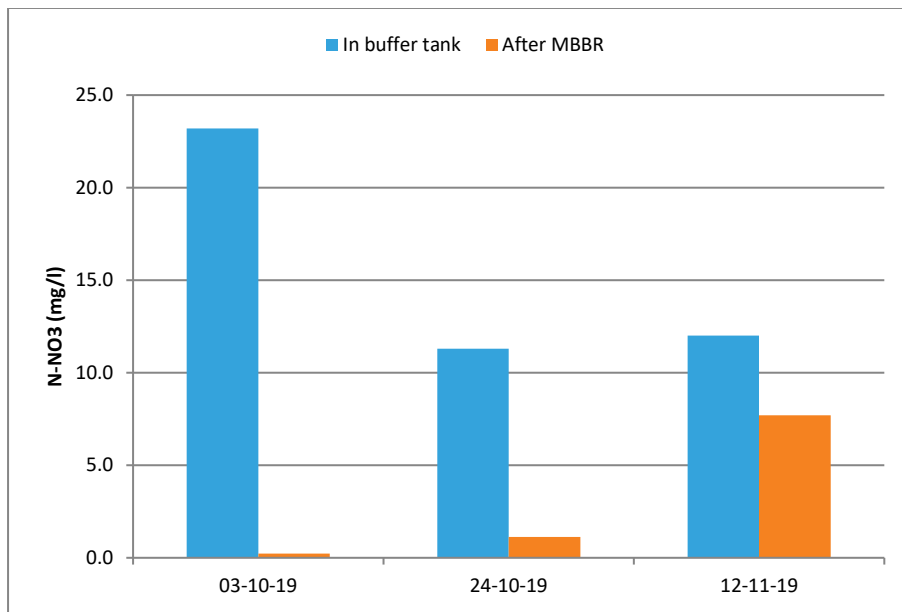
Figure 6 Results of nitrate removal for MBBR at Floristry Azaro in 2019

mg/l N-NO₃ and after MBBR, there was 7,7 mg/l N-NO₃. Afterwards, the MBBR was placed indoor to protect the installation for frost damage.

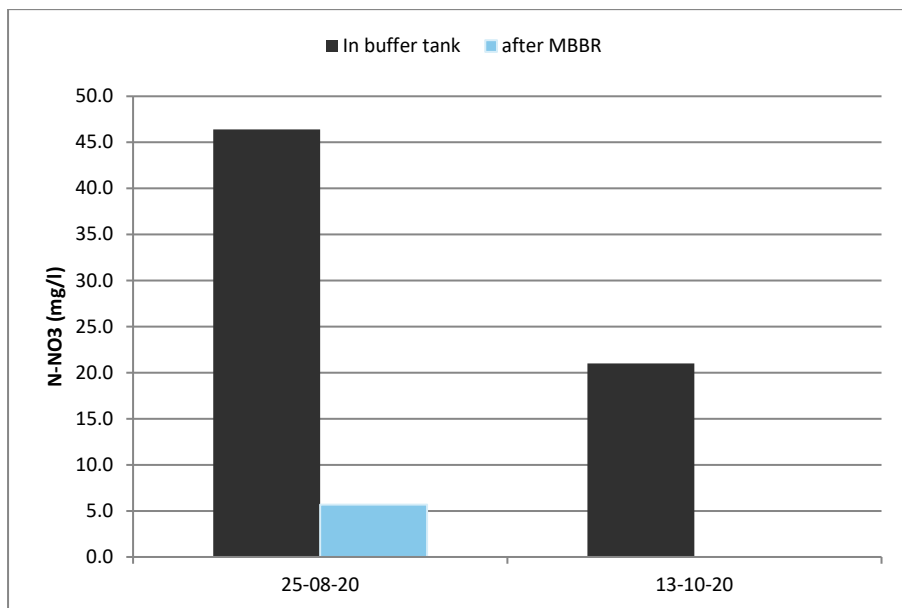
Figure 7 Results of N-nitrate removal for MBBR at Floristry Azaro in 2020

In 2020, when carbon was added, the MBBR worked very well. Unfortunately, sometimes the carbon source was not added, therefore, the efficiency of the MBBR could only be measured twice (Figure 7).
