## **FILTER SYSTEMS FOR A SUSTAINABLE AGRICULTURE**

# FIELD CASE DESCRIPTION

**Phosphorus filter box  
for drainage water at Staden**

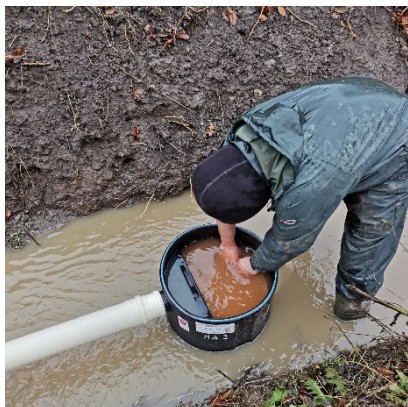
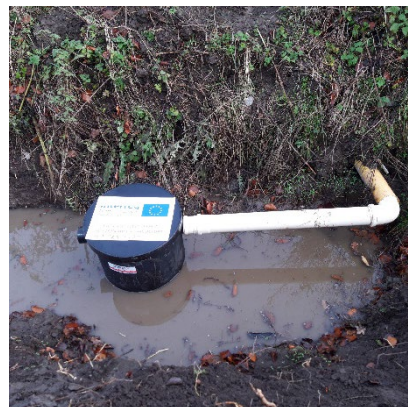
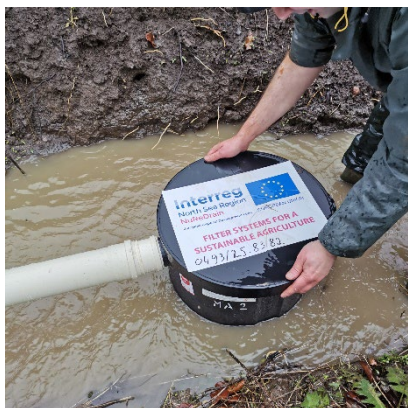
Figure 4 Prototype installed in the season of 2019-2021

The new prototype filter (cylindric shape, Figure 4) was installed in December 2019 with sieved filter materials (ICS>2mm). A layer of 24 cm being approximately 35 l of ICS was filled in the filters.

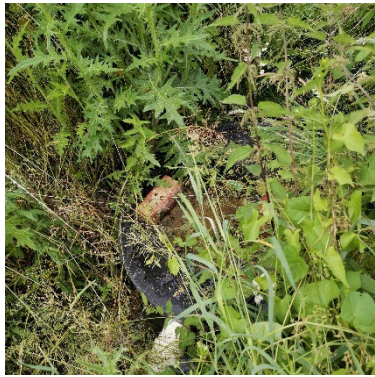
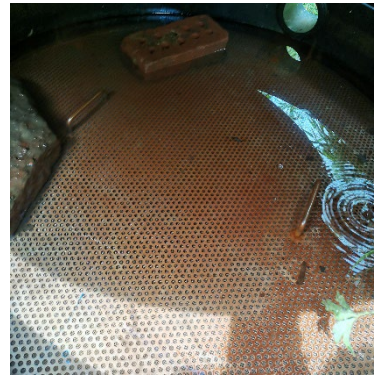
Figure 5 Prototype installed in February 2021

The prototype from season 2019-2020 was kept until January 2021 to check the long-term performance of the filter. Then a bigger filter was installed on 2 February 2021 and filled with a layer of 24 cm, approximately 120 l, of ICS >2mm (Figure 5). The water in Staden was drained from a larger field (1-2 ha) which was beyond the processing capability of the small filter. Therefore, a bigger filter was designed and installed to check if P removal efficiency could be improved.

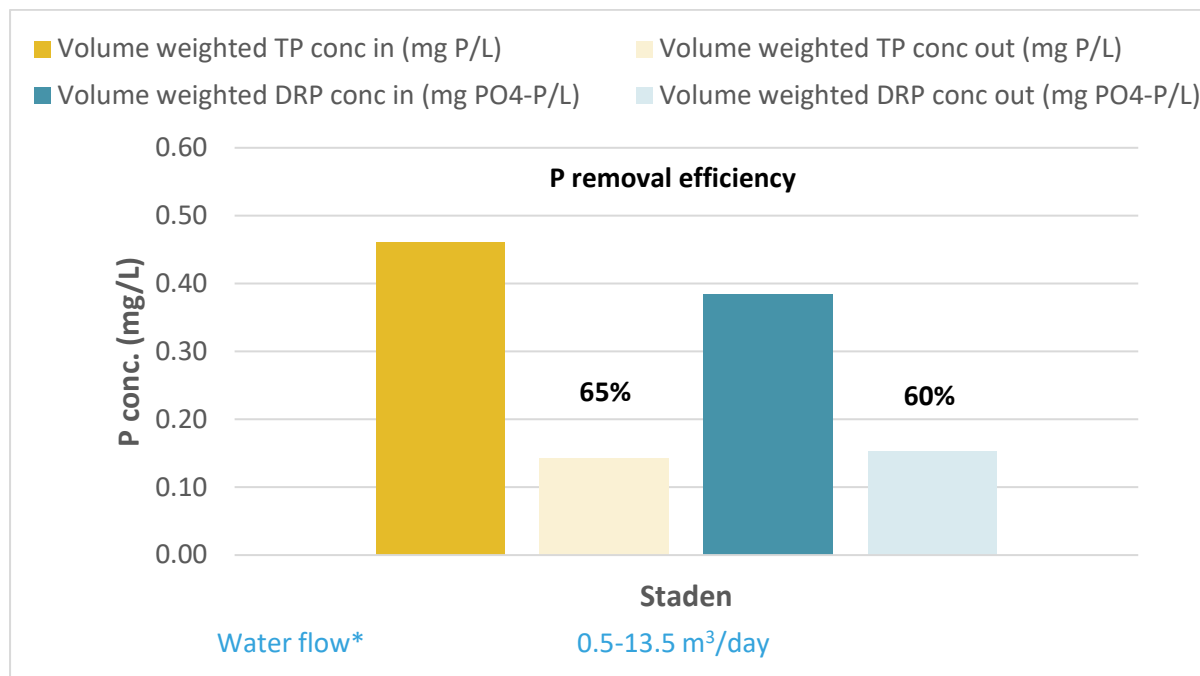
Figure 6. P removal efficiency of custom-made filter box during the season of 2017-2018.

\*water flow was measured every week and this range represented the water flow on the measuring days.

In the site of Staden, 65% of total phosphorus (TP) and 60% of dissolved reactive phosphorus (DRP) was removed by the filter box during the period of 9/1/2018 - 11/4/2018 with an average water flow of 5 m<sup>3</sup>/day. Frost problems occurred during the period of 21/2/2018 - 28/2/2018.

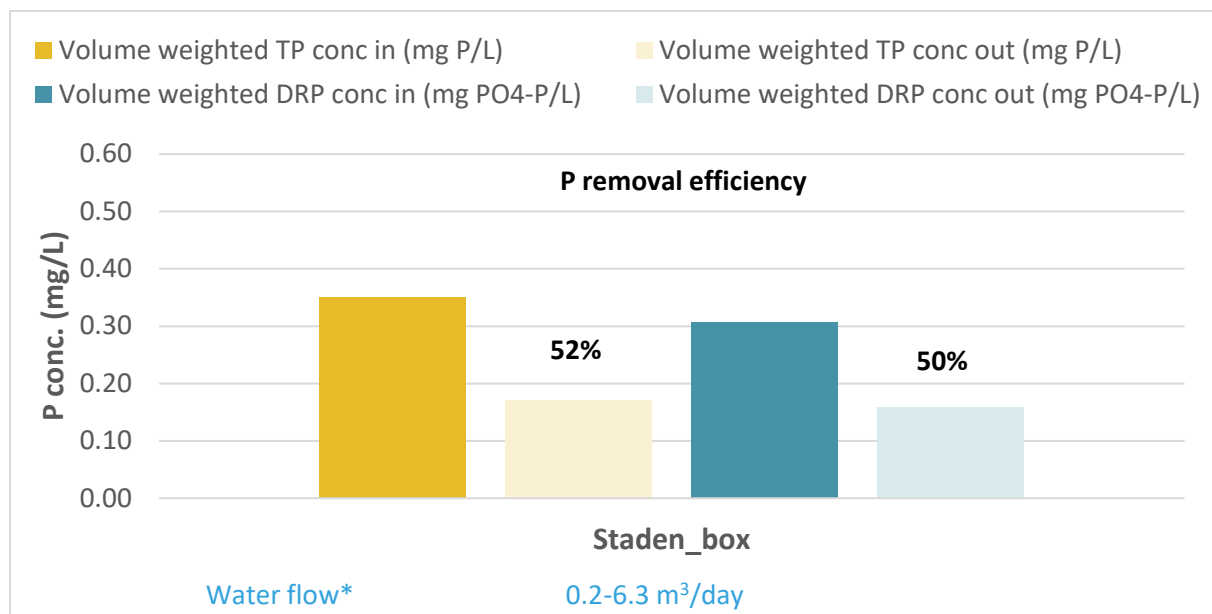
Figure 7. P removal efficiency of custom-made filter box during the season of 2018-2019.

\*water flow was measured every week and this range represented the water flow on the measuring days.

In the site of Staden, 52% of TP and 50% of DRP was removed by the filter box during the period of 20/12/2018 - 28/3/2019 with an average water flow of 2.3 m<sup>3</sup>/day. Overflow happened on the dates of 31/1, 8/2, 8/3, 15/3/2019 and a white foam was observed in the drainage tube on 8/2/2019.

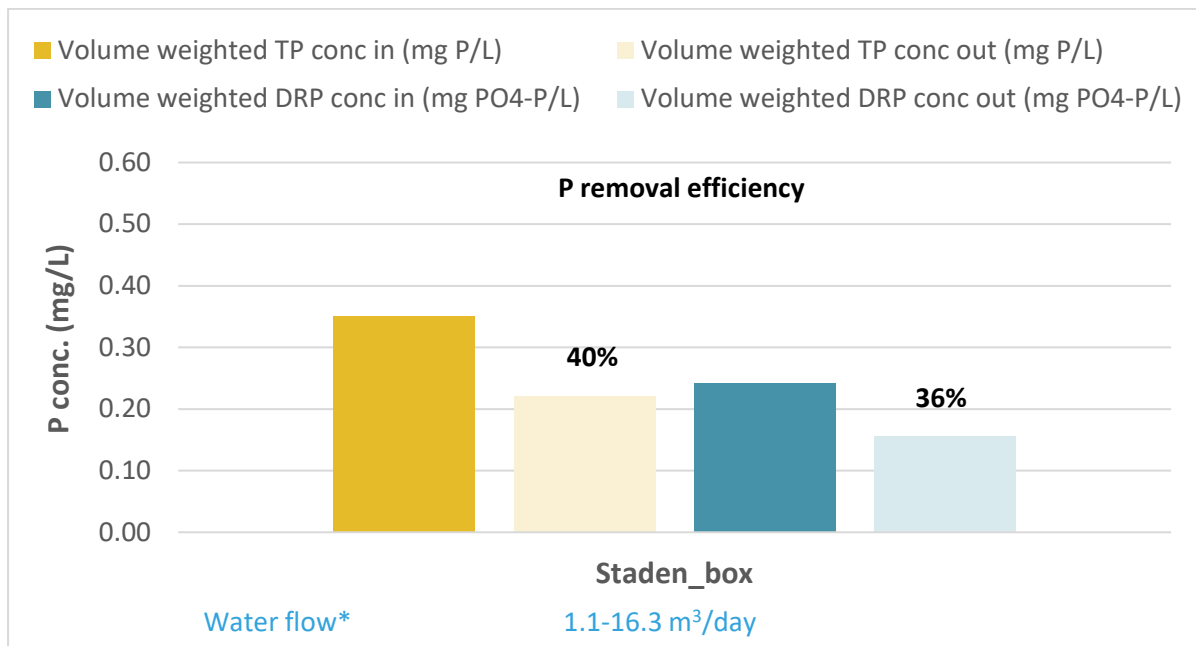
Figure 8 P removal efficiency of prototype filter during the season of 2019-2020.

\*water flow was measured every week and this range represented the water flow on the measuring days.

The same prototype filters were installed at three different sites. In Staden, 40% of TP and 36% of DRP was removed during the period of 9/1/2020 – 13/3/2020 with an average water flow of 6.36 m<sup>3</sup>/day. It was reported with overflow on the dates of 10/2, 14/2 and 3/3/2020.

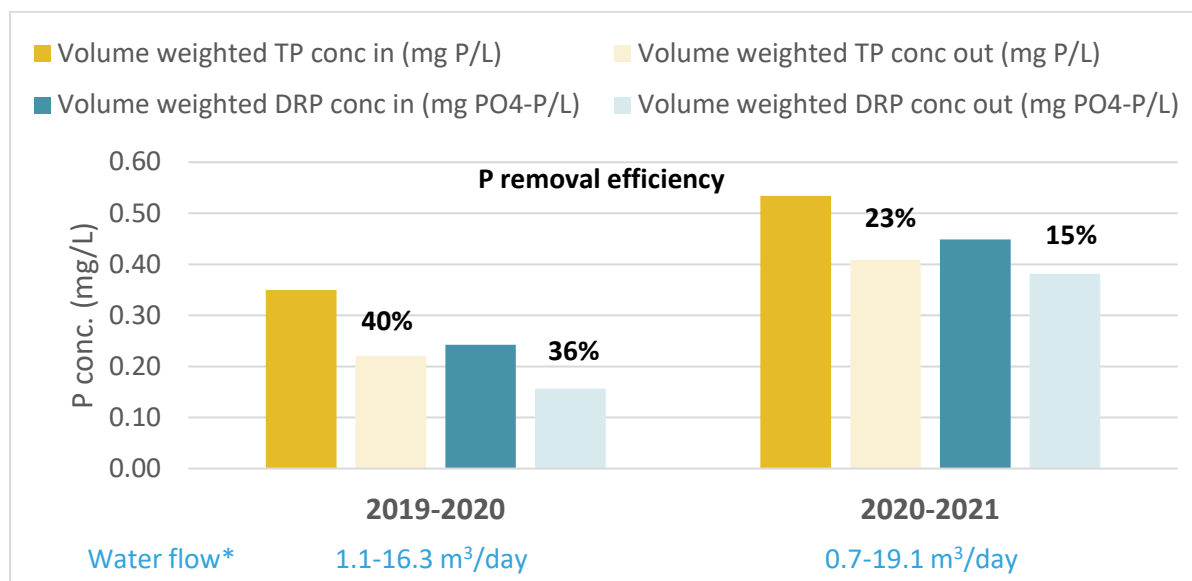
Figure 9 Long-term performance of prototype filter in Staden over two drainage seasons

\*water flow was measured every week and this range represented the water flow on the measuring days.

After two drain seasons, the P removal efficiency of the prototype filter decreased gradually: on average 40% and 23% of total P (TP) and 36% and 15% of dissolved reactive P (DRP) were removed in the first and second season, respectively (Figure 9). To test whether ICS got saturated after two seasons, the sample (well mixed) was sent to KULeuven and an adsorption and desorption experiment was applied. At a P level of 0.45 ppm, ICS will still be able to adsorb P but the discharge standard will no longer be met.
