### FILTER SYSTEMS FOR A SUSTAINABLE AGRICULTURE

# FIELD CASE DESCRIPTION

## Phosphorus filter system for agricultural drainage water (second field case)

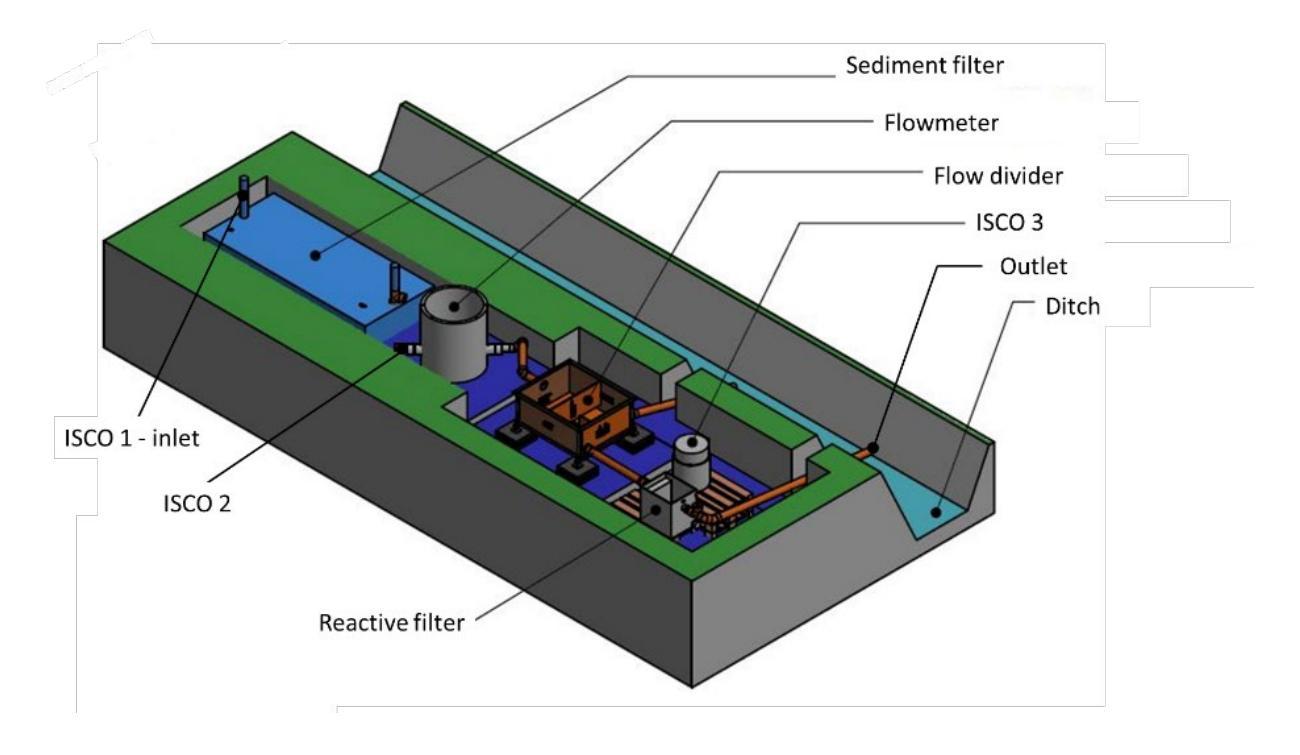
Figure 1 Schematic drawing of the drainage P-filter system

The filter system consists of the following main units:

- a pump feeding drainage water from the collector drain into the filter system at flow rates of typically 1 – 1.5 l/s.

- a WaterCare A/S DPF sediment filter of 1000 l capacity which has the function of retaining small particles and thus particulate P.

- Krohne<sup>™</sup> electromagnetic flowmeter that measures the actual amount of water transported through the WaterCare A/S sediment filter unit.

- a flow divider for directing ca. 10% of the incoming drainage water to the reactive filter for dissolved P.

- a CGK group BV filter box containing 50 kg of iron coated sand (ICS).

- a flow meter at the outlet of the filter box.

Three ISCO<sup>™</sup> samplers for continuous automated water collection are positioned at the inlet (ISCO1), between the sediment and reactive filter (ISCO2) and at the outlet (ISCO3). Total P (TP), total dissolved P (TDP), turbidity, pH and EC are measured in the lab on time proportional samples.

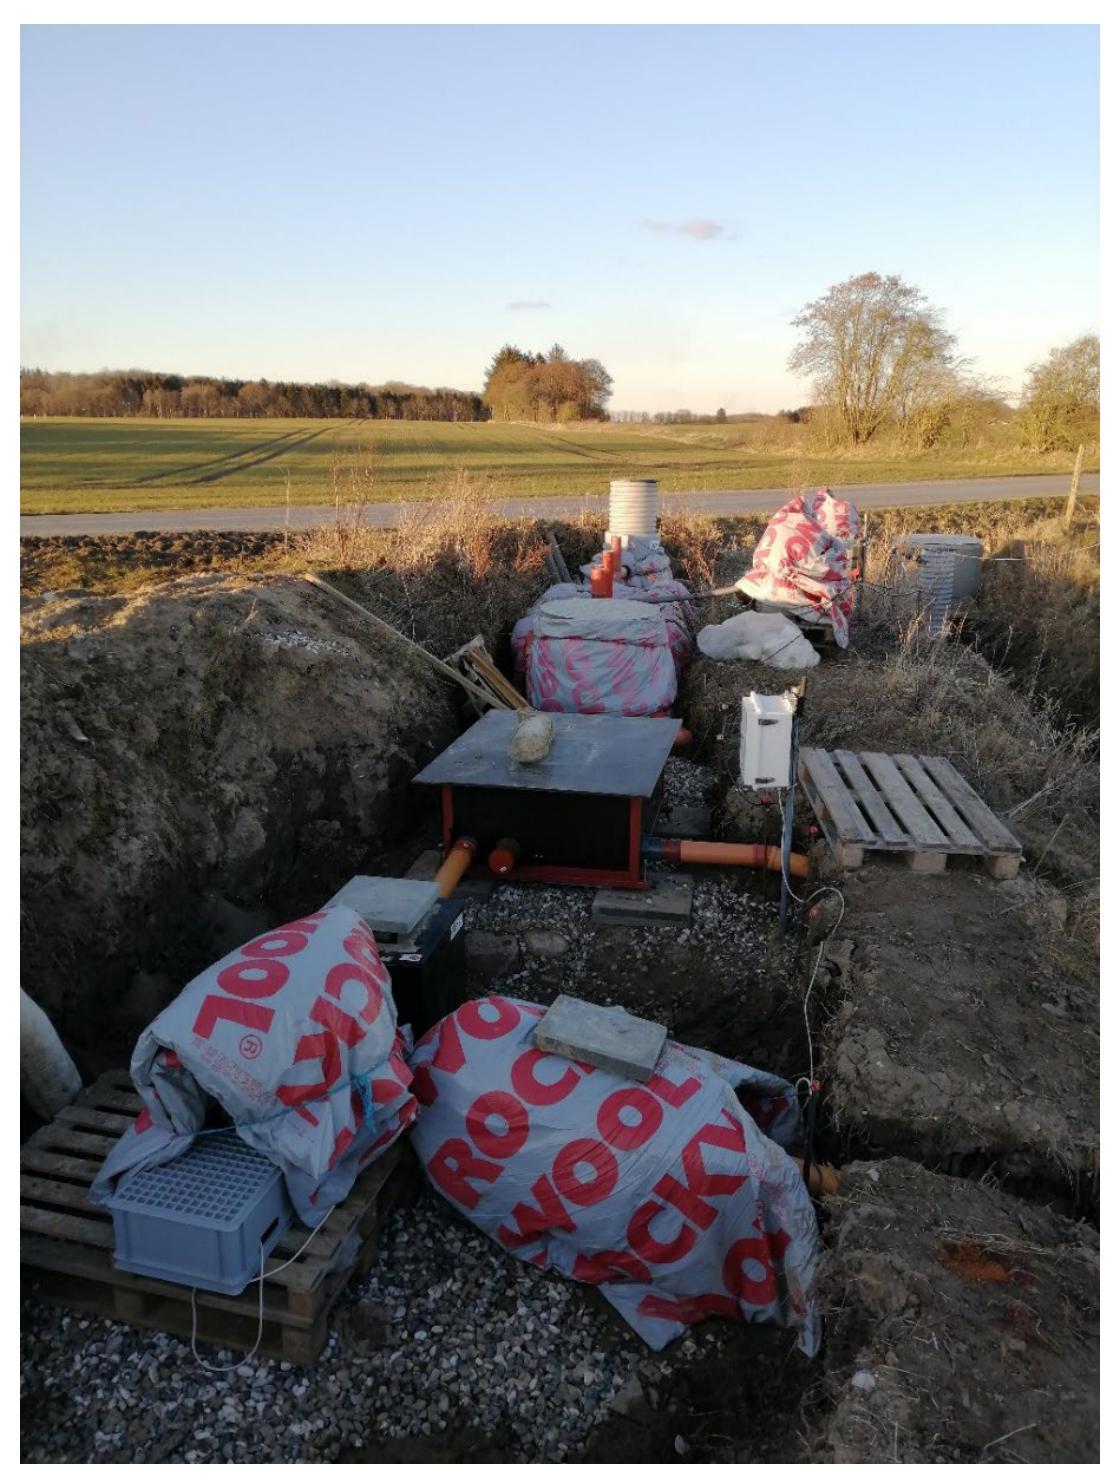
Figure 2 Drainage P-filter system near Odder, Denmark.

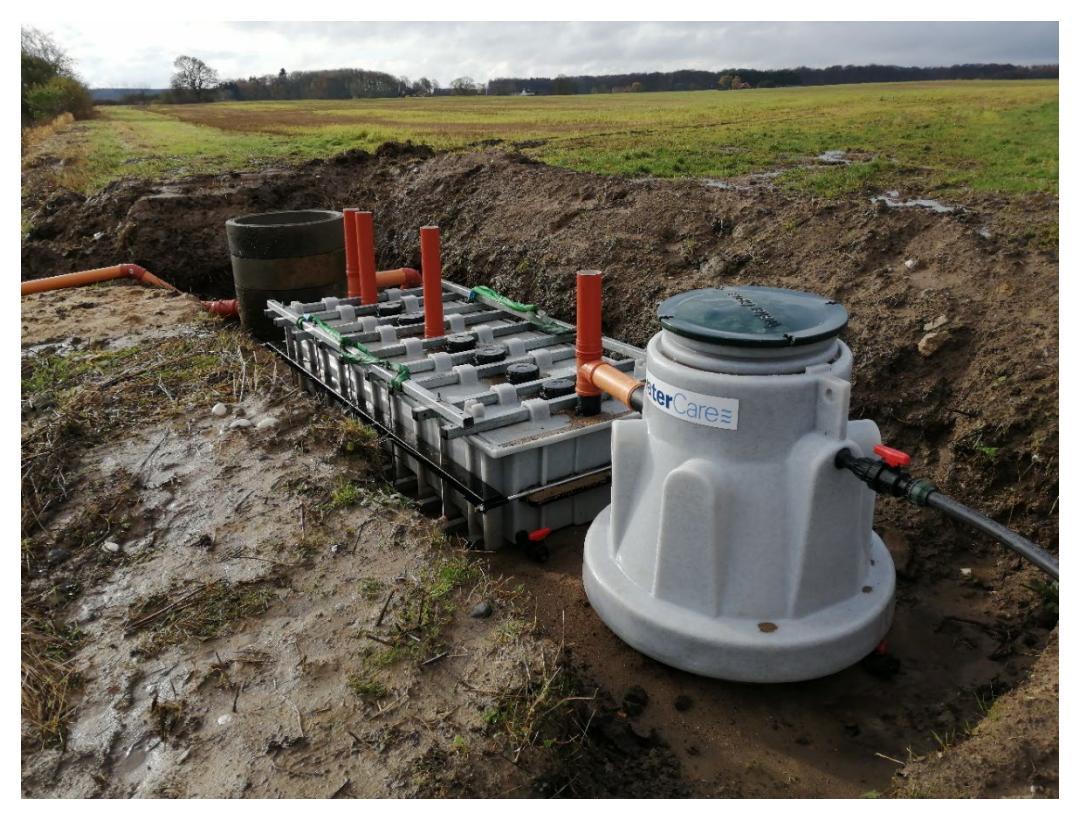
Figure 3 WaterCareTM prefilter for retaining sand and larger particles (right) and DPF sediment filter (left) during installation.

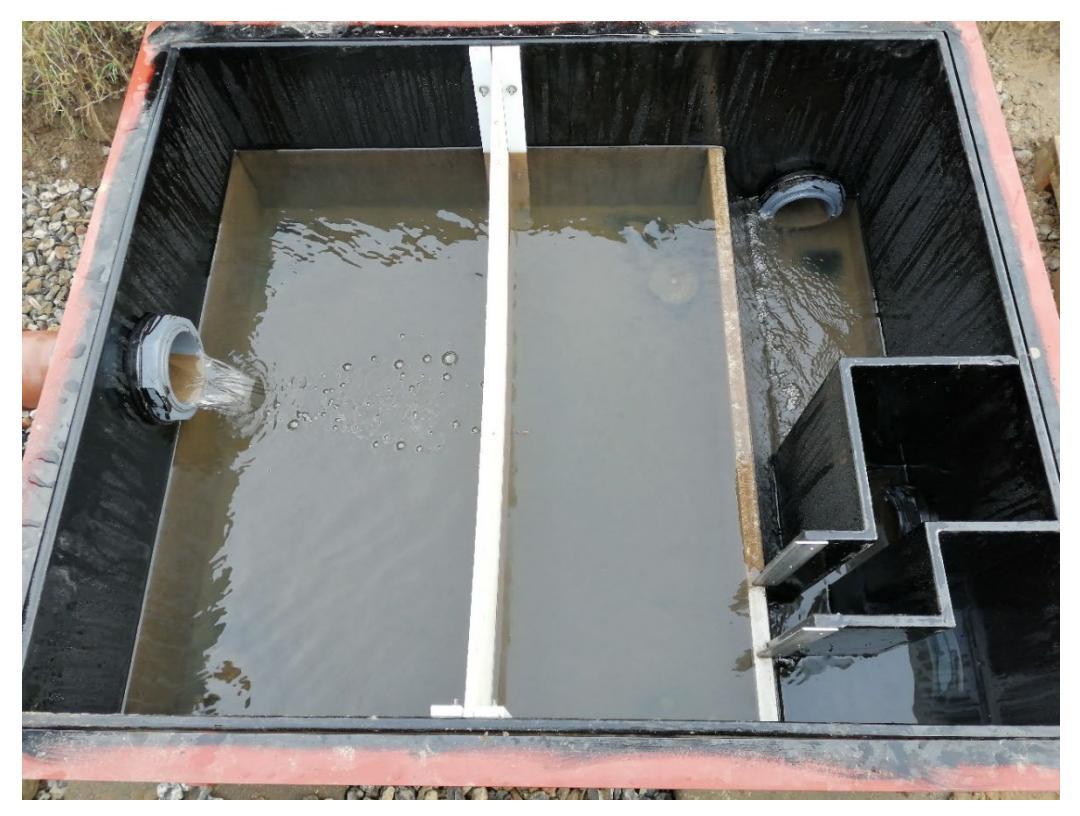
Figure 4 Flow divider

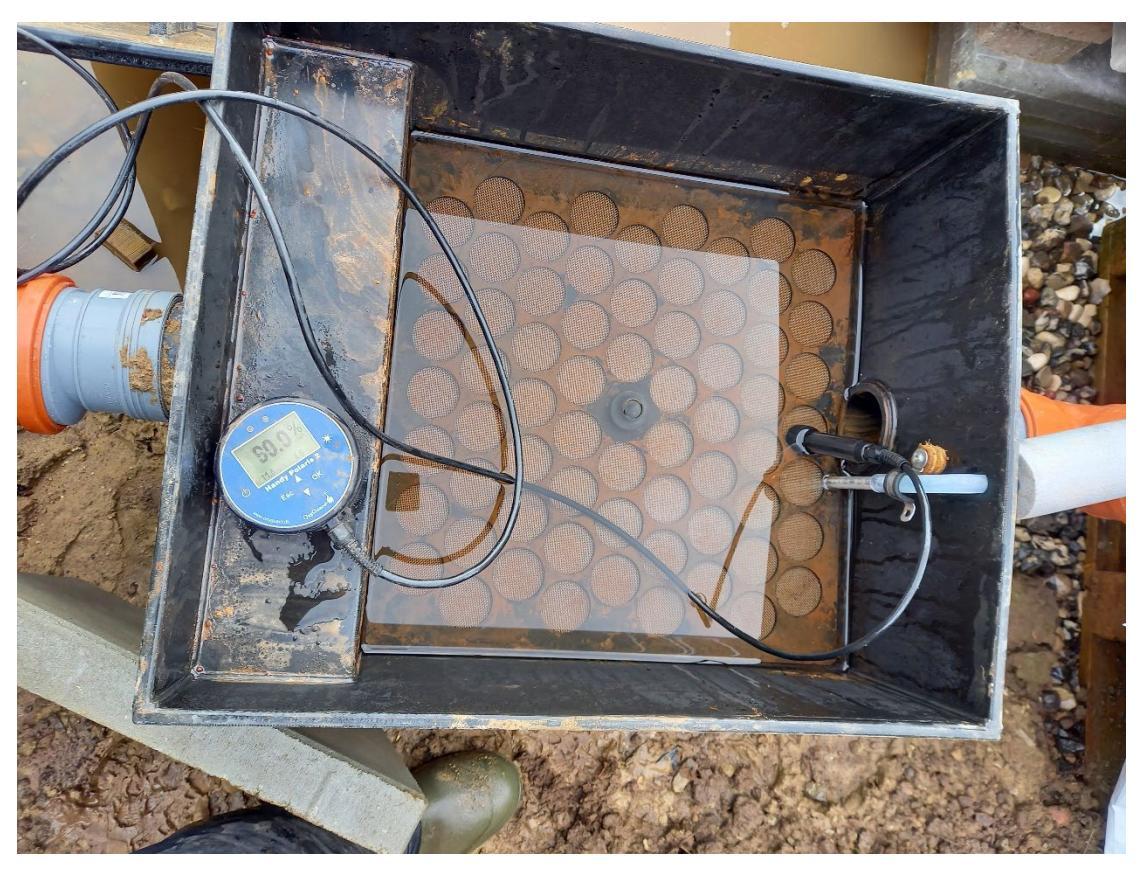
Figure 5 Filter box with reactive ICS filter

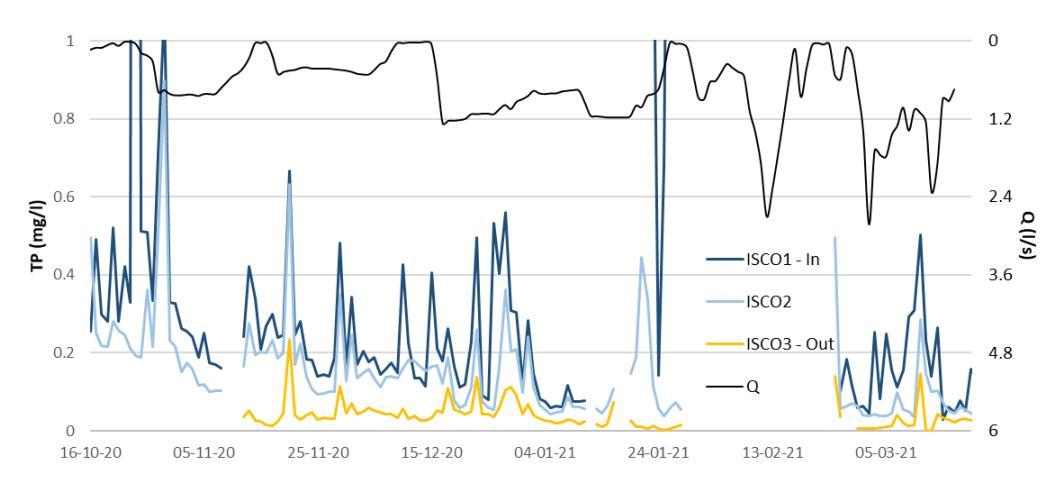
Figure 6 Daily values of total phosphorus (TP) at the inlet (ISCO1), between the sediment and reactive filter (ISCO2) and at the outlet (ISCO3) of the filter system. The hydrualic loading (Q) is given on the secondary axis.

The hydraulic loading (Q) to the filter system during the 2020-2021 season reached 2.82 l/s. Higher peaks were recorded from February 2020 and their reduction generally occurred in the 2-5 days following isolated rain events.

Total P concentrations in drainage water at the inlet (ISCO1) varied between 0.03 and 2.47 mg TP/l, while TDP varied between 0.04 and 0.84 mg/l. Values of TP at the outlet (ISCO3) ranged from 0.00 to 0.36 mg/l, while TDP ranged from 0.00 to 0.32 mg/l. The three highest peaks in October and January were due to partial remobilization of P during cleaning operations of the filter system. The missing data in February 2021 are due to very low temperatures and consequent system freezing.

Average monthly retention of TP for the overall system varied between 73 and 83%. The positive retention efficiency was primarily attributed to the TDP retention by the ICS, which varied between 60 and 79%.

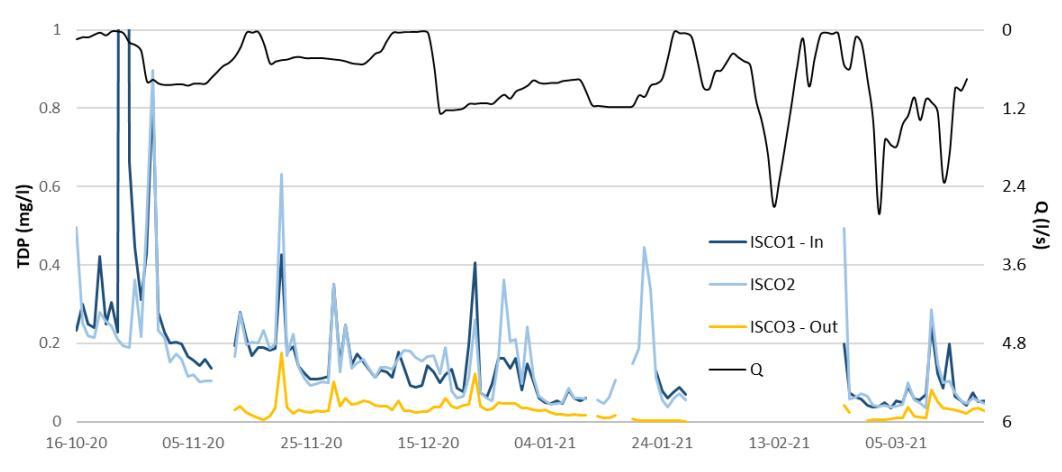
Figure 7 Daily values of total dissolved phosphorus (TDP) at the inlet (ISCO1), between the sediment and reactive filter (ISCO2) and at the outlet (ISCO3) of the filter system. The hydrualic loading (Q) is given on the secondary axis.
